18 April 2018

Shellharbour City Council

February 2018 Quarterly Environmental Monitoring – Dunmore Recycling and Waste Disposal Depot, Dunmore, New South Wales.

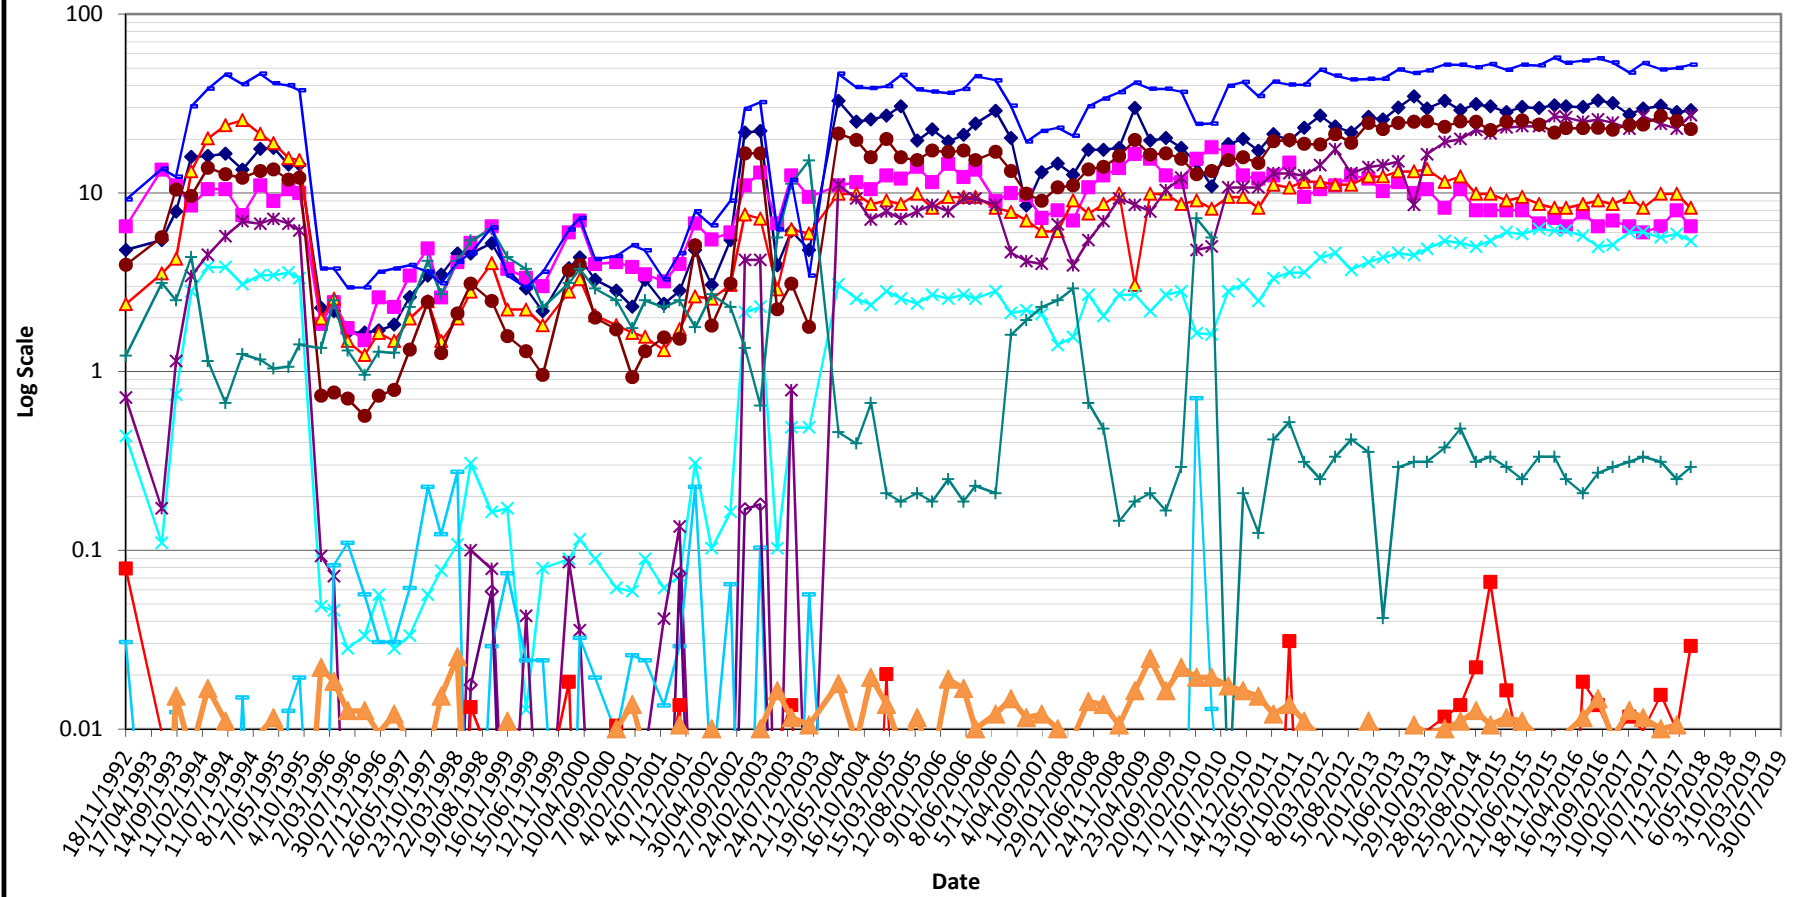
Bore BH1c is located near the old unlined landfill cell and intercepts leachate within the cell. As such the chemical signature of this bore has historically contained elevated leachate indicators in comparison to other monitoring bores (Schoeller plot BH1 a/b/c, Attachment 3). This continued during the current monitoring event and the groundwater was found to have a light brown colour, and leachate odour noted in combination with elevated TDS (3910 mg/L), K^+ (210 mg/L) [resulting in low Ca/K – 1.21] and NH_4^+-N (380 mg/L) concentrations. The low levels of oxygen (1.44 ppm, Table 1) and presence of soluble Fe^{2+} indicate an anaerobic state and biochemical demand in response to microbial respiration. BOD has fluctuated since the bore was installed, ranging from 830 mg/L to 6 mg/L. BODs have remained at similar levels during August 2016, November 2016, February 2017, May 2017, August 2017, November 2017 and February 2018 rounds and were 8, 7, 7, 6, 6, 6 and 8 mg/L respectively. Further evidence of microbial activity / respiration is elevated HCO_3^- resulting in a low Cl/ HCO_3^- ratio of 0.44 (Table 4). This suggests some degradation of the leachate plume has occurred in this monitoring bore.

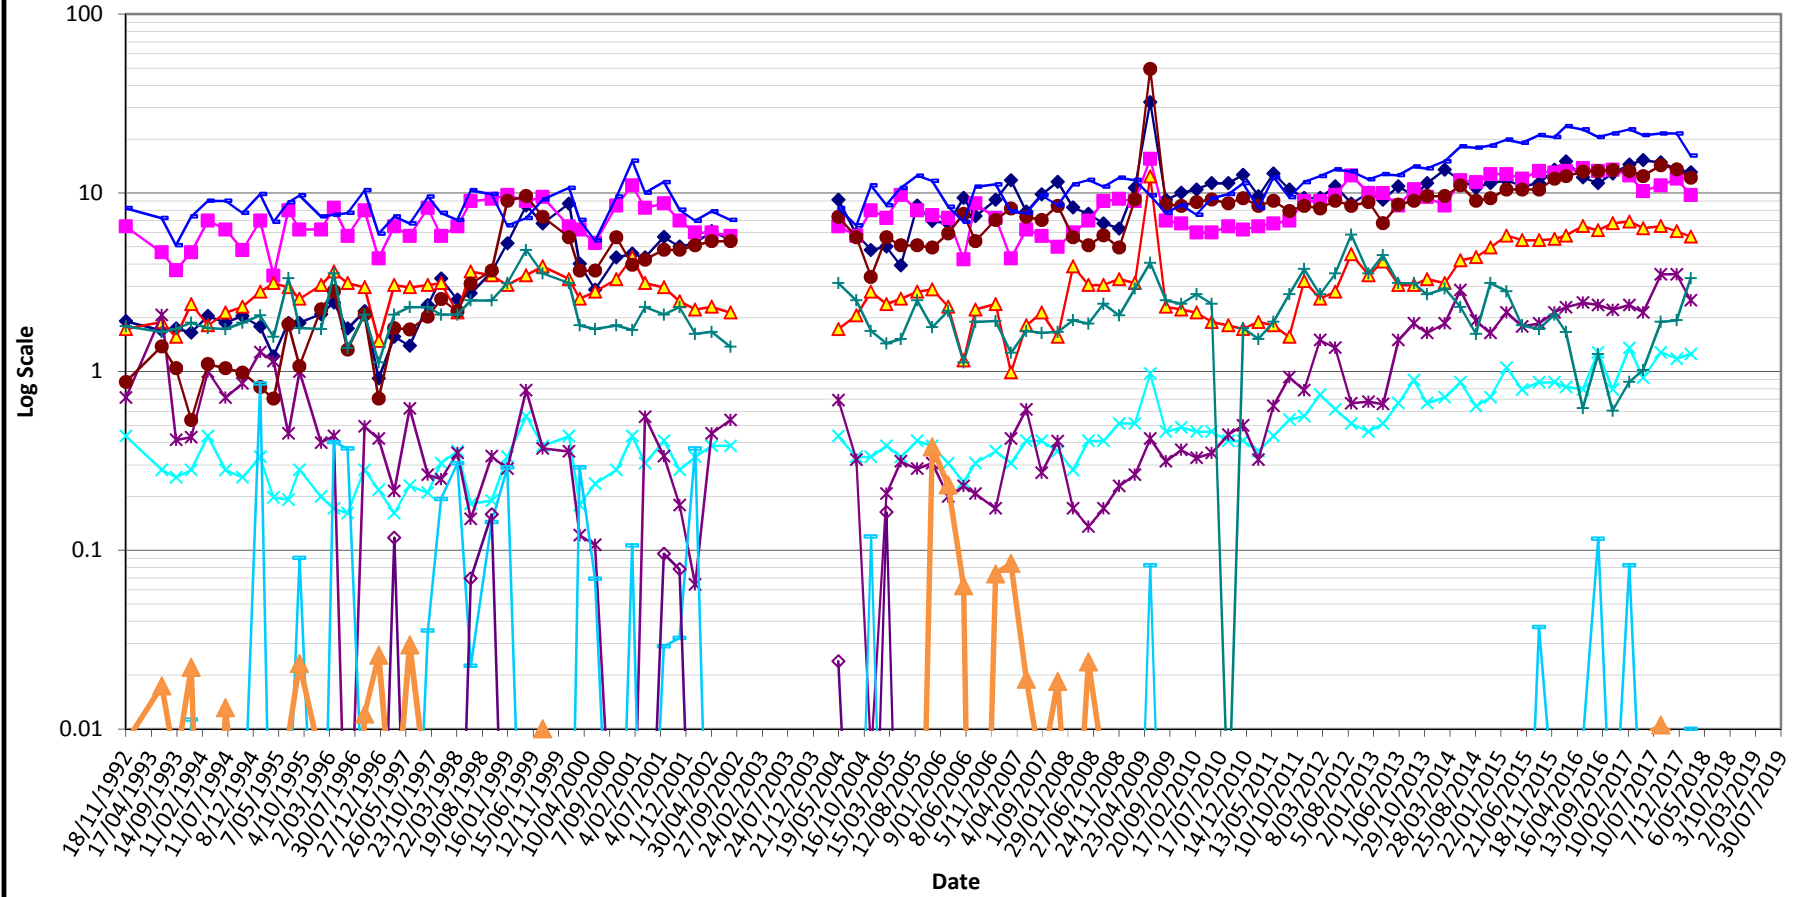
Bore BH2 is located down gradient from the old unlined landfill cell. Historically elevated levels of NH_4^+-N indicate some leachate impact at this location. NH_4^+-N concentration at BH2 showed an increasing trend since 2010 and reached its historical maximum in August 2017 and November 2017 (49 mg/L in both months). NH_4^+-N concentration decreased in the February 2018 monitoring round to a level of 35 mg/L. Bicarbonate (HCO_3^-), Na^+ and Mg^{2+} concentrations in groundwater have shown an increasing trend since January 2008 despite slight decreased concentrations in the February 2018 sampling event (Table 2, Schoeller plot BH2, Attachment 3). Chlorine (Cl⁻) and calcium (Ca^{2+}) concentrations slightly decreased whilst potassium (K^+) slightly increased since the last monitoring round (Table 2, Schoeller plot BH2, Attachment 3). This is representative of the small decrease in TDS. Low oxygen and negative redox (Table 2) continue to suggest microbial respiration and therefore degradation of the leachate is occurring at this location. Additionally, a leachate odour was noted.

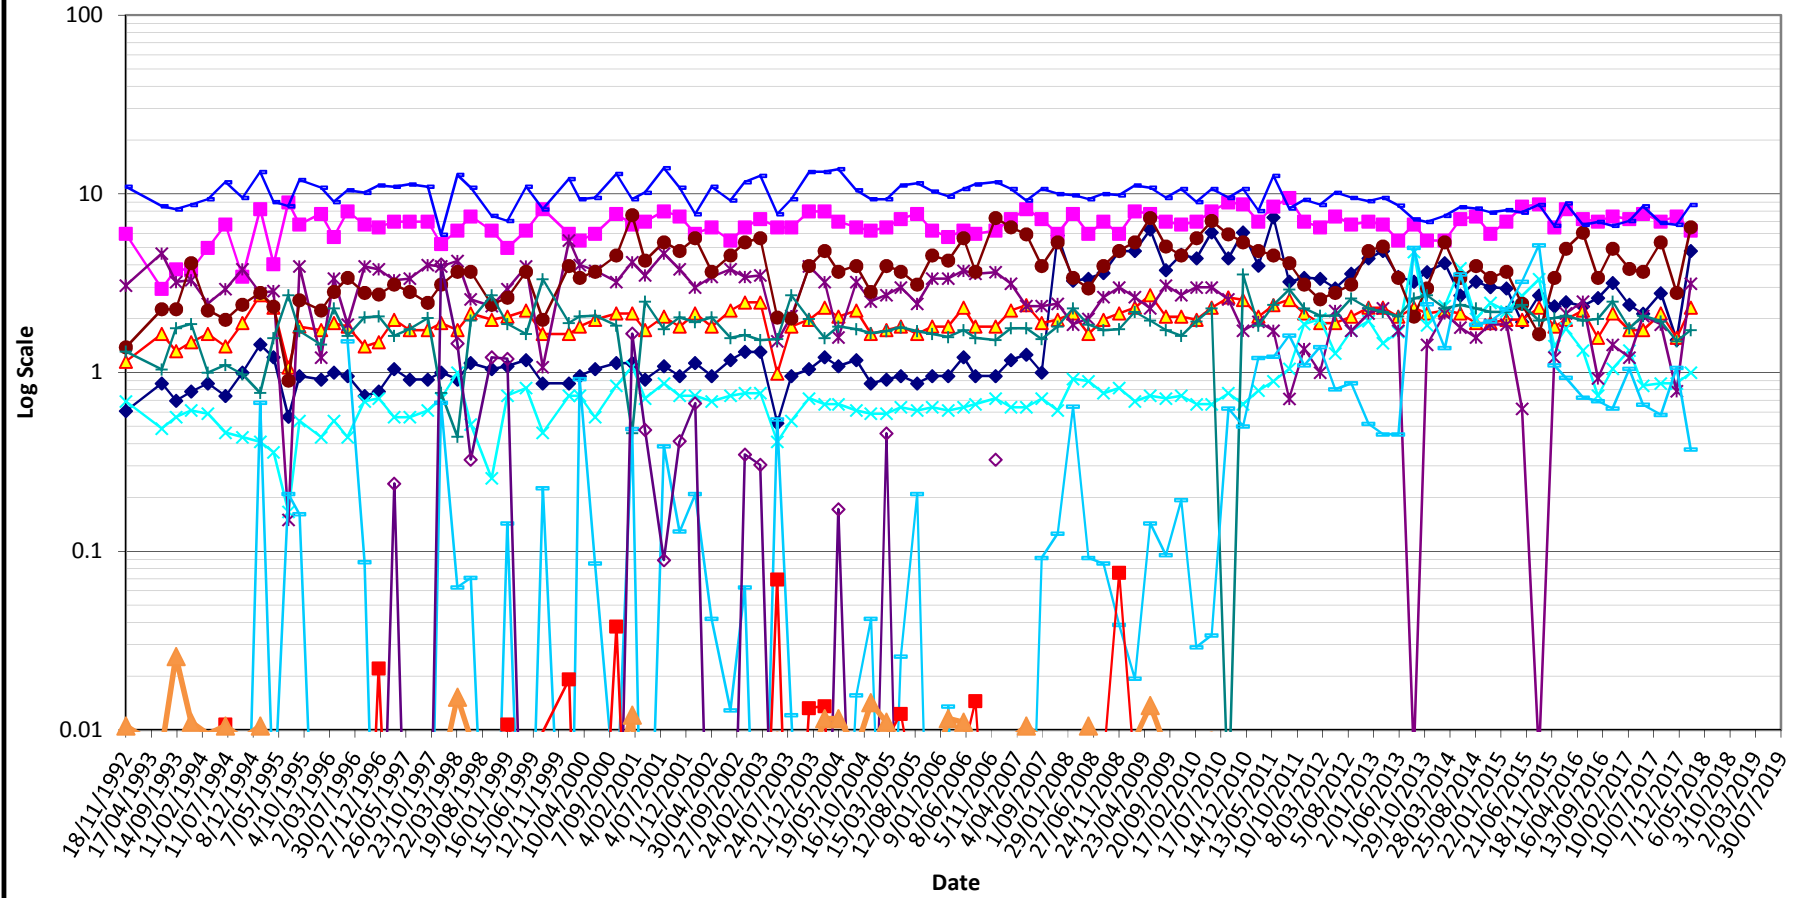
Groundwater from bore BH3 reported decreases in concentration of one native ion (Ca^{2+}) as well as one non-native ion (NO_3^-) since last monitoring round. Comparatively, the concentration of Na^+ , Mg^{2+} , K^+ , $\text{NH}_4^+\text{-N}$, Cl^- , SO_4^{2-} and HCO_3^- increased. The L/N ratio (40.30%) has decreased since the November 2017 monitoring round (54.41%). However, due to the low TDS (<1000 mg/L) the L/N ratio must be used with some caution. Long term trends (since 1992) show that K^+ concentrations generally had an increasing trend from February 2011 until November 2015, the levels have then returned to historical levels by August 2016. Nitrogen species (NO_3^- , NO_2^- and $\text{NH}_4^+\text{-N}$) have remained within historical levels. It was reported and verified during the drilling of BH3 that old unconfined waste dumps were in the vicinity of bore BH3 (outside the designated cells near bore BH2). This waste is likely to have an impact on the results.

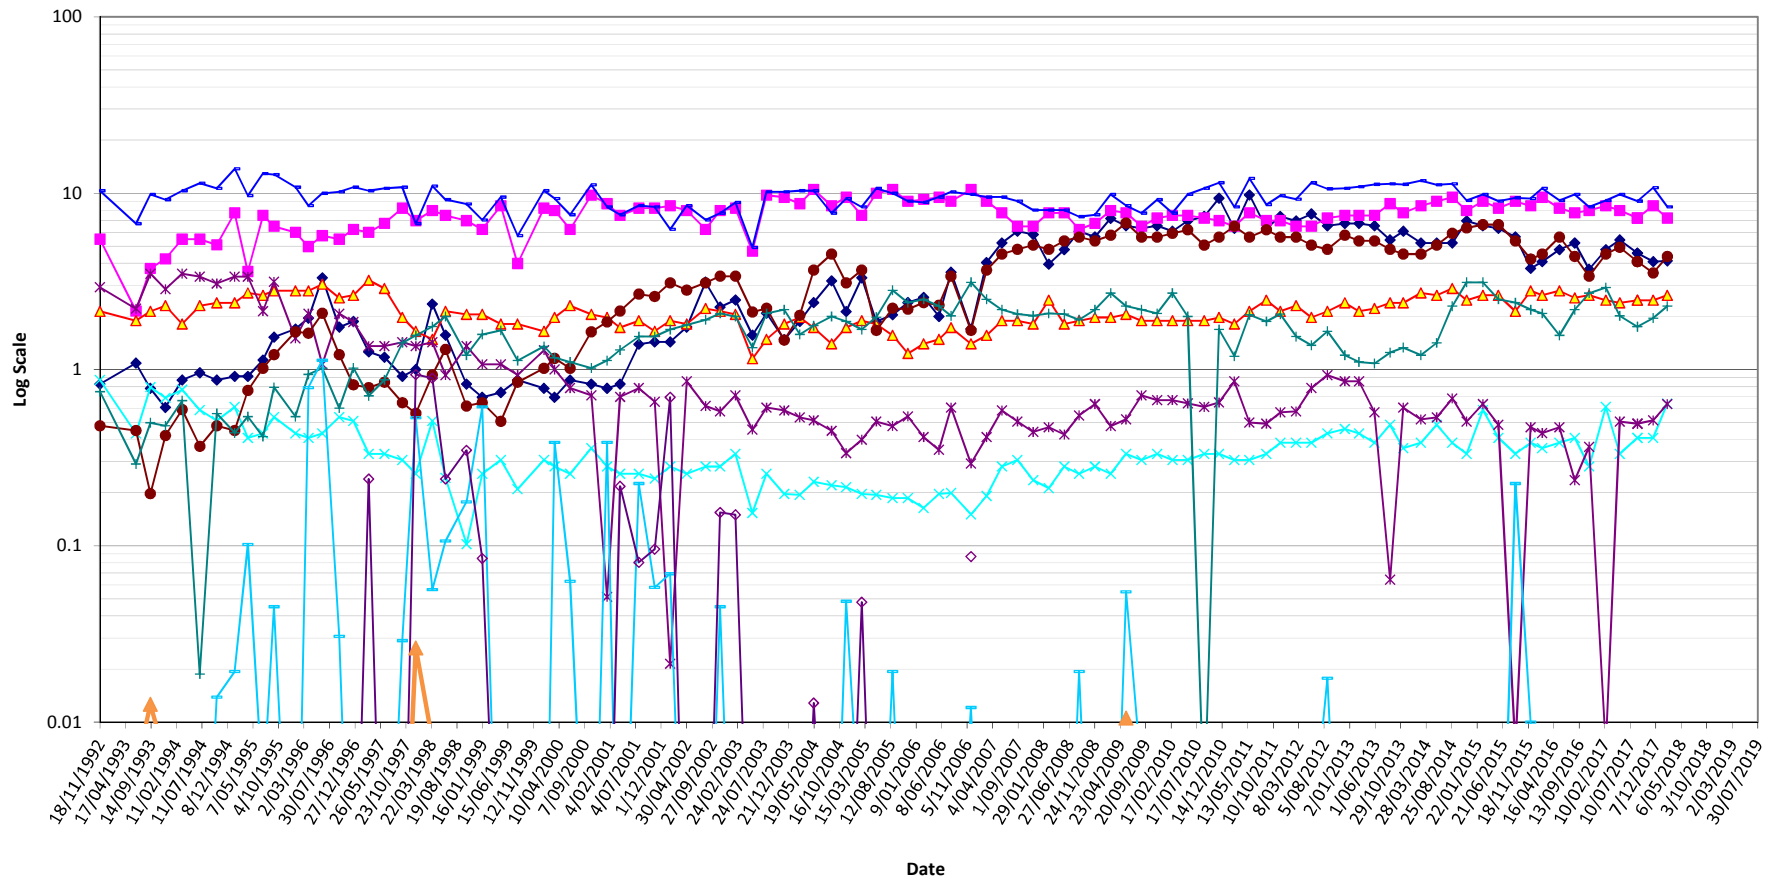
The L/N ratio at bore BH4 showed an increase in the February 2018 round (12.54%) — in November 2017 monitoring round the L/N ratio was 7.93% at this location. The L/N ratio at this location has not exceeded 10% since February 2003 and this trend should be examined in following monitoring rounds. Increased concentrations of non-native ions $\text{NH}_4^+\text{-N}$ and K^+ and relatively stable concentrations of native ions Na^+ , Ca^{2+} and Mg^{2+} can be attributed to the increase in L/N ratio however this value should be used carefully due to low TDS <1000 mg/L. Bore BH4 is placed on the border of an historic shallow landfill site and down gradient of landfilling activities and should be continually monitored to determine water quality in this area.

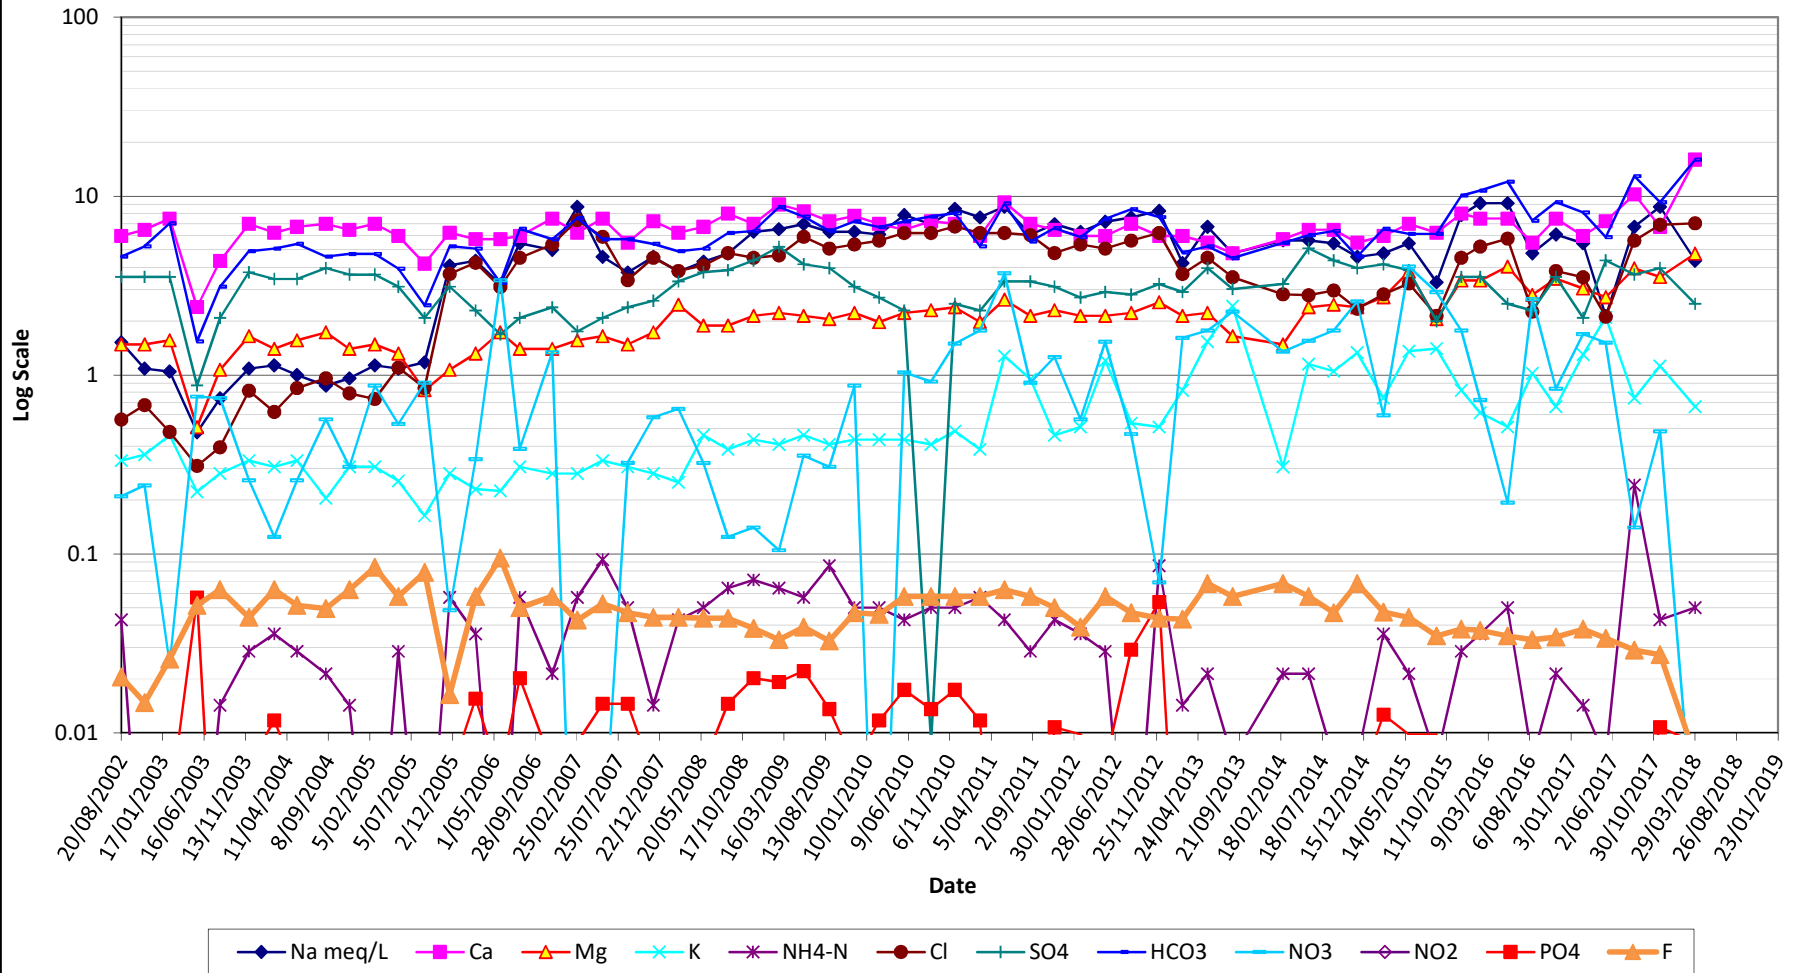
The L/N ratio at bore BH14 showed a decrease in the February 2018 round (5.61%) — in November 2017 monitoring round the L/N ratio was 19.74% at this location. Concentrations of K^+ were lower in the February 2018 monitoring period compared to November 2017 levels (Schoeller plot BH14, Attachment 3). $\text{NH}_4^+\text{-N}$ concentration increased slightly to 0.70 mg/L from 0.60 mg/L in November 2017. This increase in the non-native ions was offset by a steep reduction in NO_3^- which dropped by two orders of magnitude – from 30.00 mg/L in November 2017 to 0.13 mg/L in February 2018 monitoring period. Bore BH14 is strategically placed down gradient of landfilling activities and should be continually monitored to determine the water quality in this area given its history of leachate impact.

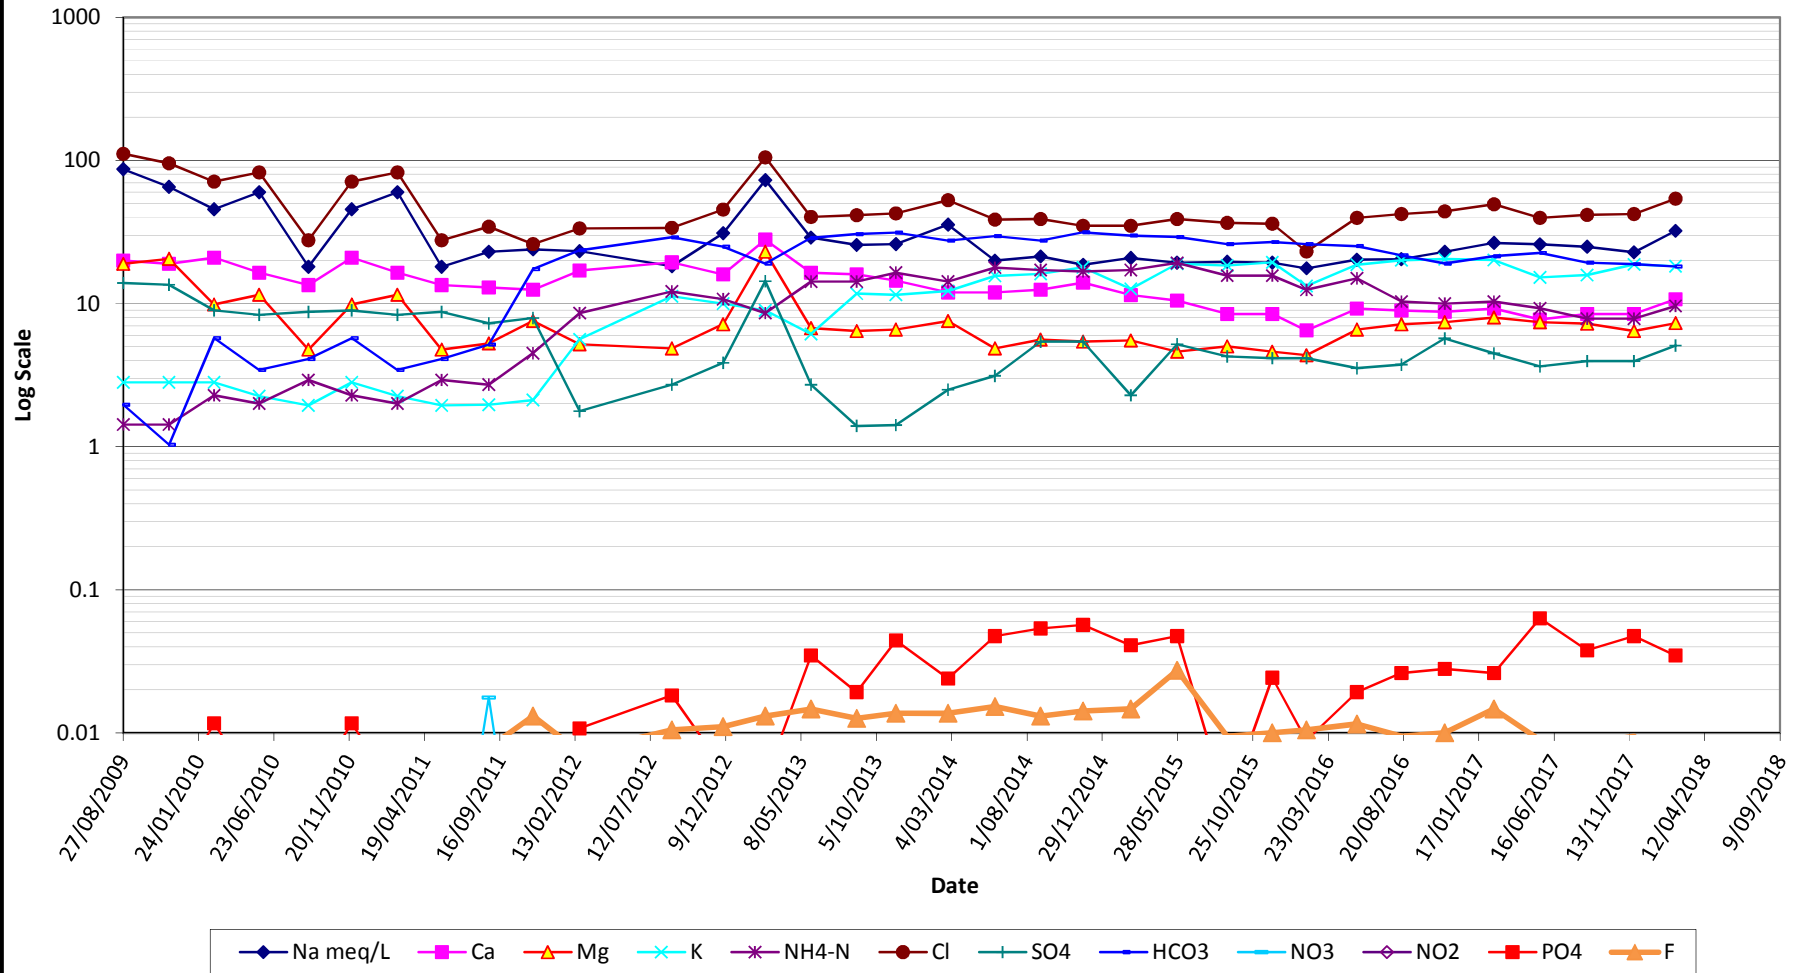
Bore BH15 displayed a decrease in L/N ratio however the value remains high at 81.45%. The decrease can be attributed to the decreased levels of K^+ and NO_3^- concentrations and the increase in Na^+ , Ca^{2+} and Mg^{2+} concentrations. The K^+ /TDS ratio of 15.82% was high when compared to non-leachate influenced sites generally with K^+ /TDS < 3 (Schoeller plot BH15, Attachment 1). Ammonium ($\text{NH}_4^+\text{-N}$) is elevated at 135 mg/L, compared to other non-impacted locations at the site, which is consistent with previous monitoring rounds. Field observations of a negative redox (negative ORP) and low dissolved oxygen are indicative of a reducing environment. This reducing environment promotes the elevated levels of soluble Mn^{2+} (0.52 mg/L) and Fe^{2+} (18 mg/L). Additionally, bore BH15 is located within a swampy environment where microbiological activity drives reducing reactions that can result in naturally high levels of leachate indicators such as organic carbon and HCO_3^- . Furthermore, bore BH15 is located near a drainage line within the groundwater bearing zone <0.5 m below the ground surface. Groundwater therefore has the potential to be influenced from local onsite and offsite works and surface water.

Leachate impacted groundwater may potentially be influencing water quality at bore BH15. It is important to note that bores BH15 and the adjacent BH16 are located in or near swampy environments or near heavily vegetated areas. Heavily wooded areas to the south can also have a natural attenuation effect on leachate impacted water. Natural attenuation and lower hydraulic gradients in the downstream of BH15 and BH16 are expected to inhibit its rate of migration and should continue to limit its extent of impact on Rocklow Creek. SWC_Down_2 should continue to be sampled to monitor any potential migration from this area to Rocklow Creek.

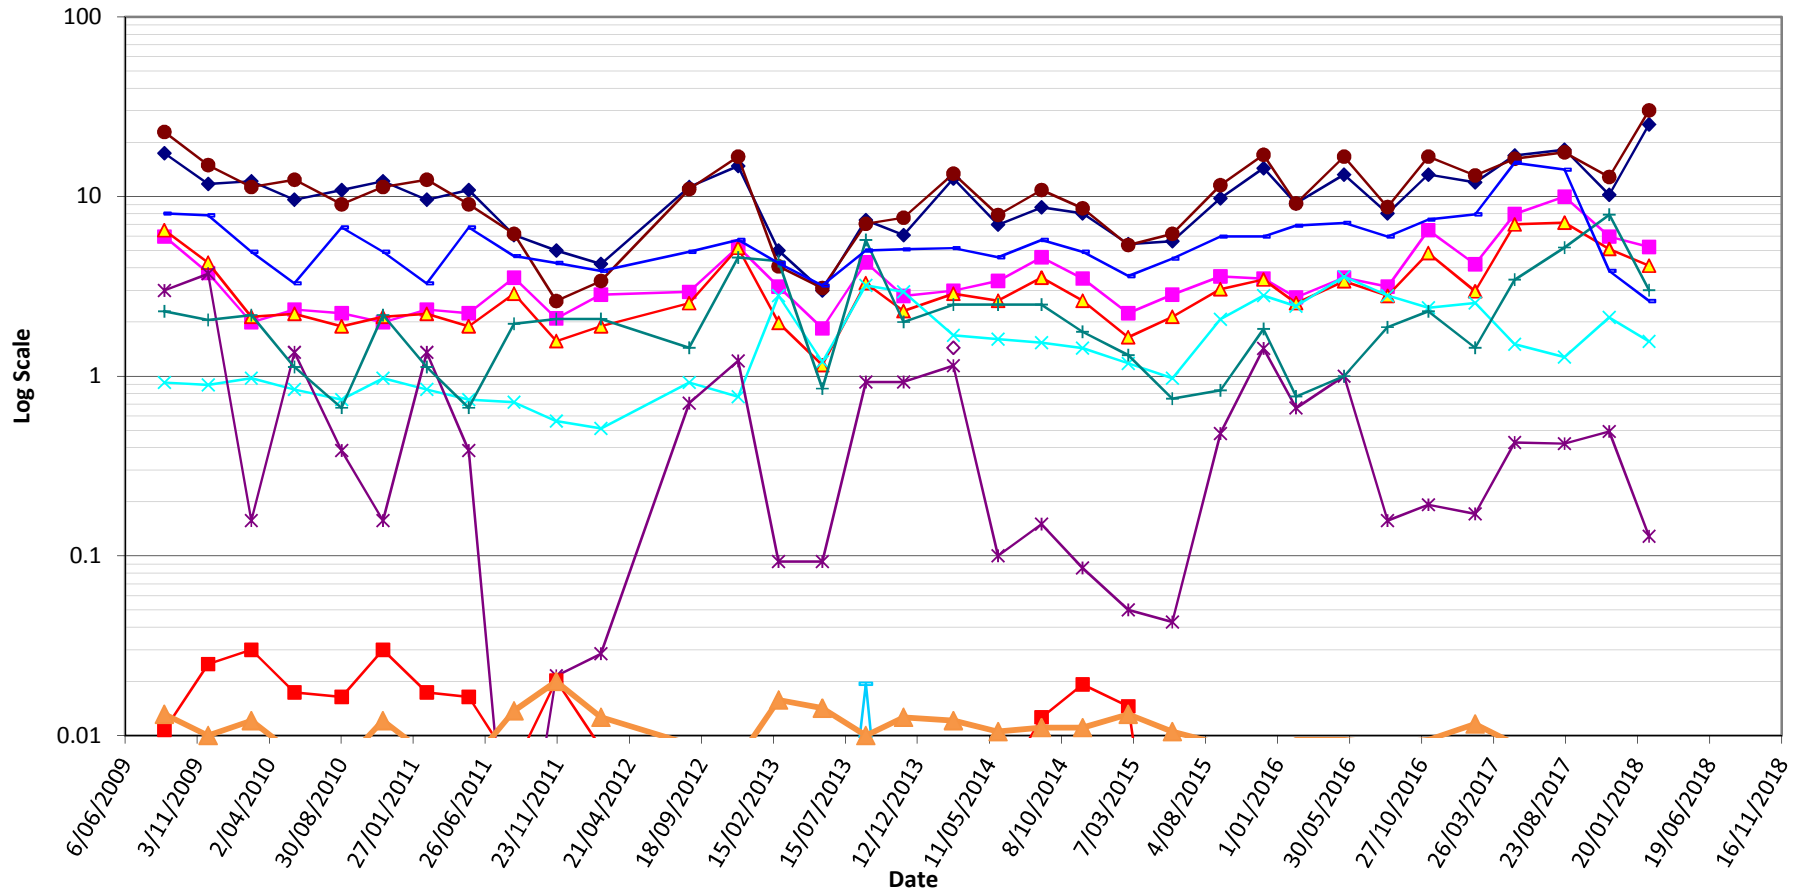
Bore BH16 is located in a swampy area with groundwater field observations recording a brown/black colour and a sulfuric odour. The sampled redox potential indicates a reducing environment (-145 mV), which may have an influence in the dominance of $\text{NH}_4^+\text{-N}$ over NO_3^- . Groundwater sampling in February 2018 indicated limited to no leachate impact at BH16 which was represented by the L/N ratio of 8.56% and a decrease in K/TDS ratio 5.89% in November 2017 to 2.84% in February 2018. The lower L/N ratio can be attributed to the significant increase in concentrations of the native ion Na^+ and the decrease in concentrations of two non-native ions (K^+ and $\text{NH}_4^+\text{-N}$). Bores BH15 and BH16 are located close to a drainage channel where offsite impacts can readily influence the chemical characteristics of the shallow groundwater and should continue to be monitored for fluctuations.

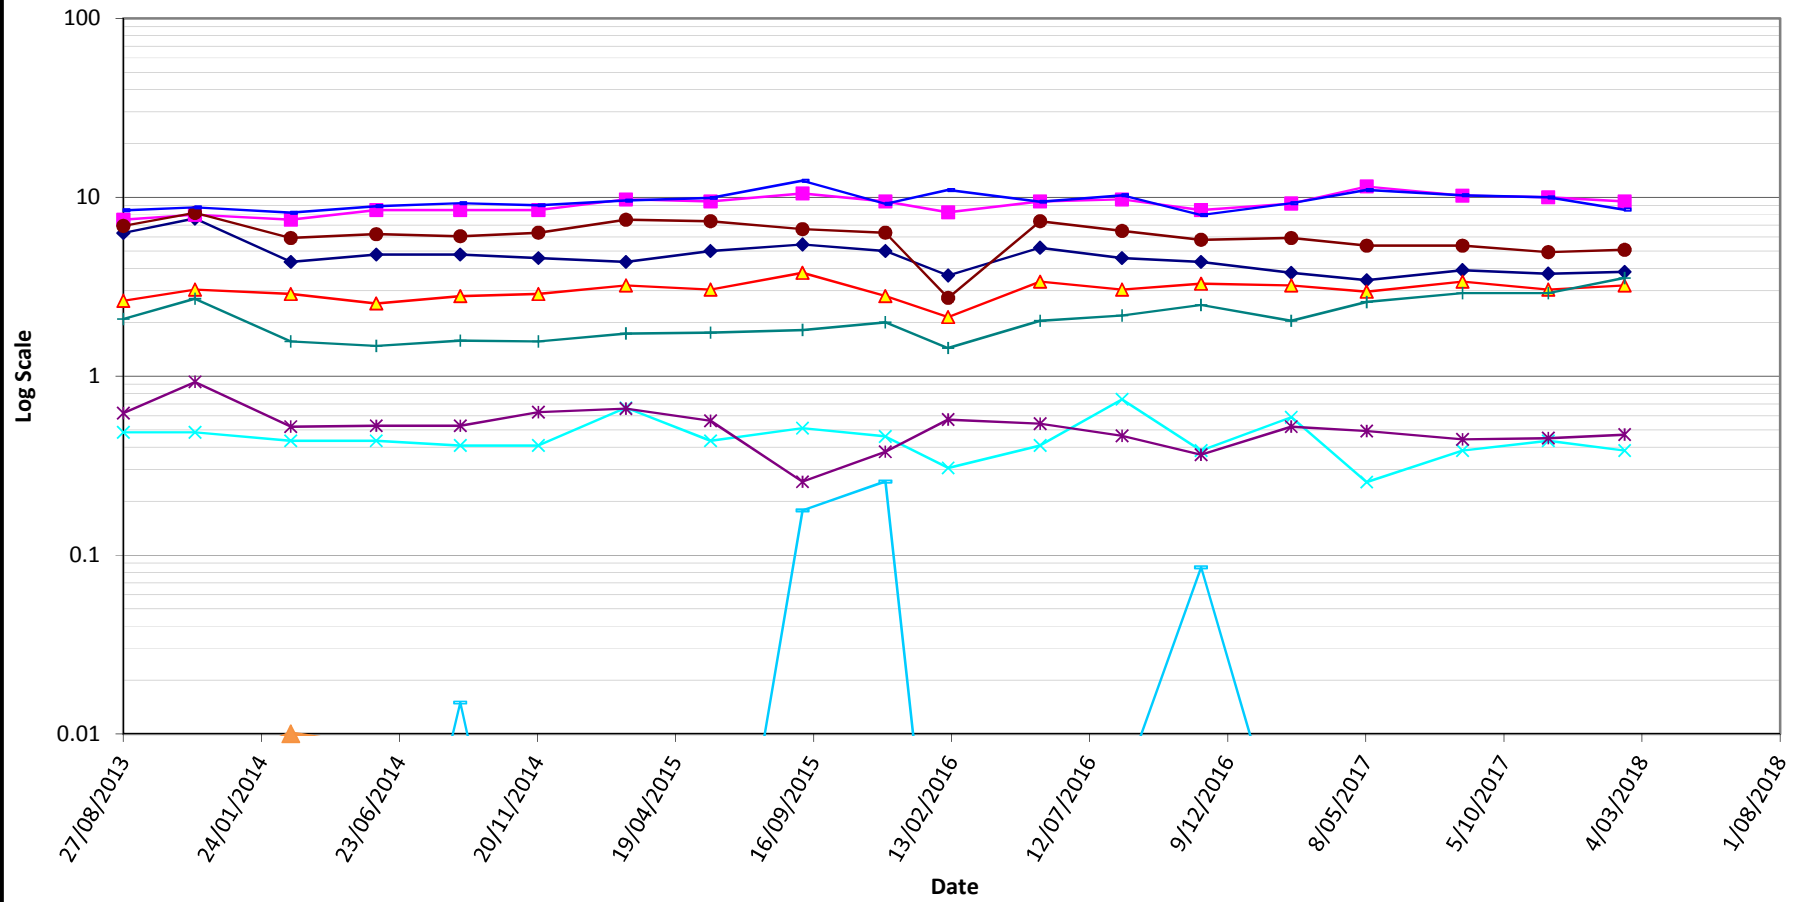
Bore BH19 is located on the south west boundary of the site. Field observations included a negative ORP and a milky colouring to the groundwater. The chemical characteristics of the groundwater support no or limited leachate influence with an L/N ratio of 6.85 % and a high Ca/K ratio. Bore BH19 is down gradient of current sand dredging activities and unlined landfill cells. Ammonium ($\text{NH}_4\text{-N}$) at this location (6.6 mg/L) exceeds the ANZECC (2000) trigger levels. Bore BH19 is positioned to detect any potential leachate migration to the south west of site and will continue to be monitored.

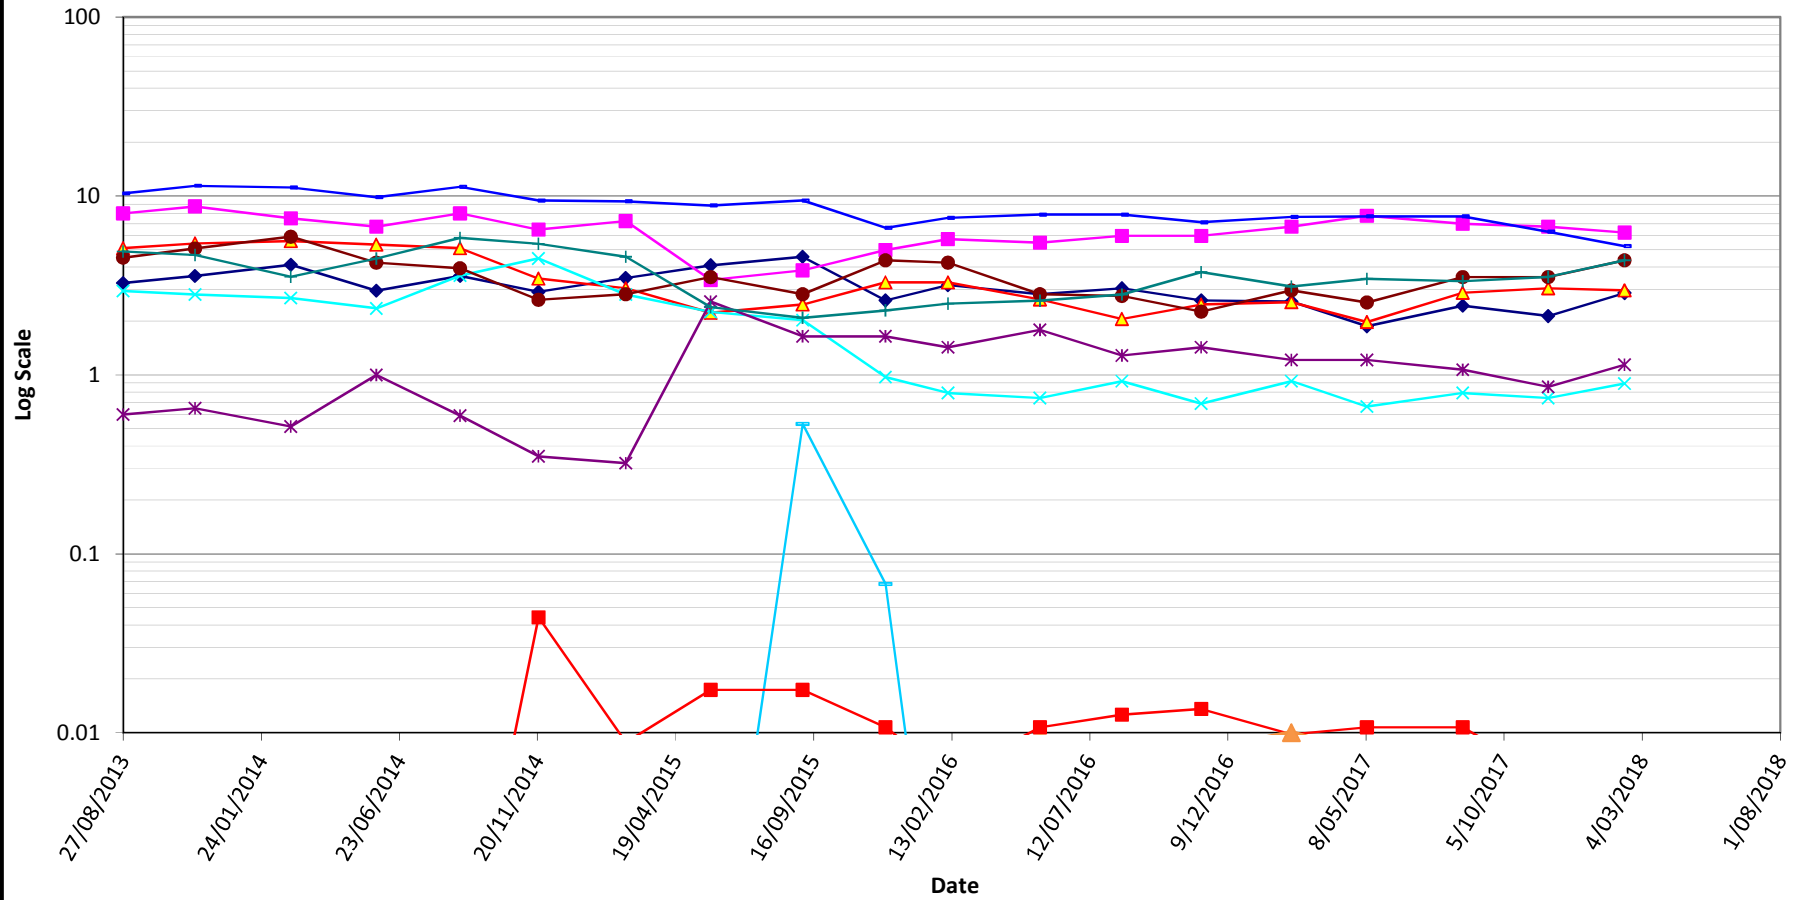
Bore BH20 is located down gradient of the landfill, leachate ponds and shallow old landfill. This bore was positioned to assess the chemical characteristics on the boundary of the landfill site. Field observations at bore BH20 recorded a negative redox (-140 mV) with a clear colour of the groundwater and H_2S odour. The L/N ratio (22.51%) in the February 2018 round increased compared with the last monitoring round (16.60%). K^+ showed a slight increase from 29 mg/L (November 2017) to 31 mg/L (February 2018). The TDS remained relatively low (785 mg/L) making the L/N susceptible to natural variations or fluctuations in chemistry. Chemical characteristics of the bore show groundwater is low in Na^+ , with a moderate Ca/K and K/TDS ratio (Table 4). Ammonium levels remained elevated at 16 mg/L however other landfill indicators were low or absent.

Assessment of monitoring bores BH20 and BH20s has detected the presence of leachate indicators despite the nearby surface water sampling locations SWC-Up, SWC-Down and SWC_Down_2 (Rocklow Creek), which displayed results indicating background characteristics. This indicates the occurrence of nitrogen uptake by trees and mangroves in the area between BH20 and Rocklow Creek, protecting the creek from a potential nitrogen impact by eliminating the pathway. The process of adsorption is also thought to have a role in stabilising the nitrogen plume at this location. Although the historical data sets of these new locations are relatively limited, it can be said it is likely that on site activities are not significantly impacting Rocklow Creek.

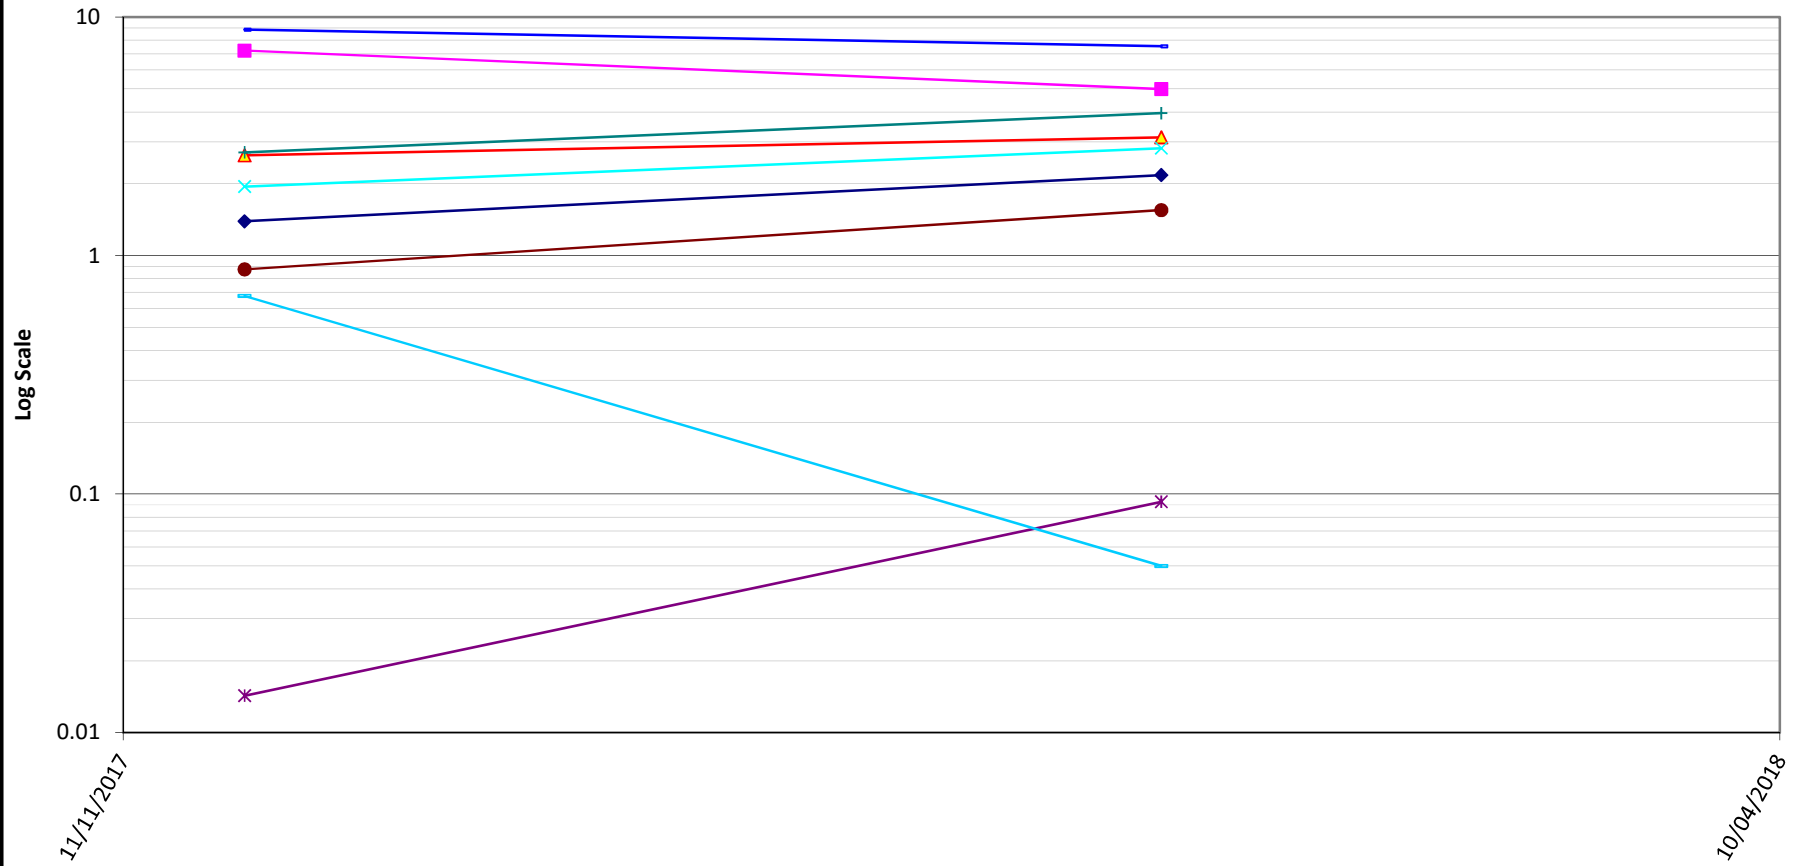
Bore BH20s is located directly adjacent to BH20 but at a shallower depth – *screened intervals of BH20 and BH20s are 6.0-9.0 mBGL and 1.5-4.5 mBGL respectively*. Similarly, this bore was positioned to compare the chemical characteristics on the boundary of the landfill site in order to locate potential transport pathways to Rocklow Creek. In February 2018, field observations at bore BH20s recorded a negative redox (-24 mV), clear colour of the groundwater and an odour was detected. The L/N ratio (60.85 %) continued to indicate

potentially high leachate impact at this site. However, TDS is relatively low (790 mg/L) making the L/N susceptible to natural variations or fluctuations in chemistry. Chemical characteristics of the bore show groundwater was low in Na^+ , with a moderate Ca/K and K/TDS ratio (Table 4). Ammonium levels (1.3 mg/L) have increased since November 2017 but remain lower than those seen at the deeper BH20 bore. Nitrate levels have decreased significantly in February 2018 to 3.1 mg/L from 42 mg/L in November 2017. It was previously thought that high nitrate levels in this shallower bore location was indicative of nitrification throughout the soil profile. Continued monitoring at this location will be necessary to determine potential transport pathways to Rocklow Creek.

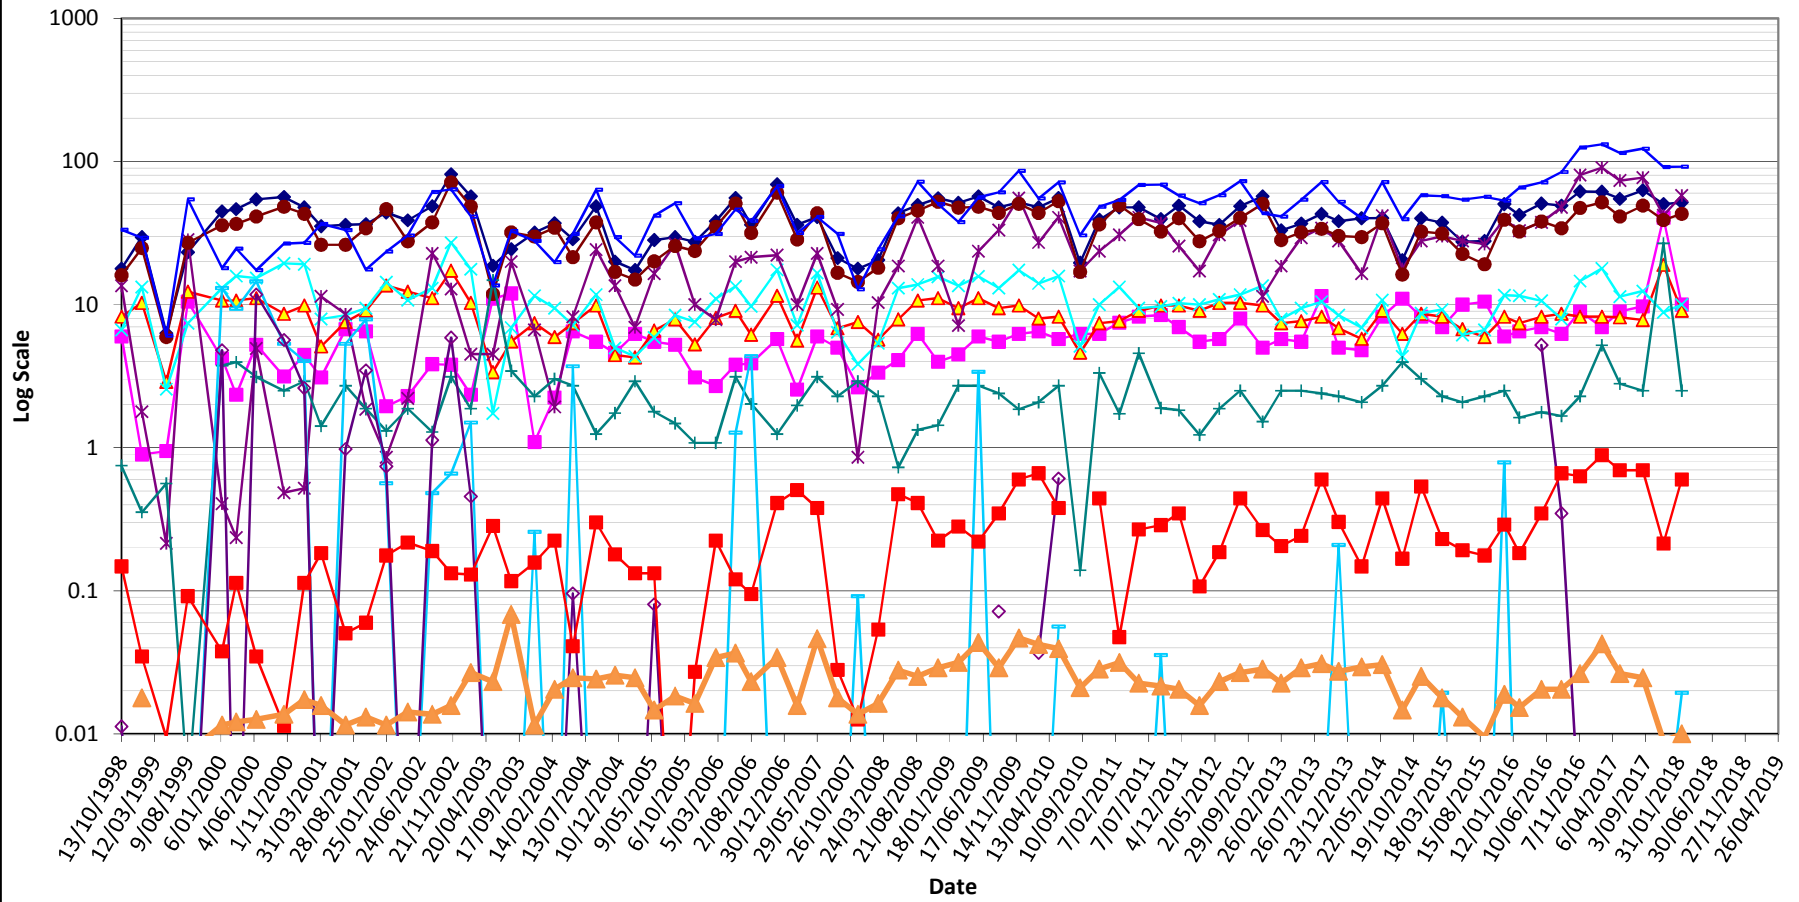
LP1

The chemistry of leachate water at the Dunmore Recycling and Waste Disposal Depot is significantly different when compared to the surface and groundwater chemistry of non-leachate influenced bores. This is demonstrated through comparison of chemical data for groundwater from the various bores and the leachate pond presented in Table 2. In particular TDS, BOD, TOC, Na^+ , $\text{NH}_4^+\text{-N}$, K^+ , HCO_3^- , PO_4 and total iron concentrations are generally elevated in leachate pond water compared to other monitoring bores (Schoeller Plot Leachate, Attachment 3). Ionic ratios (Table 4) such as low Ca/K (1.00) and high Na/Ca and L/N ratios represent landfill leachate chemical characteristics. These chemical characteristics have been relatively stable over the past 10 years of monitoring.
