18 April 2018

Shellharbour City Council

February 2018 Quarterly Environmental Monitoring – Dunmore Recycling and Waste Disposal Depot, Dunmore, New South Wales.

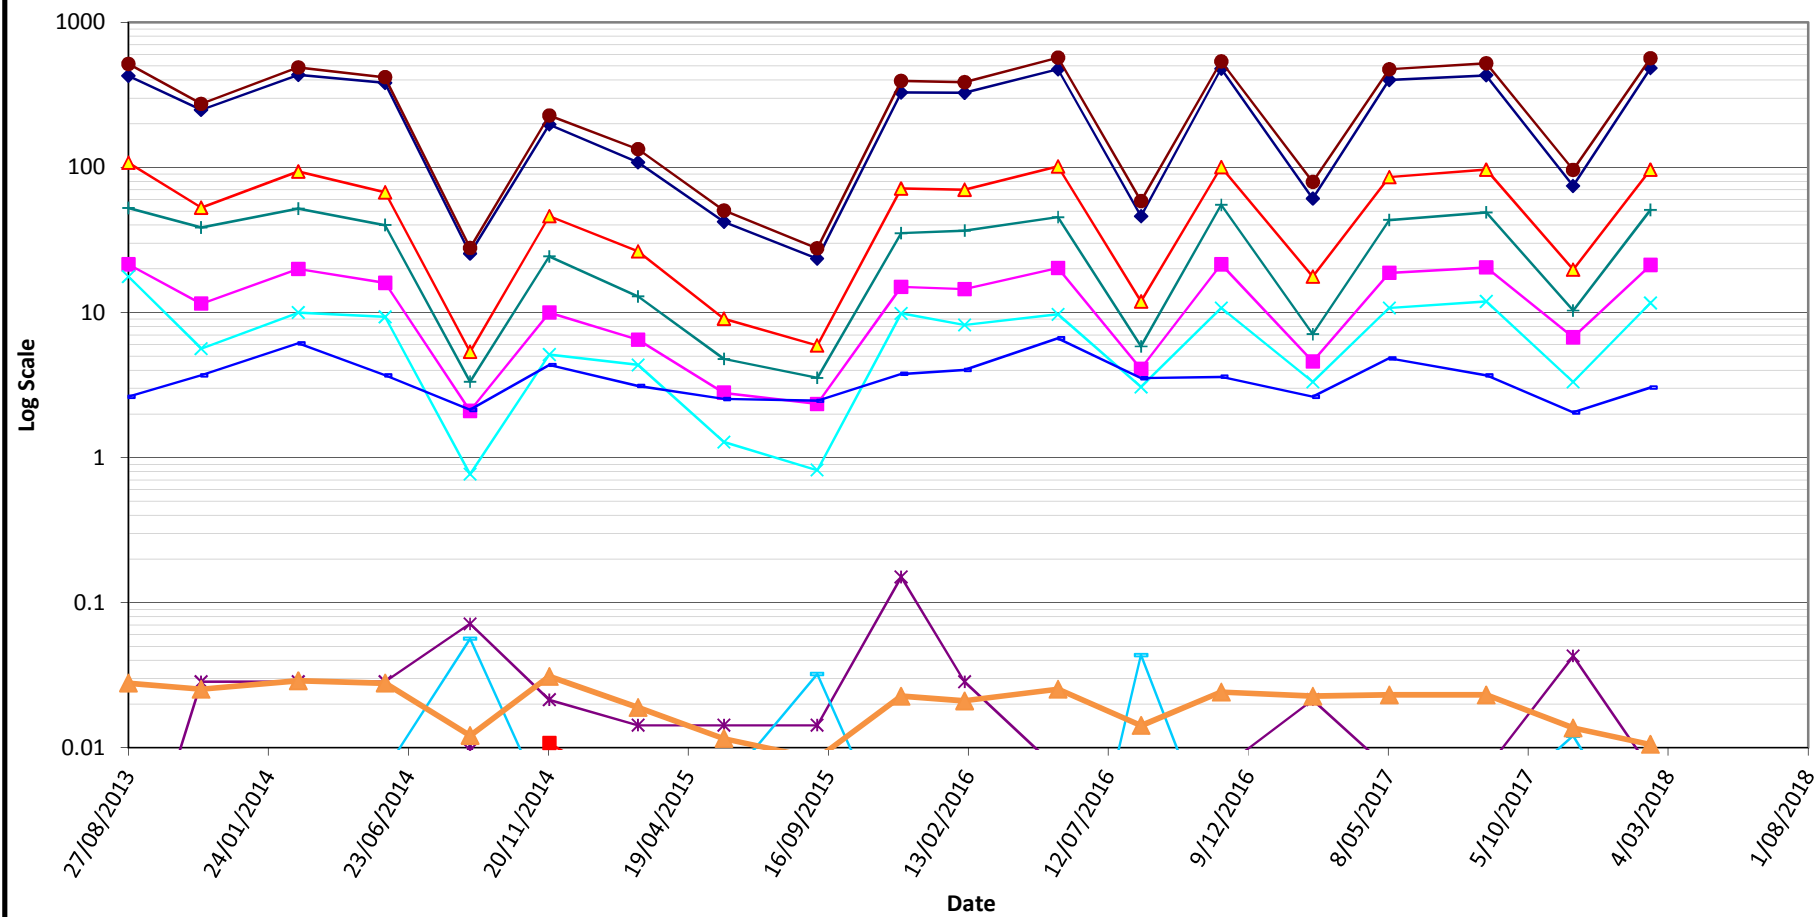
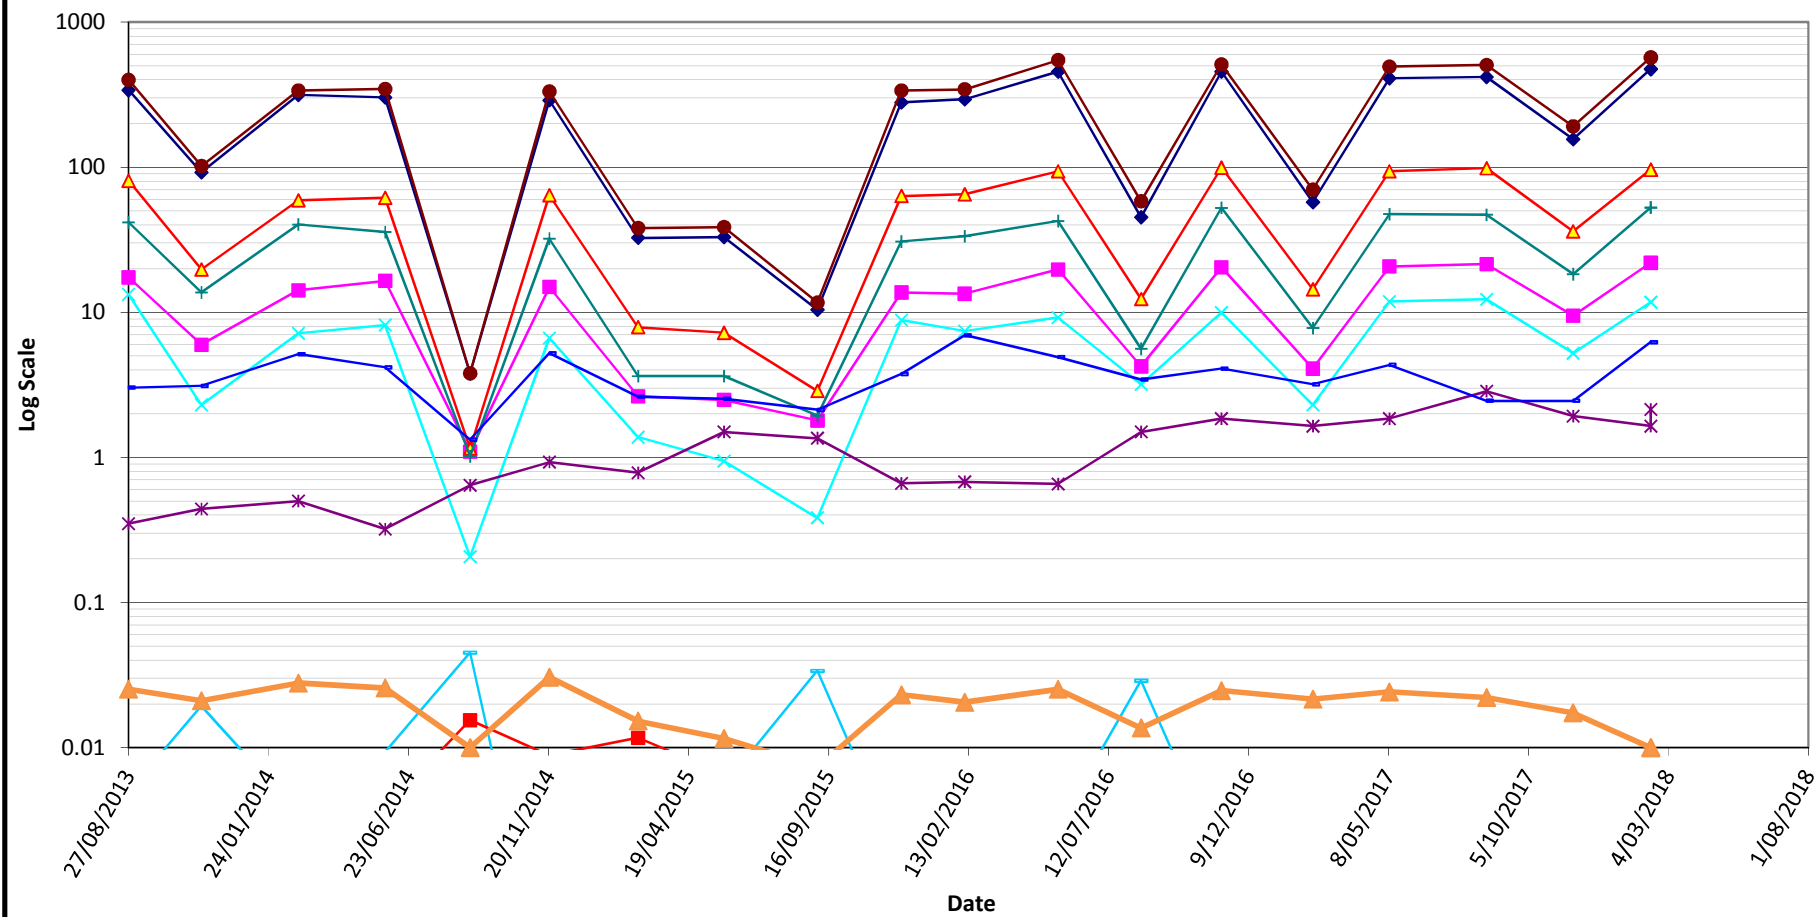
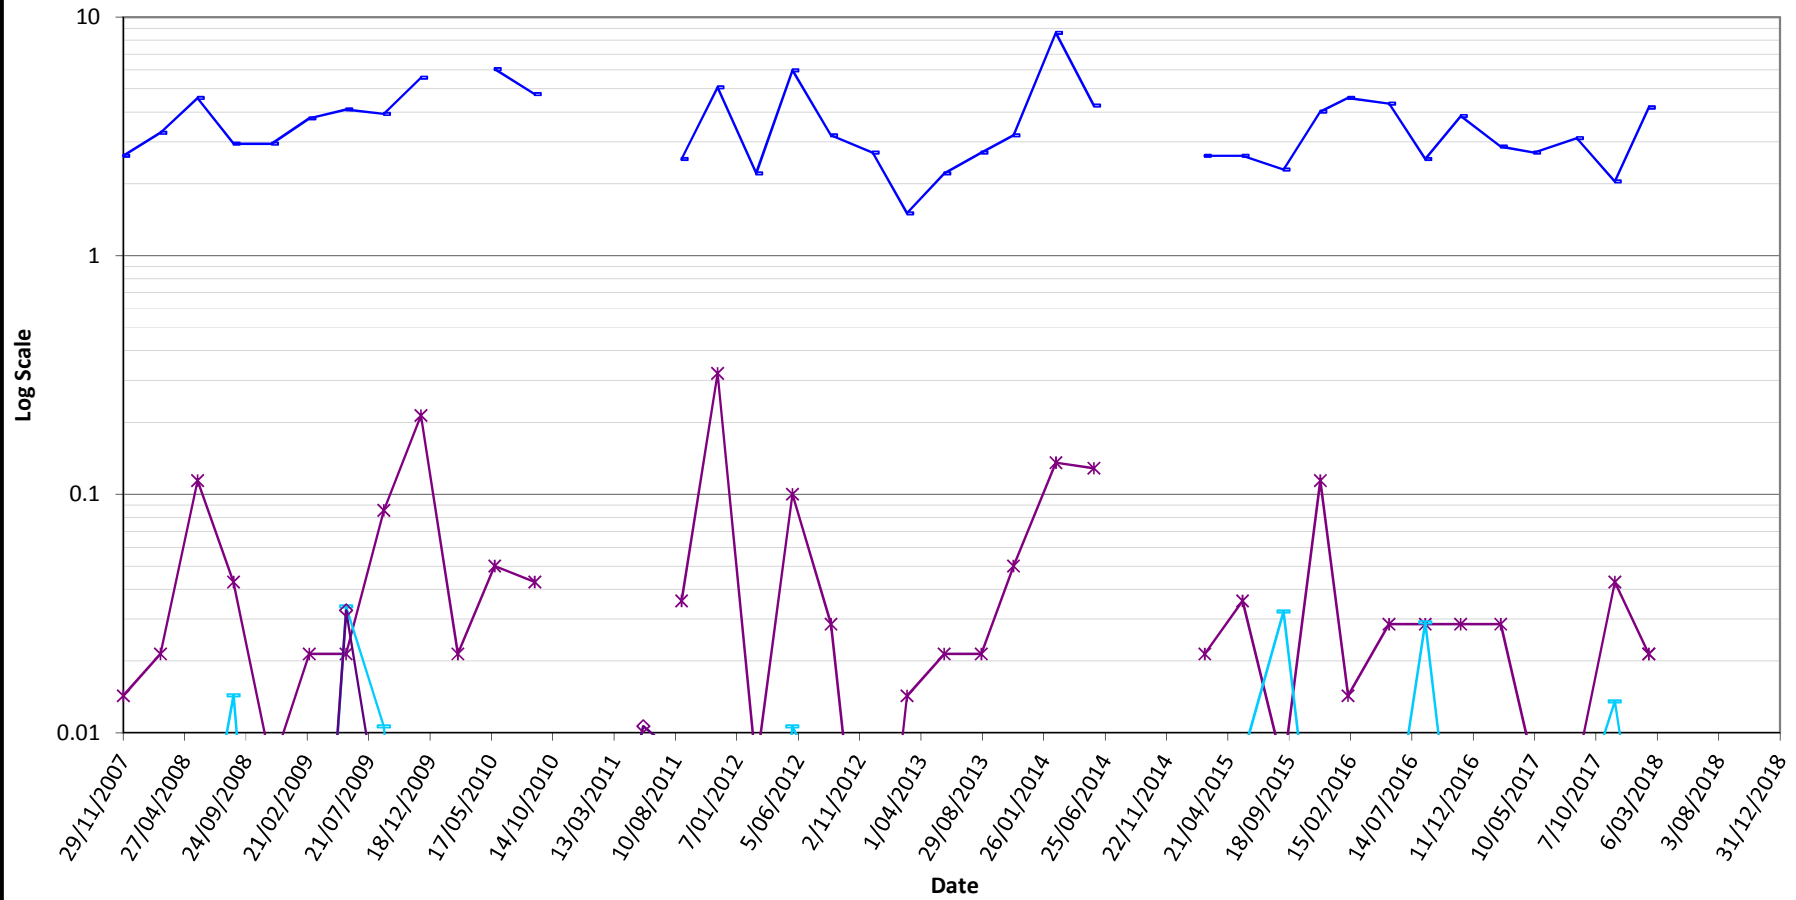
The four surface water creek sites SWC2, SWC_Up, SWC_Down and SWC_Down_2 were also sampled during the February 2018 sampling event. SWC_Up, SWC_Down and SWC_Down_2 are up-and-down-gradient of SWC2 and help assess leachate impacts within Rocklow Creek. SWC_Down_2 is still a relatively new sampling location which was established in order to detect potential leachate impacts to Rocklow Creek originated from the eastern portion of the site (Environmental Earth Sciences NSW 2017). SWC_Up, SWC_Down and SWC_Down_2 had high concentrations of TDS, notably Na⁺ and Cl⁻ (Table 2); this is due to the tidal nature of these waters and differentiates them from landfill groundwater / surface water.

The low nutrient and L/N ratios within Rocklow Creek indicated that there was no leachate impact within Rocklow Creek. All surface water creek sampling sites (SWC2, SWC_Up,

SWC_Down and SWC_Down_2) had low concentrations of $\text{NH}_4^+\text{-N}$ (<0.6 mg/L) and NO_3^- (<0.1 mg/L). All four sites will continue to be monitored to ensure leachate is not impacting upon the Rocklow Creek.

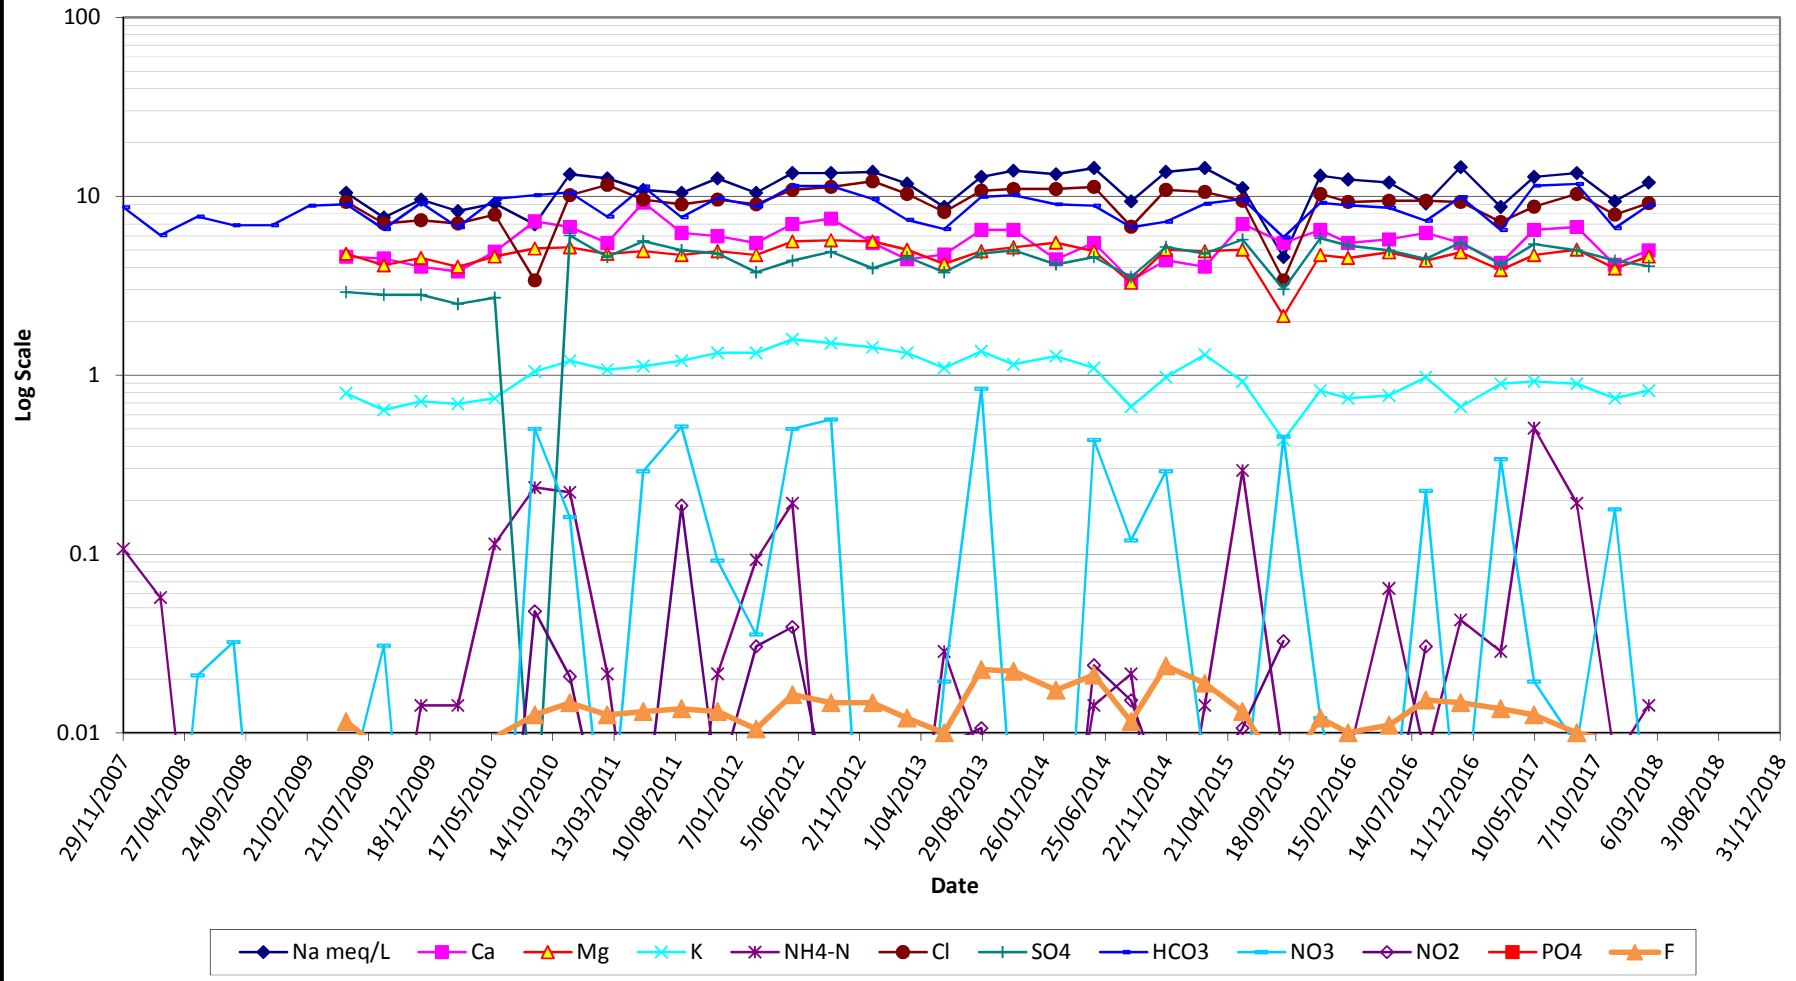
Surface water sampled at SWP2 showed little to no leachate impact. The surface water pond collects runoff from around the site and potential impacts from site activities are often observed. Ammonium concentration increased slightly to 0.20 mg/L during this sampling round compared to November 2017 round (0.10 mg/L). Nitrate (NO₃⁻) levels (0.18 mg/L) decreased to below the ANZECC 2000 trigger value that was exceeded in the November 2017 monitoring round. Fluctuating nitrate is common at this location with previous monitoring events fluctuating between 0.01 and 30 mg/L. All chemical parameters at this location are within historical ranges.

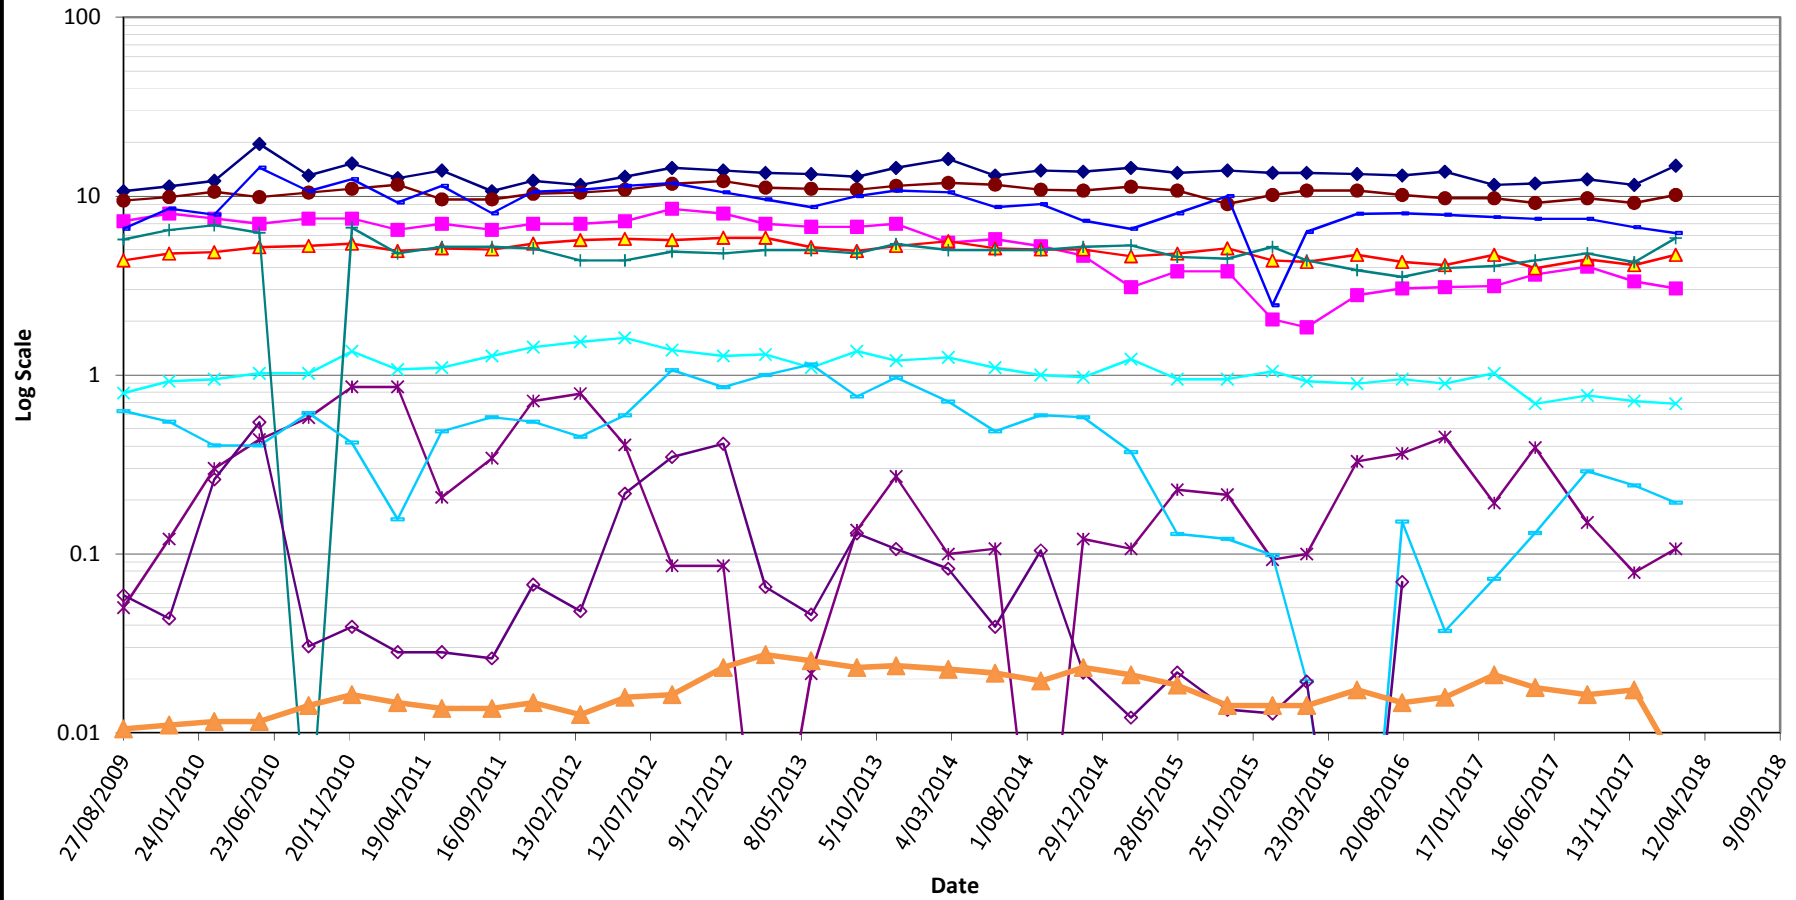
SWP4 displayed ammonium (NH₄⁺-N) levels of 1.5 mg/L which is below the defined trigger value. Nitrate (NO₃⁻) levels decreased slightly to 12 mg/L which is still above the trigger value established by the ANZECC 2000 guidelines. These values are indicative of the occurrence of the natural process of nitrification by which NH₄-N naturally attenuates. All chemical parameters at this location are within historical ranges. Both SWP4 and SWP2 should continue to be monitored for any fluctuations in chemical composition indicating a more prominent leachate impact.
