18 June 2019

**Shellharbour City Council**  
PO Box 155  
Shellharbour Square  
Shellharbour City Centre NSW 2529

**May 2019 Quarterly Environmental Monitoring – Dunmore Recycling and Waste Disposal Depot, Dunmore, New South Wales.**

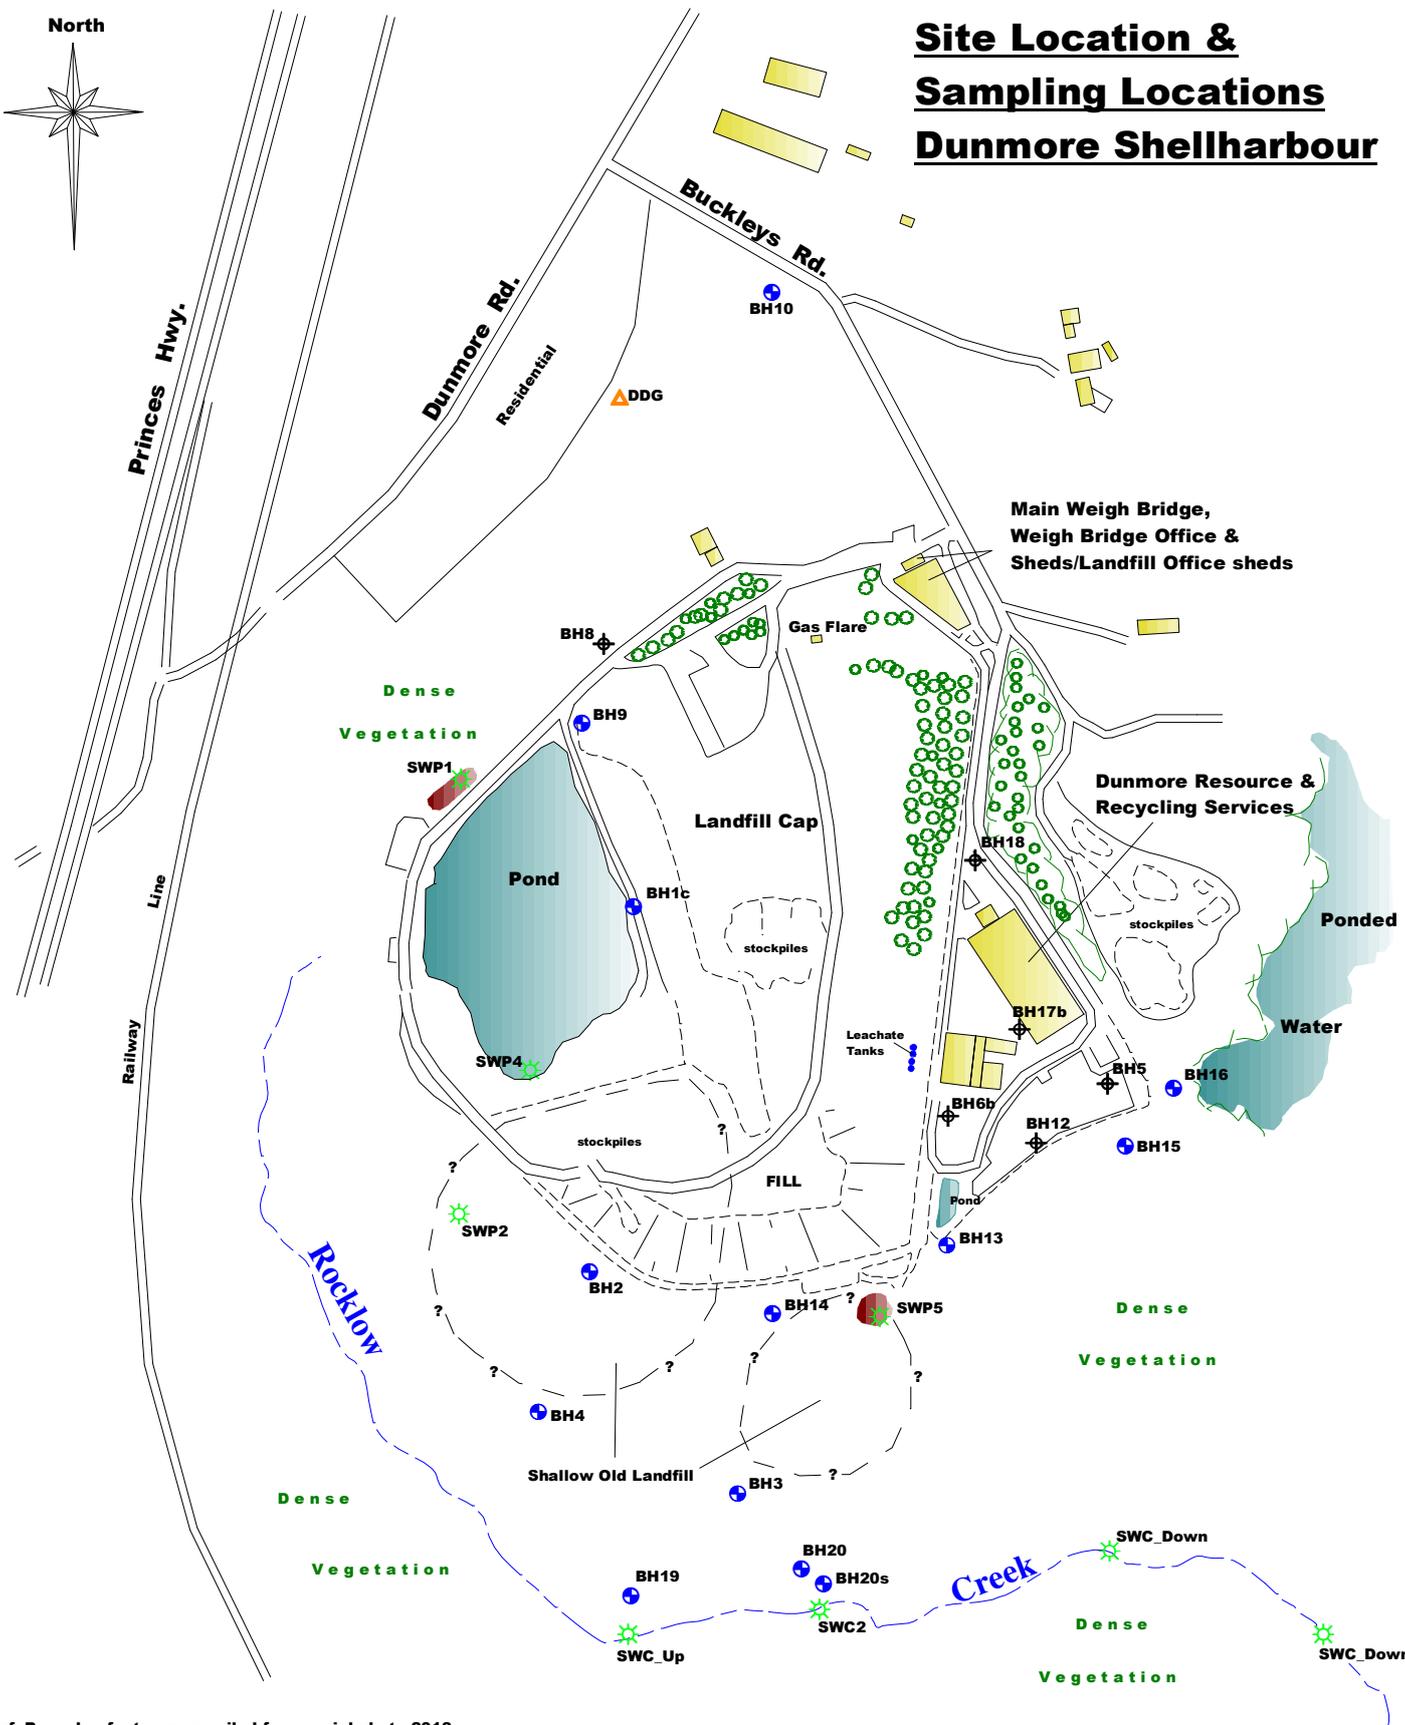
# Site Location & Sampling Locations Dunmore Shellharbour

Groundwater samples were collected from nine monitoring bores (BH1c, BH2, BH3, BH4, BH13, BH14, BH16, BH20 and BH20s). At BH10 only the standing water level (SWL) was measured and no sample was taken. Surface water was collected from the leachate pond (LP1), three on site retention ponds (SWP1, SWP2, and SWP4) and Rocklow Creek at four points (SWC2, SWC\_Up, SWC\_Down and SWC\_Down\_2). Sampling was not taken at BH19 as the blockage encountered during the August monitoring round was still present. No sample was collected from BH15 as the access point was overgrown with trees and presented a potential WHS risk to field staff. No sample was taken at SWP5 as the retention pond was dry. Sampling locations are shown on **Figure 1 (Attachment 1)**.

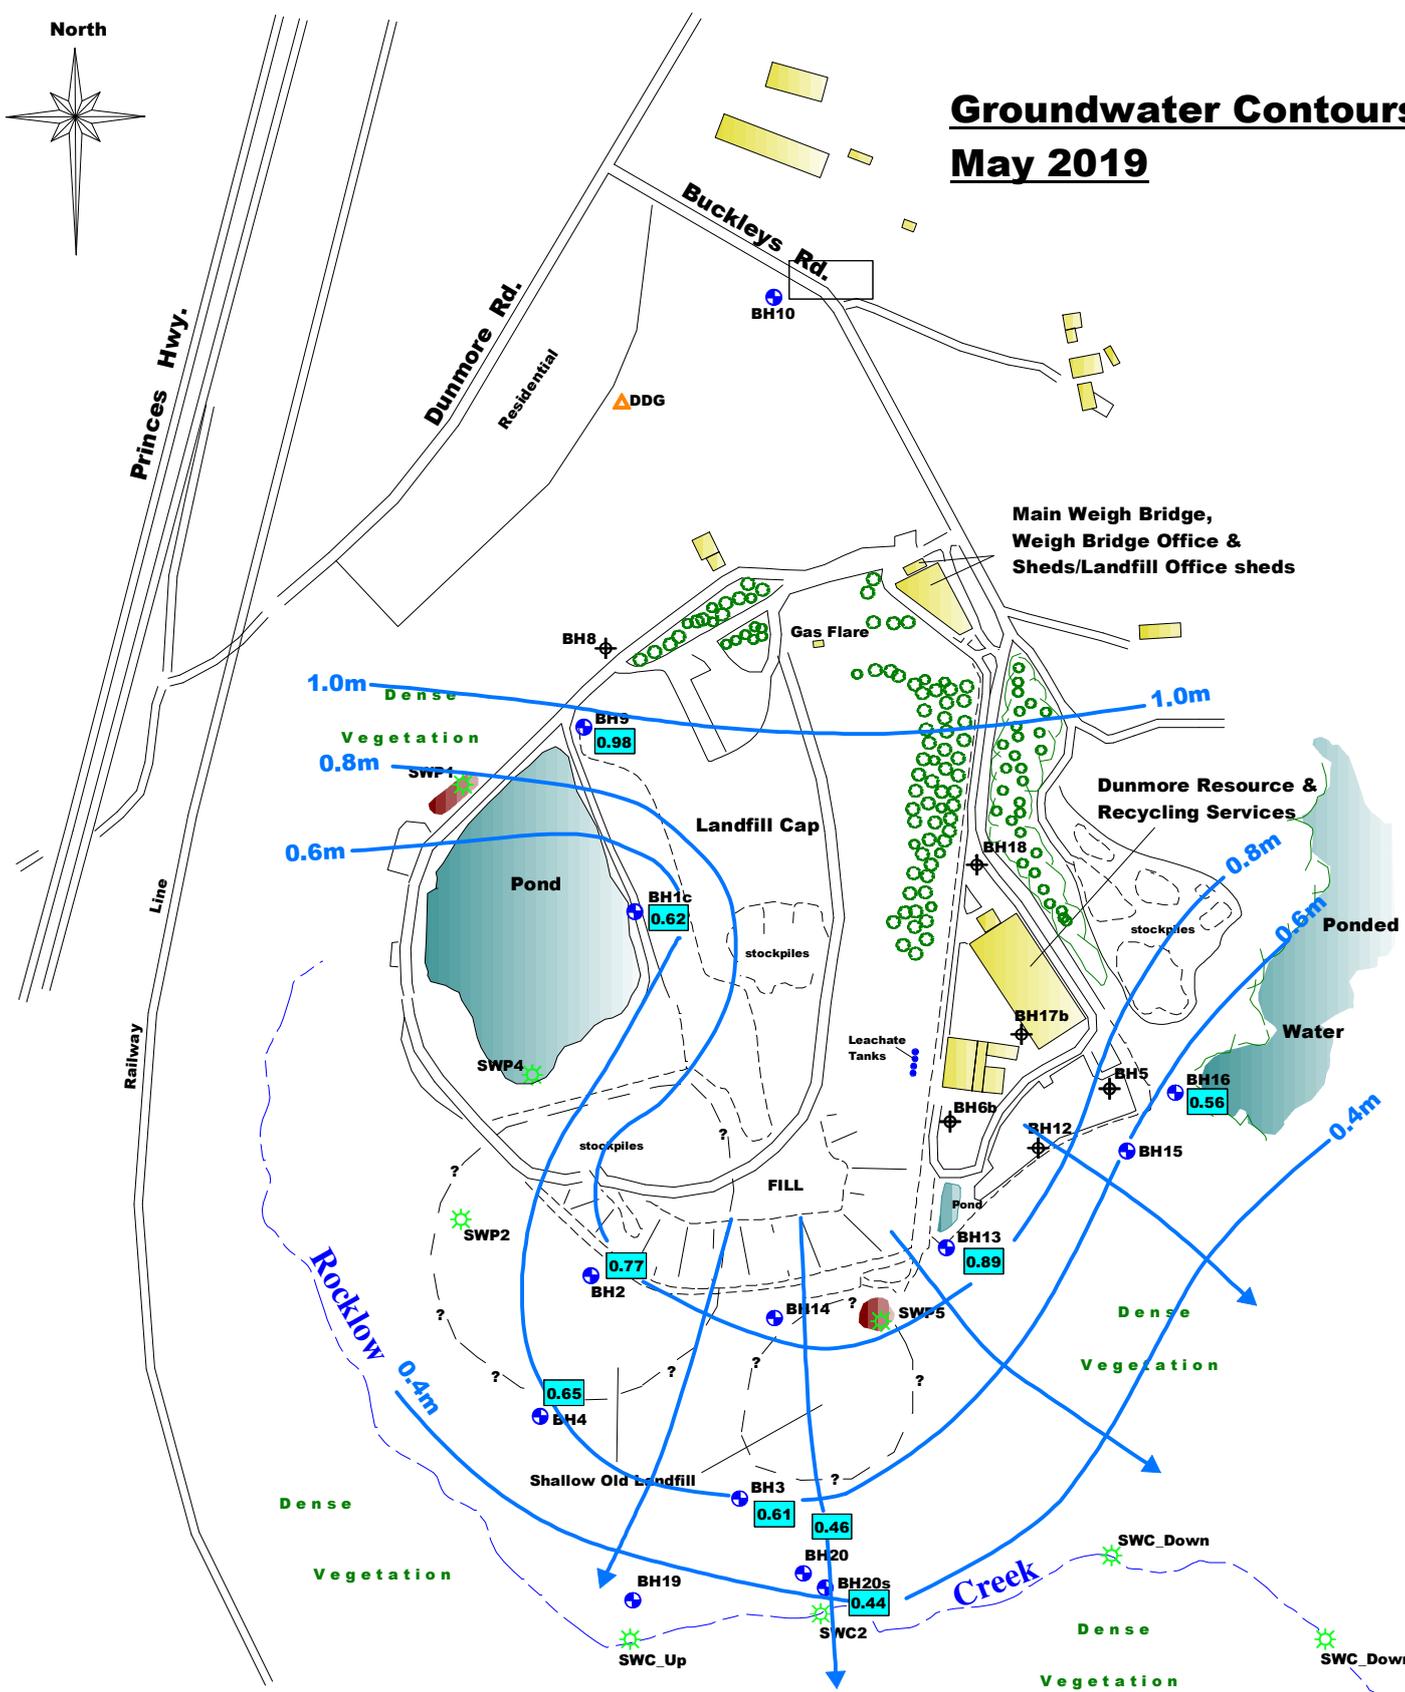
# Groundwater Contours May 2019

Inferred groundwater contours from the May 2019 standing water level (SWL) measurements are illustrated in **Figure 2 (Attachment 1)**. These were calculated using SWLs from surveyed bores. Groundwater flow direction was towards Rocklow Creek in a southerly direction similar to previous monitoring events.

Cumulative rainfall for March 2019 (157.2 mm), April 2019 (37.2 mm), May 2019 (7 mm) and June 2019 (56.2 mm) was 257.6 mm (BOM – Albion Park Wollongong Airport weather station) and slightly above 1999-2019 mean rainfall for this period of the year. Groundwater levels decreased in seven of the nine monitoring wells. The average of the measured standing water levels throughout the site have decreased by ~0.06 mAHD from 0.40 mAHD in February 2019 to ~0.46 mAHD.

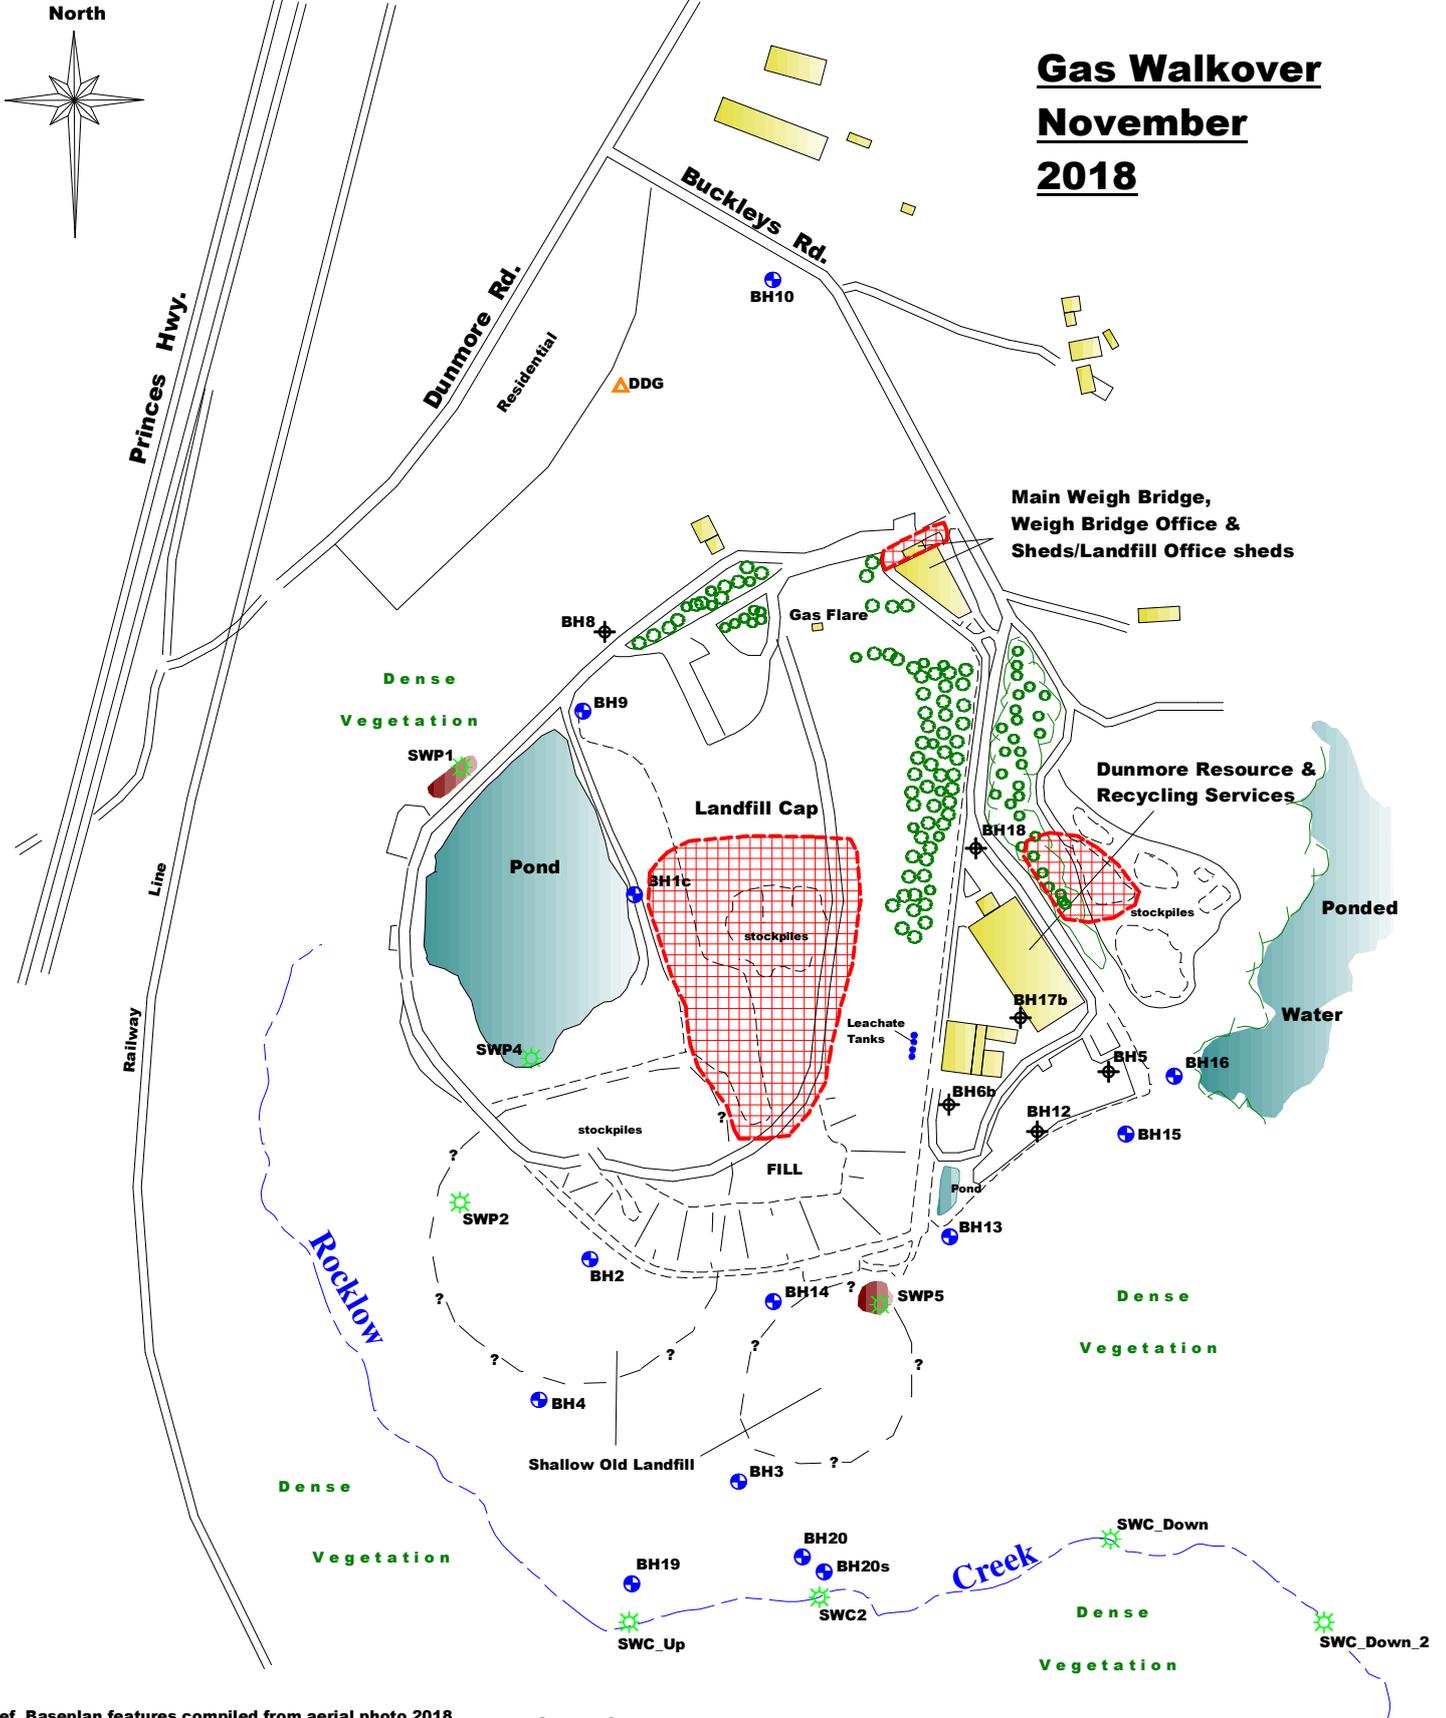
# Gas Walkover November 2018

Landfill gas was measured in the field using an Inspectra Laser Unit (ILU) and a GA5000 Landfill Gas Monitor (GA5000). Measurements were taken within and around all buildings in a 250 m radius from the current landfill cell as well as across the landfill cap (gas walkover grids of the May 2019 round are presented in **Figure 3**).

All readings were below the site-specific criteria outlined in EPL no. 5984 as the NSW EPA (2013) reporting threshold of 1.00 % v/v CH<sub>4</sub> within onsite buildings and therefore pose no direct risk. All readings were below the threshold concentration for closer investigation and

potential action (500 ppm or 0.05 % v/v, NSW EPA [2013], **Table 5**). Continued monitoring with both the GA5000 and ILU will be undertaken at quarterly monitoring events.

Gas concentrations detected at all buildings assessed on site were below guidelines and therefore no action was required. It is recommended that monitoring continue with a FID or Inspectra Laser Unit and GA5000 Landfill Gas Monitor.

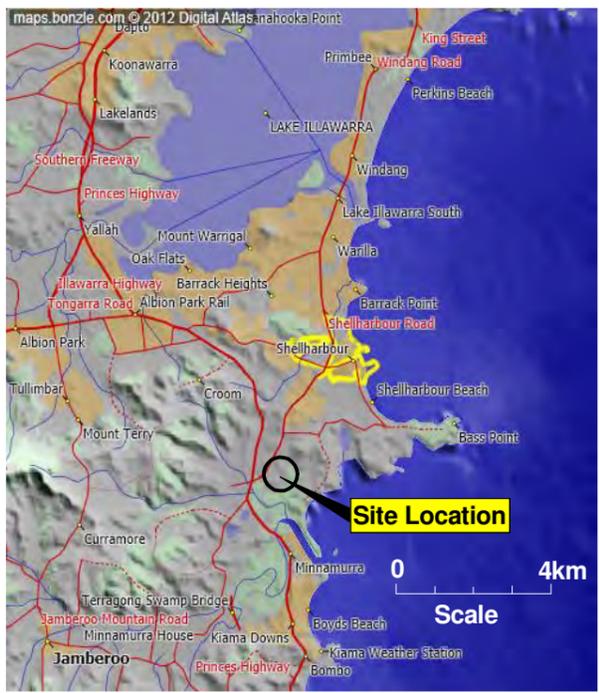
**Figure 3**

<b>ENVIRONMENTAL EARTH SCIENCES</b> CONTAMINATION RESOLVED	<b>Title:</b> Gas Walkover		
	<b>Location:</b> Buckleys Road, Dunmore, Shellharbour, NSW		
	<b>Client:</b> Shellharbour City Council	<b>Job No. 118077</b>	<b>Date:</b> May 2019
	<b>Drawn by:</b> TRJ	<b>Proj. Man.:</b> EG	<b>Scale:</b> As shown

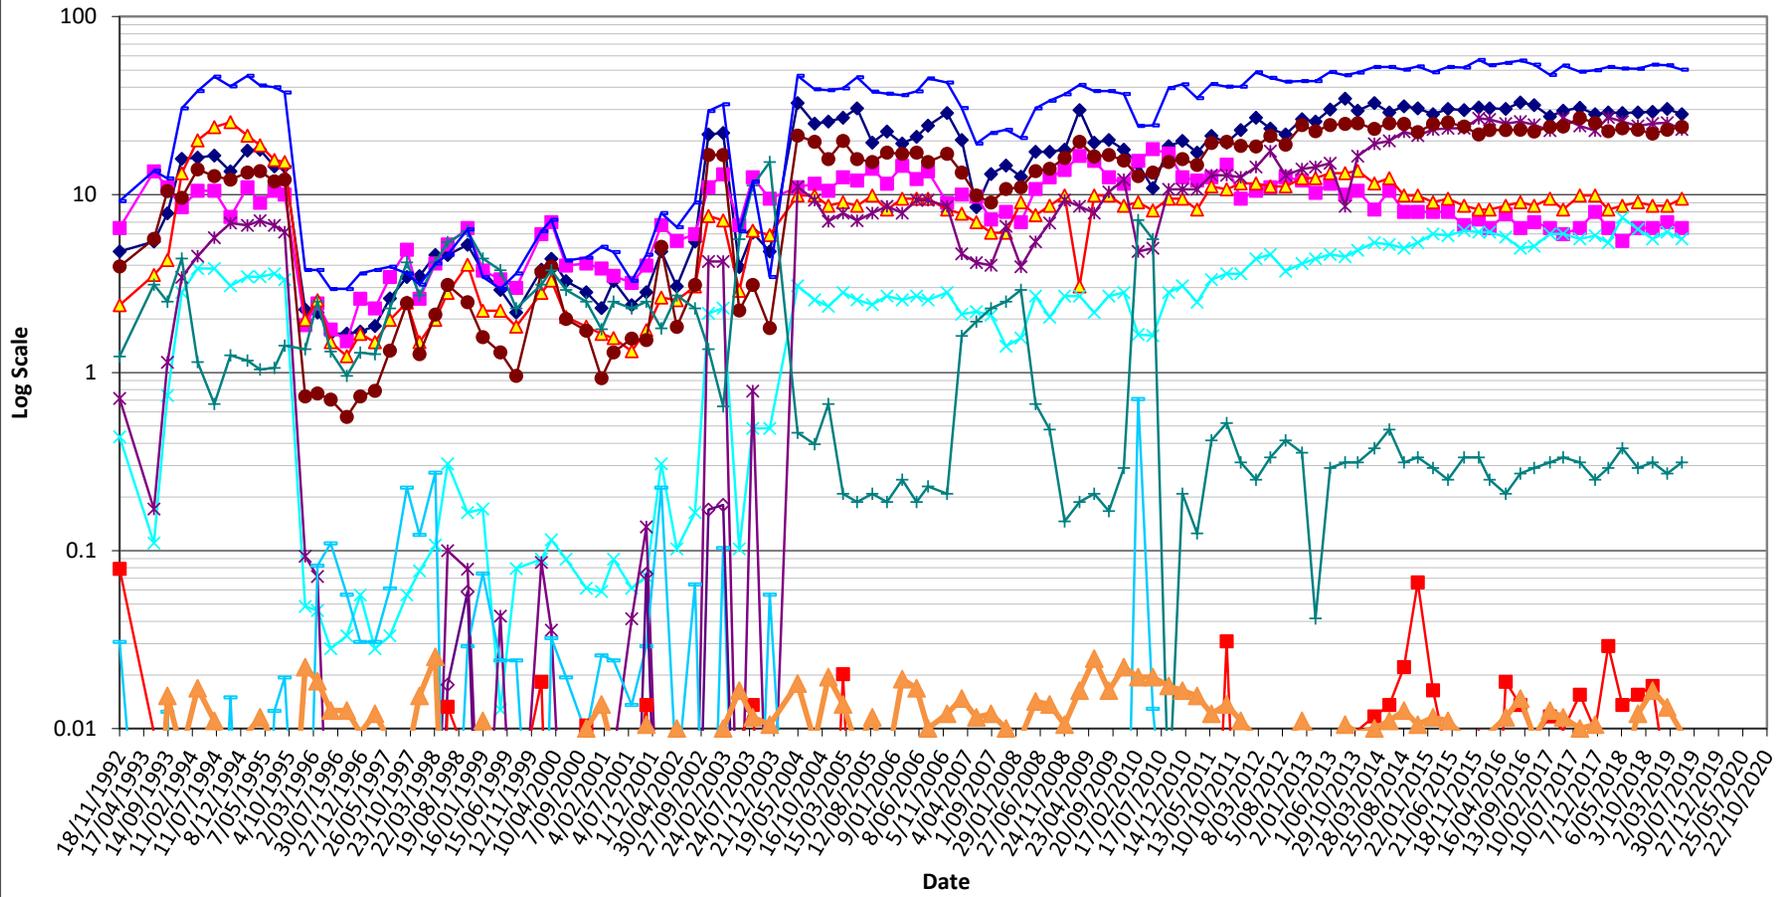
# BH1c

Bore BH1c is located near the old unlined landfill cell and intercepts leachate within the cell. As such the chemical signature of this bore has historically contained elevated leachate indicators in comparison to other monitoring bores (**Schoeller plot BH1 a/b/c, Attachment 3**). This continued during the current monitoring event and the groundwater was found to have a yellow brown colour and strong ammonia odour noted in combination with elevated TDS (4010 mg/L),  $K^+$  (220 mg/L) [resulting in low Ca/K – 1.15] and  $NH_4^+-N$  (325 mg/L) concentrations. The very low levels of dissolved oxygen (0.20 ppm, **Table 1**) and presence of soluble  $Fe^{2+}$  (3.5 mg/L) indicate an anaerobic environment and biochemical demand in response to microbial respiration. BOD has fluctuated since the bore was installed, ranging from 850 mg/L to 6 mg/L. BODs have remained at similar levels (6-25 mg/L) since August 2016 with a trend of small decreases up to the May 2019 BOD concentration of 12 mg/L. Further evidence of microbial activity and respiration of nitrogen species in groundwater is elevated  $HCO_3^-$  resulting in a low Cl/ $HCO_3^-$  ratio of 0.48 (**Table 4**). This suggests some degradation of the leachate plume, and the organic nitrogen species therein, has occurred in this monitoring bore.

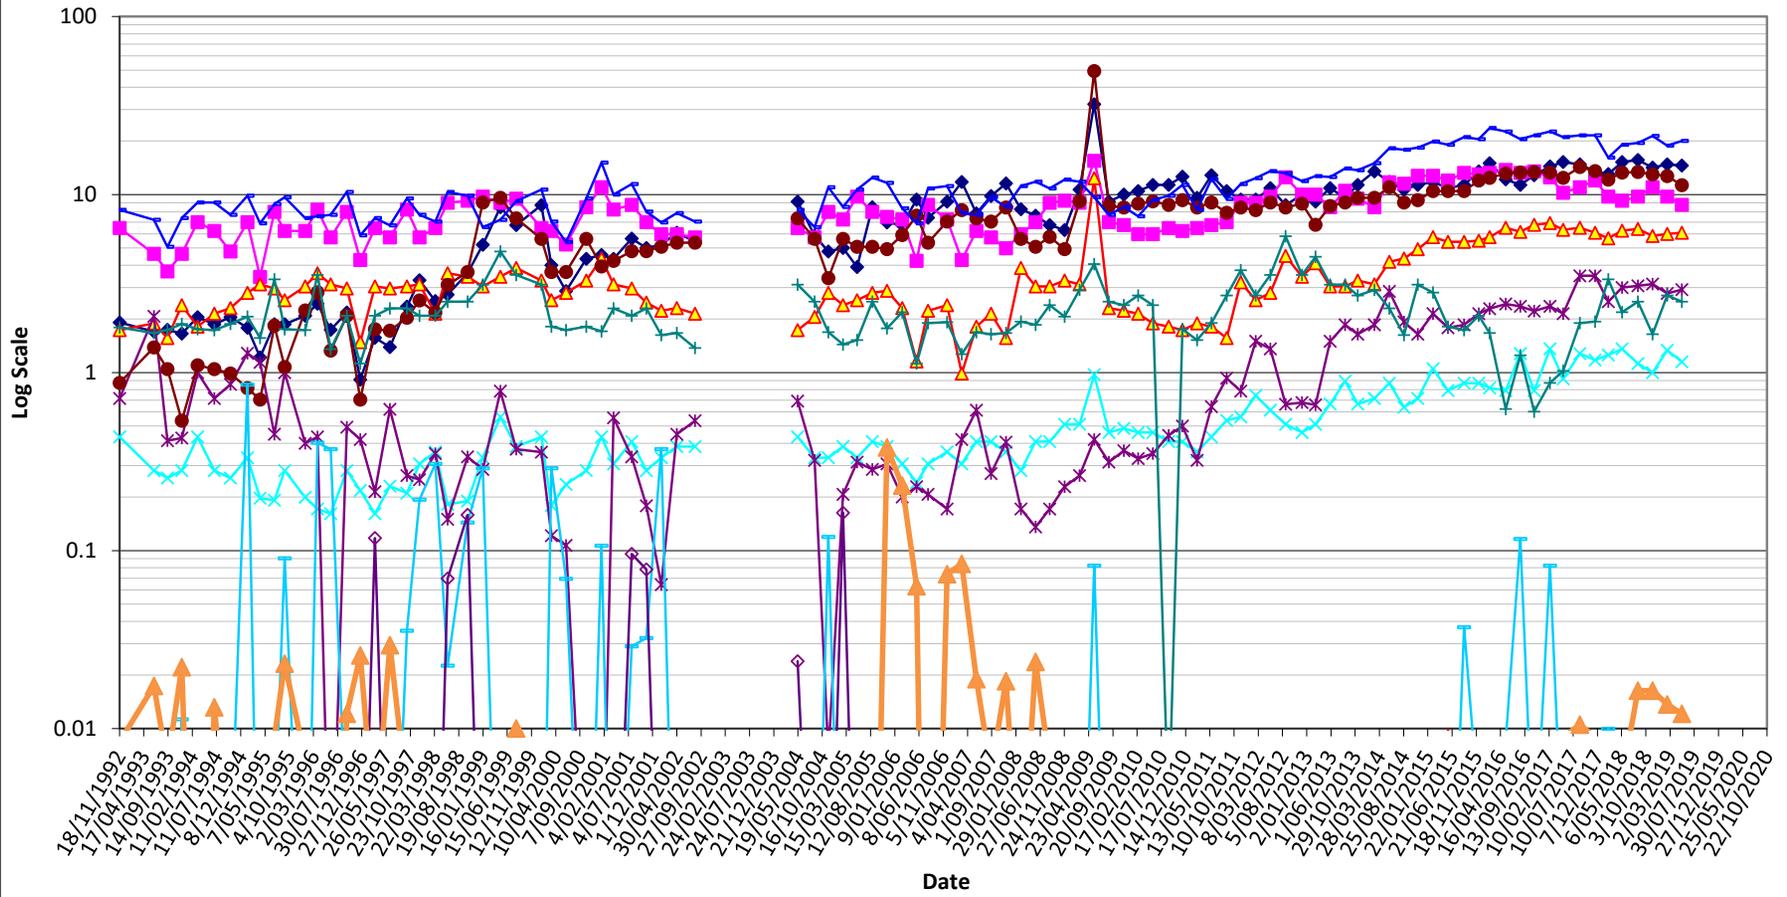
# BH2

Bore BH2 is located down gradient from the old unlined landfill cell. Historically elevated levels of  $NH_4^+-N$  indicate some leachate impact at this location.  $NH_4^+-N$  concentration at

BH2 showed an increasing trend since 2010 and reached its historical maximum in August 2017 and November 2017 (49 mg/L in both months).  $\text{NH}_4^+$ -N concentration increased slightly in the May 2019 monitoring round to a level of 41 mg/L (up from 39 mg/L in November 2018). Bicarbonate ( $\text{HCO}_3^-$ ),  $\text{Na}^+$  and  $\text{Mg}^{2+}$  concentrations in groundwater have shown an increasing trend since May 2008 (**Table 2** and **Schoeller plot BH2, Attachment 3**). Calcium ( $\text{Ca}^{2+}$ ) and potassium ( $\text{K}^+$ ) concentrations slightly decreased since the last monitoring round (**Table 2** and **Schoeller plot BH2, Attachment 3**). These two ions (and chlorine ( $\text{Cl}^-$ )) have generally followed the same trend observed in May 2019 monitoring round since September 2015. Low oxygen and negative redox (**Table 2**) continue to suggest microbial respiration and therefore degradation of the leachate is occurring at this location. Additionally, a slight sweet odour was noted.

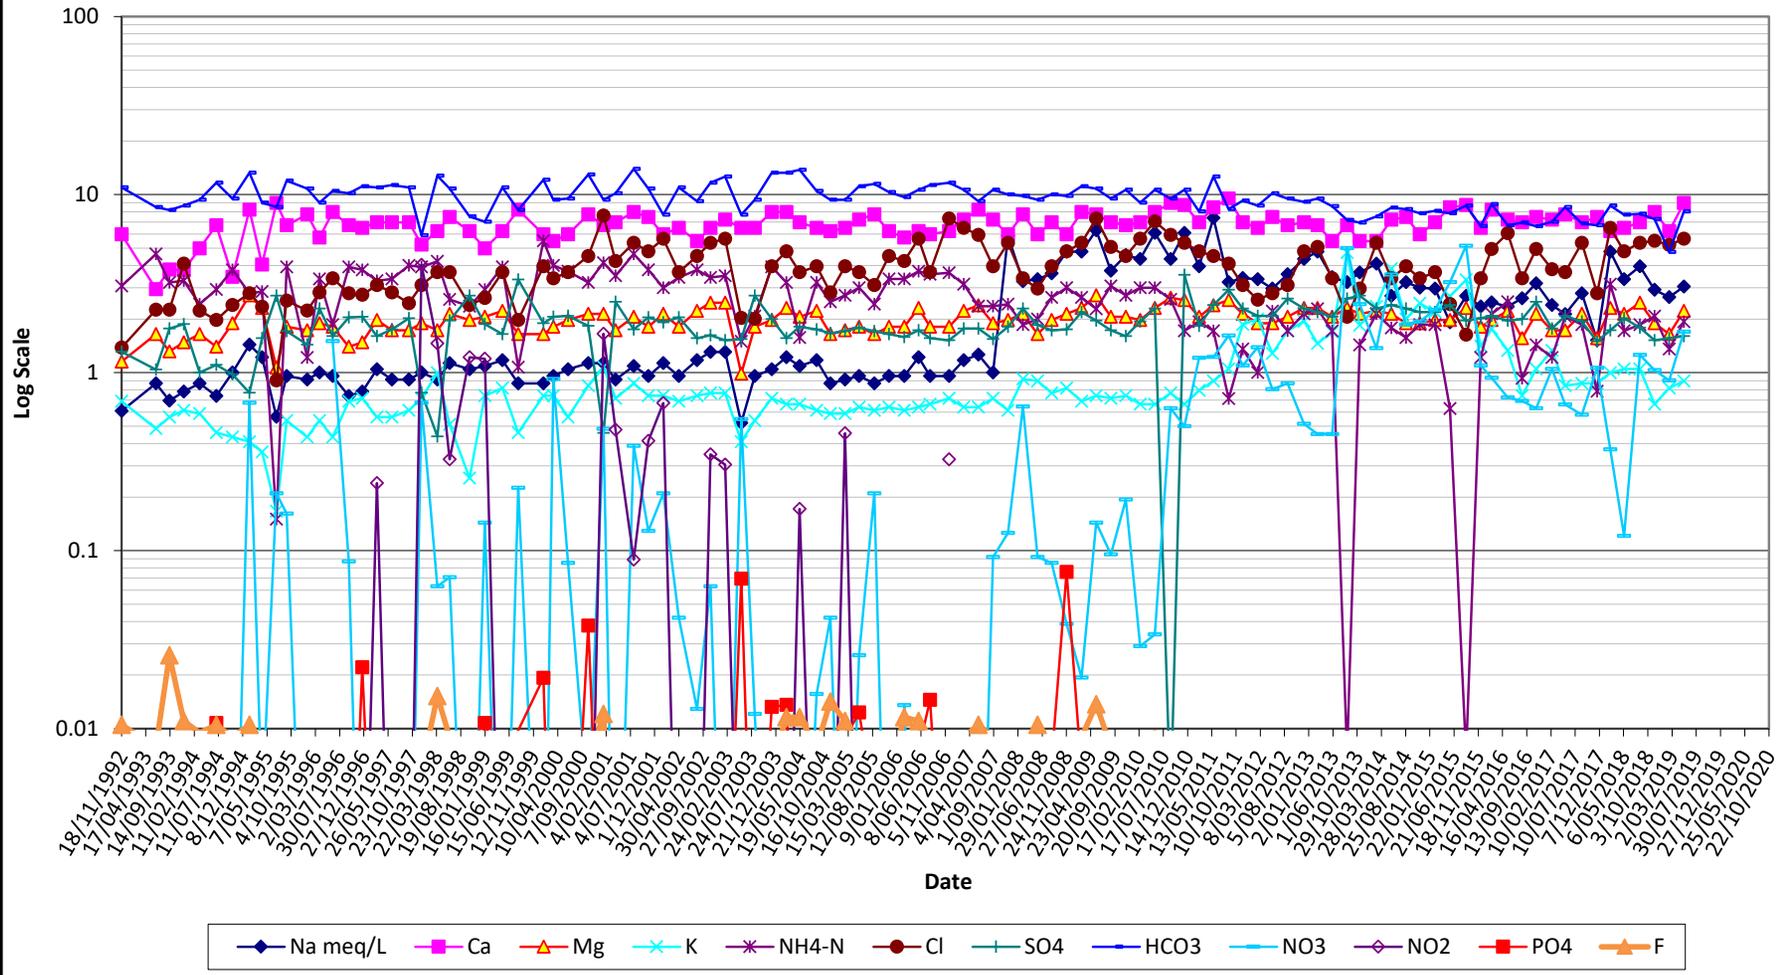
# BH3

Groundwater from bore BH3 reported an increase in concentration of native ions ( $\text{Na}^+$ ,  $\text{Mg}^{2+}$ ,  $\text{K}^+$  and  $\text{Ca}^{2+}$ ). Non-native nitrogen species increased in May 2019 with  $\text{NH}_4^+$ -N concentration rising to 27 mg/L from 19 mg/L in February 2019.  $\text{NO}_3^-$  recorded an increase in concentration to 105 mg/L from 56 mg/L in the previous monitoring event (February 2019). The concentration of  $\text{HCO}_3^-$  also increased from 290 mg/L to 490 mg/L. The L/N ratio (60.29 %) had increased since the February 2019 monitoring round (51.94 %). It was reported and verified during the drilling of BH3 that old unconfined waste dumps were in the vicinity of bore BH3 (outside the designated cells near bore BH2). In the previous monitoring report, it was suggested that elevated nitrogen species concentrations and a proportional increase of L/N ratio was due to the relatively high rainfall recorded in October and November 2018 and subsequent leaching of nitrogen species from the overlying unconfined waste in the vicinity of BH3 through the soil profile and into groundwater. Elevated L/N ratios after significant rainfall has been observed over the historical data range. The best example of this trend was observed during the August 2013 monitoring round, which was undertaken following a cumulative rainfall of 390.2 mm for May, June and July comparative to the 198.5 mm mean rainfall for 1999-2018 for that period. BH3's historic peak L/N ratio (208.90%) was recorded that monitoring round.

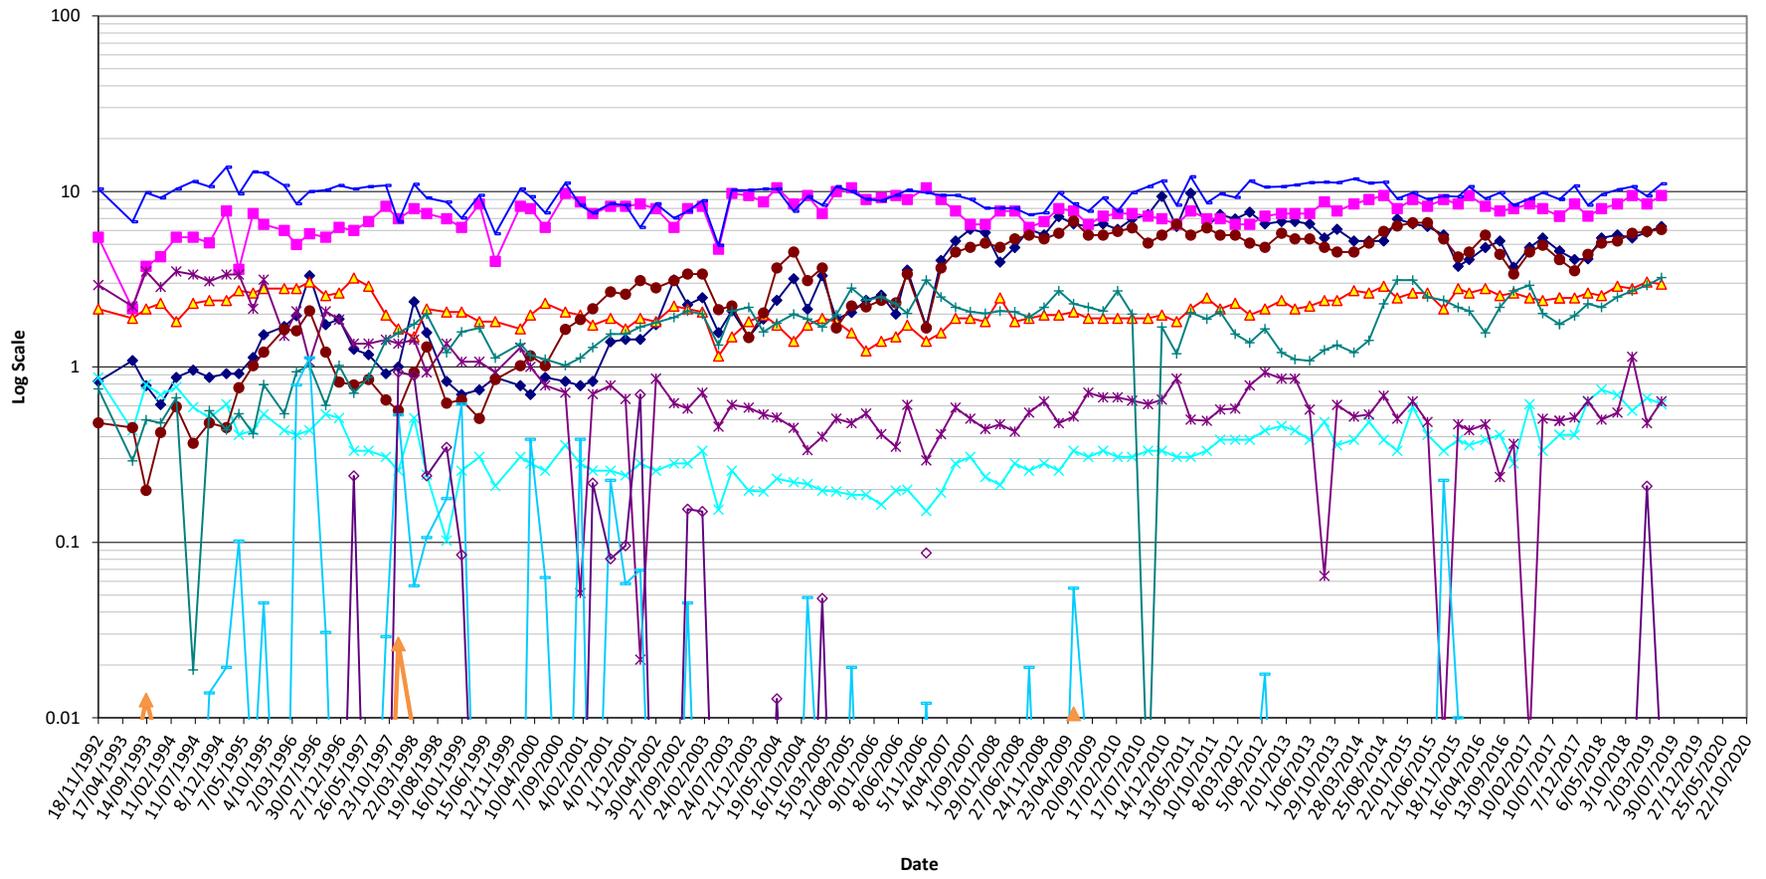
# BH4

The L/N ratio at bore BH4 showed a slight decrease in the May 2019 round (8.89 %) — in November 2018 monitoring round the L/N ratio was 9.59 %. The L/N ratio at this location had not previously exceeded 10% since May 2003.  $\text{NH}_4^+$ -N levels increased from 6.70 mg/L to 8.9 mg/L, however there was a sharp decrease in nitrite ( $\text{NO}_2^-$ ) from 9.6 mg/L to 0.23 mg/L, indicative of a decrease in the nitrification process and transformation of  $\text{NH}_4^+$ -N to  $\text{NO}_2^-$ . BH4 is placed on the border of an historic shallow landfill site and down gradient of landfilling activities. This area should be continually monitored to determine water quality in this area.

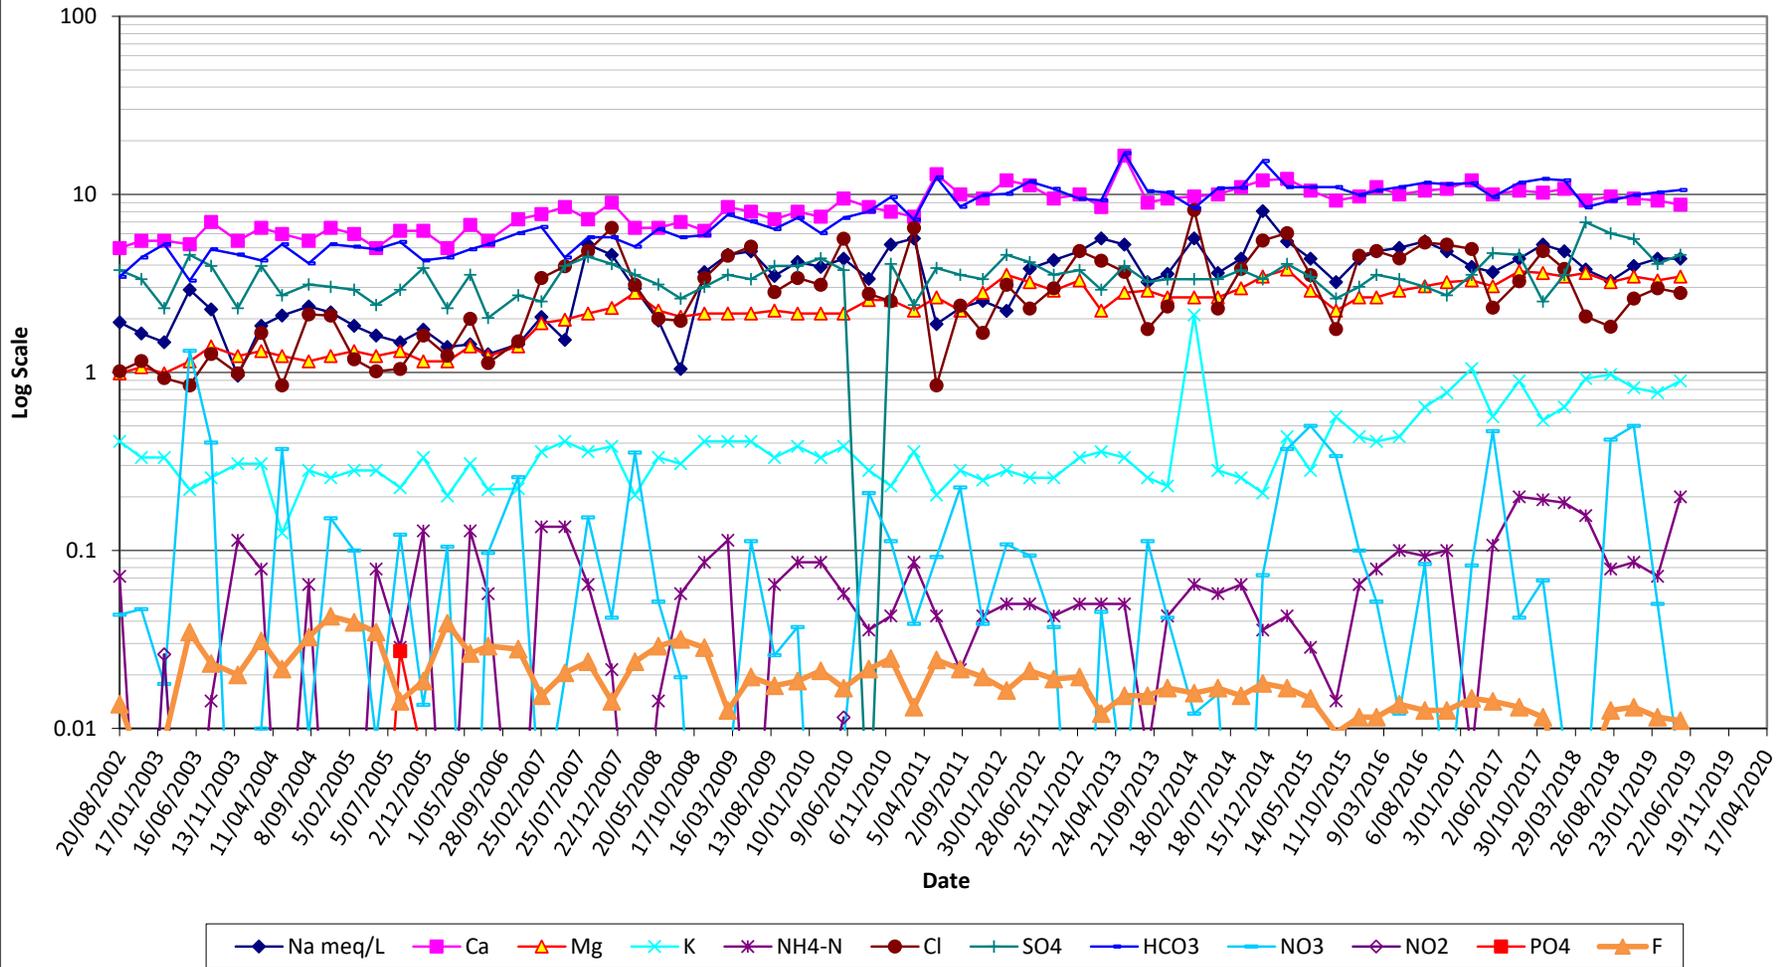
# BH13

Bore BH13 is in close proximity to a former night soil area (**Figure 1**). A slight residual leachate influence has been apparent at this location in the past. Analysis of chemical data from the May 2019 monitoring round shows an increase of L/N ratio of 12.03 % from 10.49 % in February 2019. Concentrations of  $\text{NO}_3^-$  continued to decrease from 3.10 mg/L to 0.35 mg/L. Large fluctuations in  $\text{NO}_3^-$  have previously been observed in the historic data, however, chemical composition of the groundwater has generally remained consistent since monitoring began in 2002 (**Schoeller plot BH13, Attachment 3**).

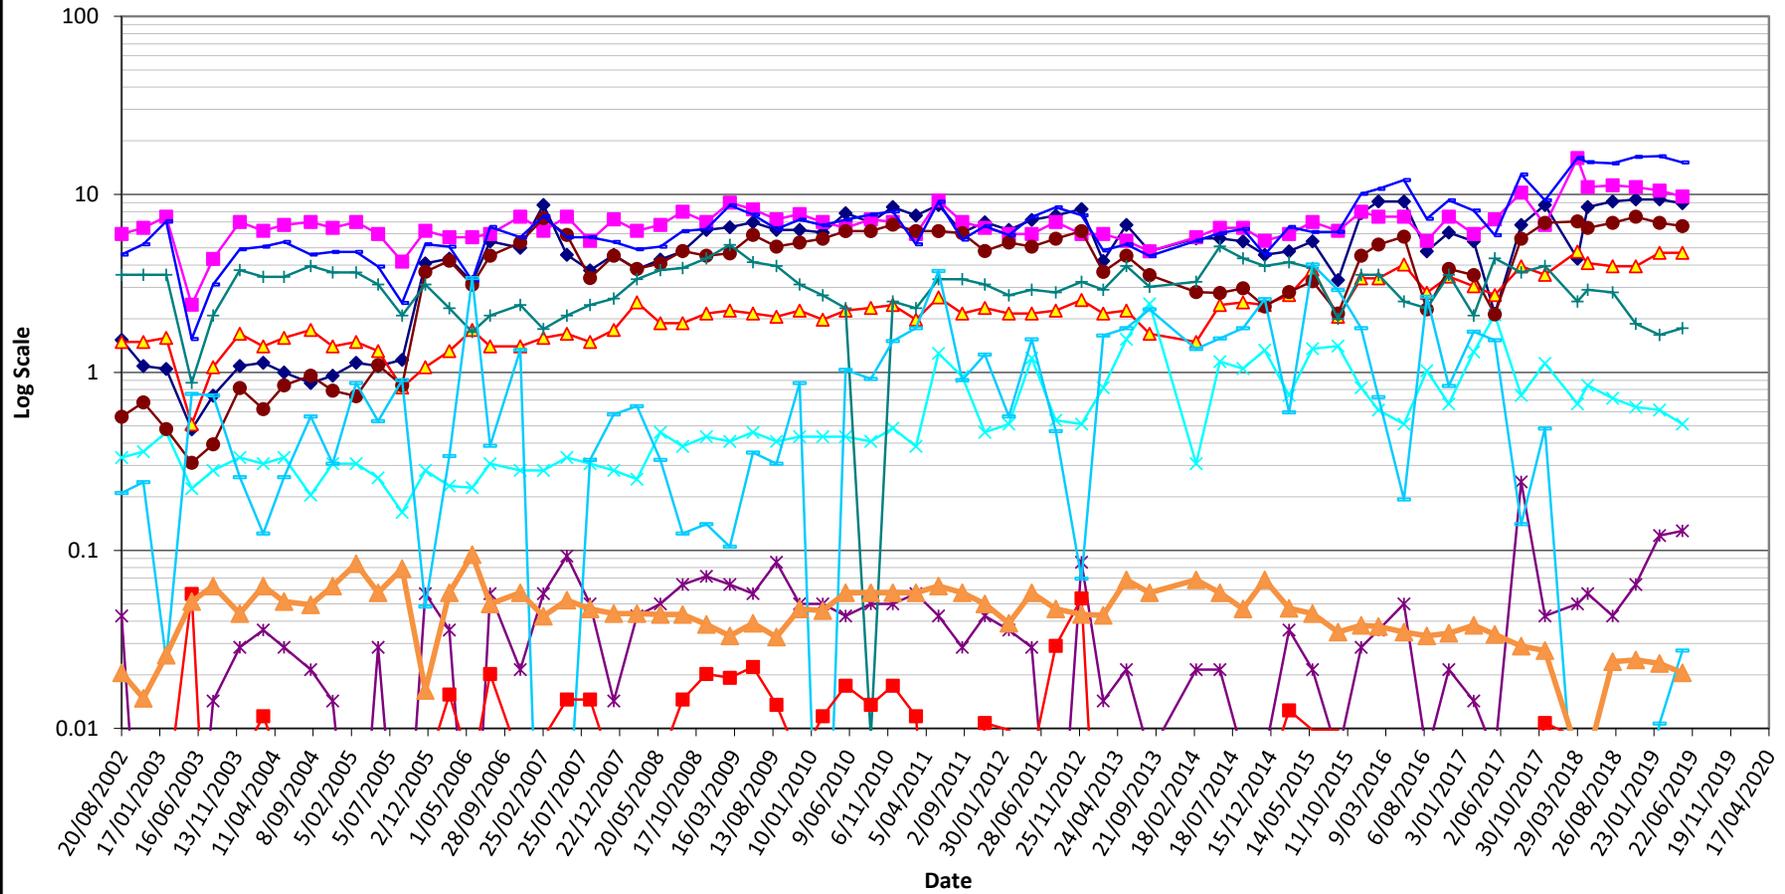
# BH14

The L/N ratio at bore BH14 remained stable in the May 2019 round (5.14 %) — in February 2019 monitoring round the L/N ratio was 5.47 % at this location.  $\text{NO}_3^-$  concentration remained stable at low levels however  $\text{NO}_3^-$  levels have been historically high at this location.  $\text{NH}_4^+$ -N concentrations increased slightly from 1.70 to 1.80 mg/L however remain below the site criteria of 1.88 mg/L. Bore BH14 is strategically placed down gradient of landfilling activities and should be continually monitored to determine the water quality in this area given its history of leachate impact.

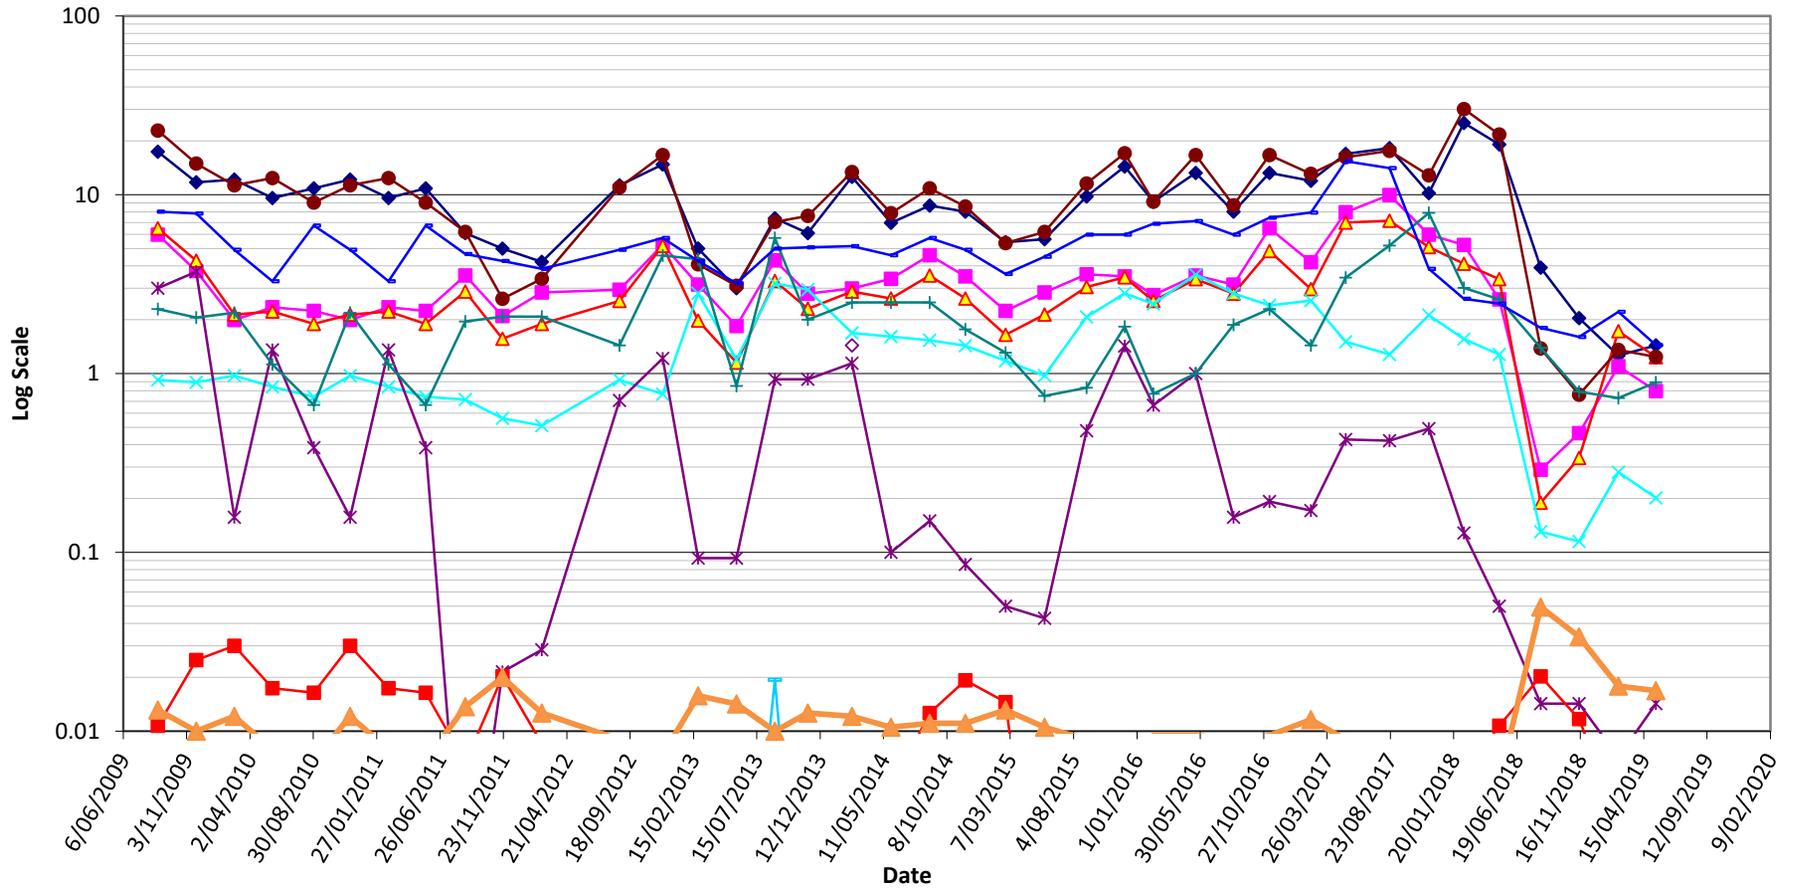
# BH16

Bore BH16 is located in a swampy area with groundwater field observations recording a murky colour and a minor leachate odour. The sampled redox potential indicates a reducing environment (-161 mV), which may have an influence on the historical dominance of  $\text{NH}_4^+$ -N over  $\text{NO}_3^-$ . This round  $\text{NH}_4^+$ -N concentrations increased slightly to 0.2 mg/L from 0.1 mg/L. Groundwater sampling in May 2019 indicated limited to no leachate impact at BH16 despite a slightly elevated L/N ratio of 12.81 %. Bore BH16 is located close to a drainage channel where offsite impacts can readily influence the chemical characteristics of the shallow groundwater and should continue to be monitored for fluctuations.
