18 June 2019

**Shellharbour City Council**  
PO Box 155  
Shellharbour Square  
Shellharbour City Centre NSW 2529

**May 2019 Quarterly Environmental Monitoring – Dunmore Recycling and Waste Disposal Depot, Dunmore, New South Wales.**

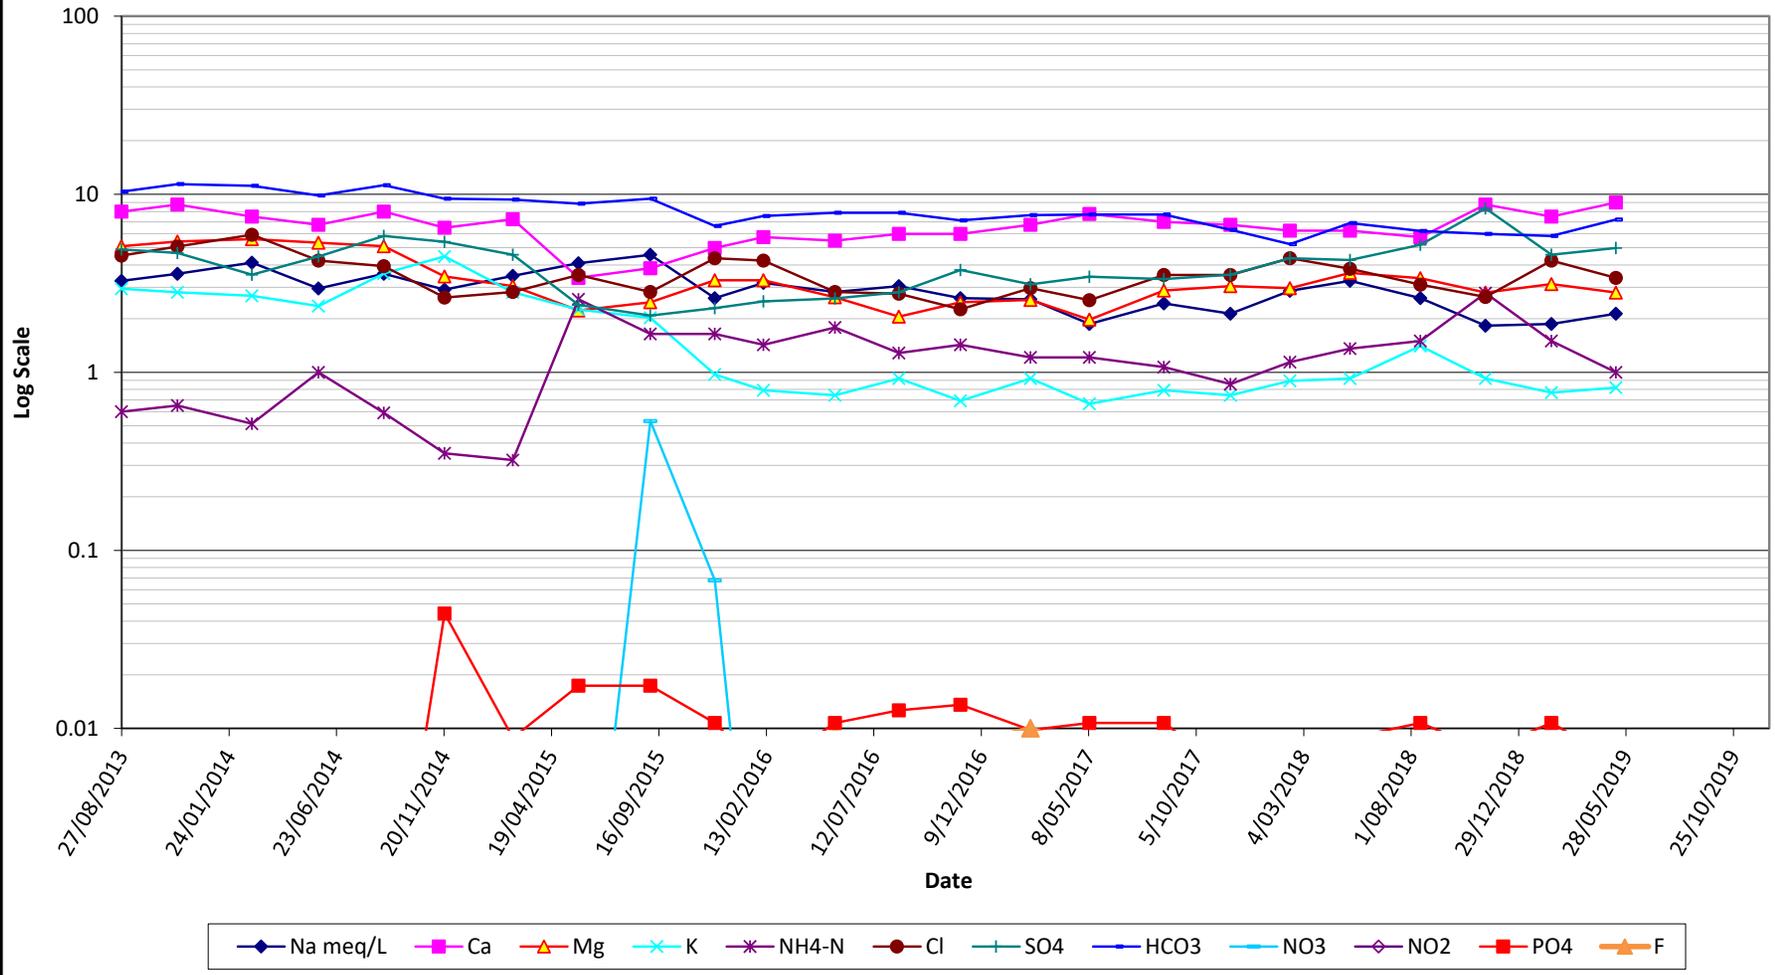
# BH20

Bore BH20 is located down gradient of the landfill, leachate ponds and shallow old landfill. This bore was positioned to assess the chemical characteristics on the boundary of the landfill site. Field observations at bore BH20 recorded a negative redox (-89 mV) with clear groundwater and no odour. The L/N ratio (17.54 %) in the May 2019 round had decreased from the February 2019 value (22.12 %) but was still considered significantly elevated. The TDS remained relatively low (rising from 815 mg/L to 855 mg/L) making the L/N susceptible to natural variations or fluctuations in chemistry. Chemical characteristics of the bore show groundwater is low in  $\text{Na}^+$ , with a moderate Ca/K and K/TDS ratio (**Table 4**). Ammonium levels remained elevated at 21 mg/L however other landfill indicators were low or absent.

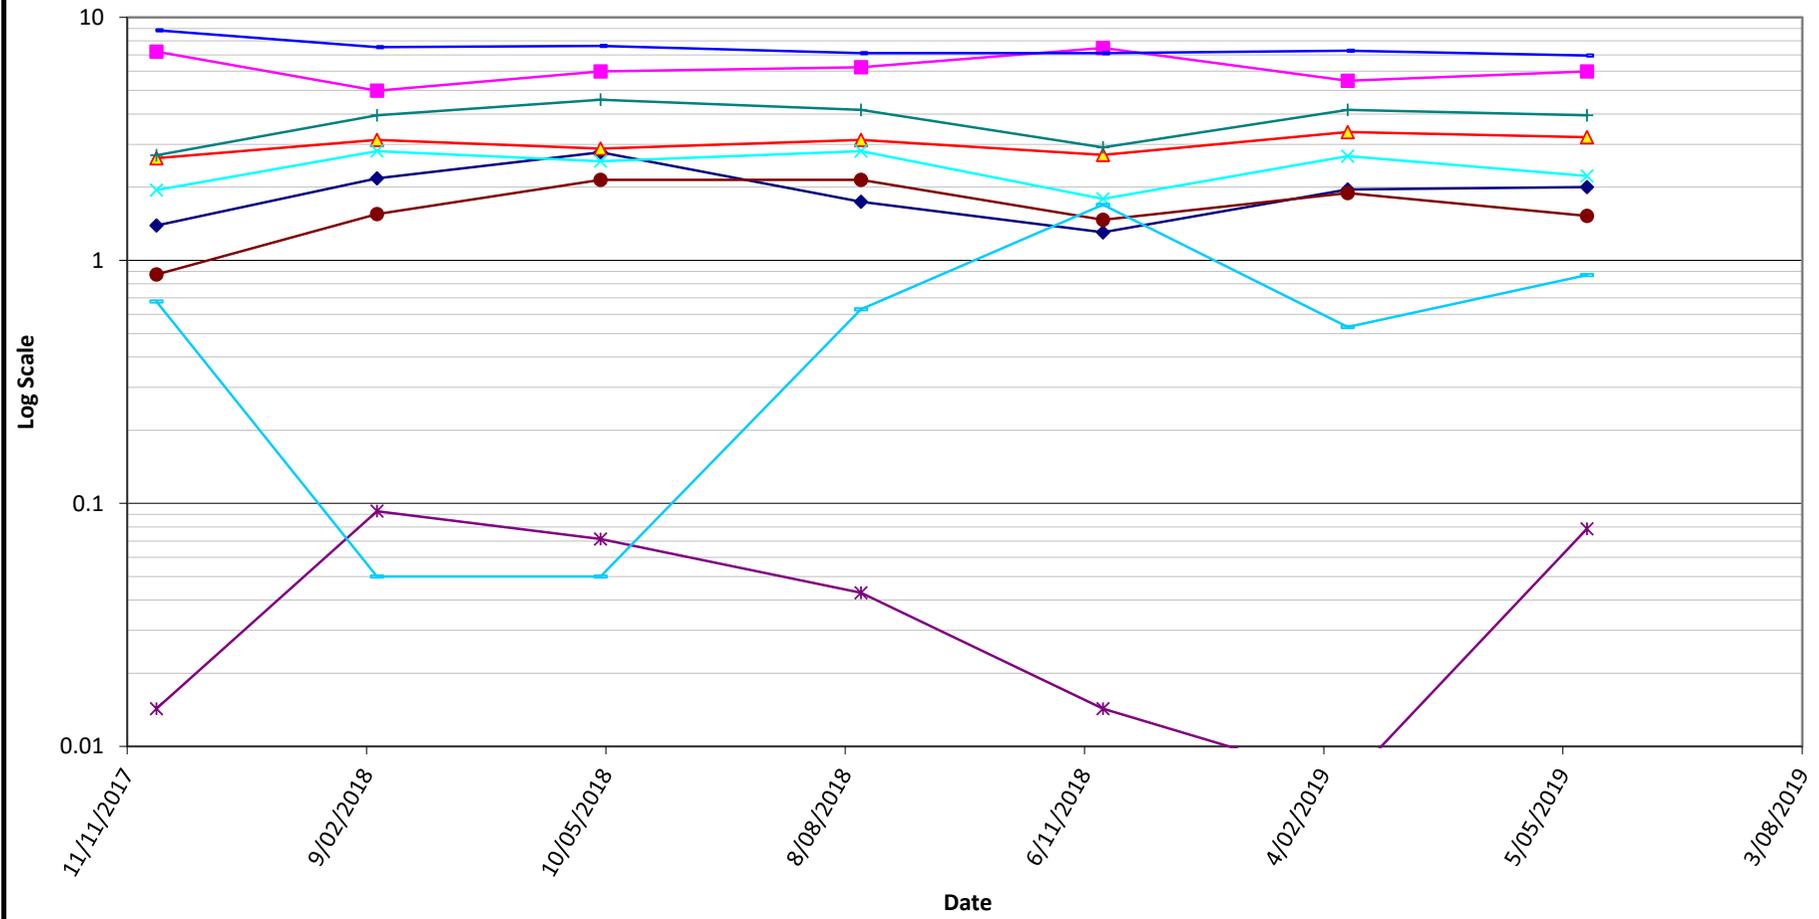
# BH20s

Bore BH20s is located directly adjacent to BH20 but at a shallower depth. Screened intervals of BH20 and BH20s are 6.0-9.0 mBGL and 1.5-4.5 mBGL respectively. Similarly, this bore was positioned to compare the chemical characteristics on the boundary of the landfill site in order to locate potential transport pathways to Rocklow Creek. In May 2019, field measurements at bore BH20s recorded a positive redox (24 mV), indicative of an oxidative atmosphere. Groundwater was clear, and no odour was detected.  $\text{NO}_3^-$  concentrations increased from 33 mg/L in February 2019 to 54 mg/L in May 2019. The increase in  $\text{NO}_3^-$  led to a slight decrease in L/N ratio (from 70.46 % to 69.32 %), however this value was still elevated and is indicative of potentially high leachate impact at this site. TDS is relatively low (810 mg/L) making the L/N susceptible to natural variations or fluctuations in

chemistry. Chemical characteristics of the bore show groundwater was low in  $\text{Na}^+$ , with a moderate Ca/K and K/TDS ratio (**Table 4**). As observed within BH3, the relatively high rainfall from March to June 2019 may have impacted the nitrogen species within BH20s, causing leaching of nitrogen species from the soil into the groundwater, resulting in elevated  $\text{NO}_3^-$  concentrations. Ammonium levels (1.1 mg/L) have increased significantly since February 2019 (0.1 mg/L) and remain lower than those seen at the deeper BH20 bore. It was previously thought that high nitrate levels in this shallower bore location was indicative of nitrification throughout the soil profile, however, continued monitoring at this location will be necessary to determine potential leachate transport pathways to Rocklow Creek.

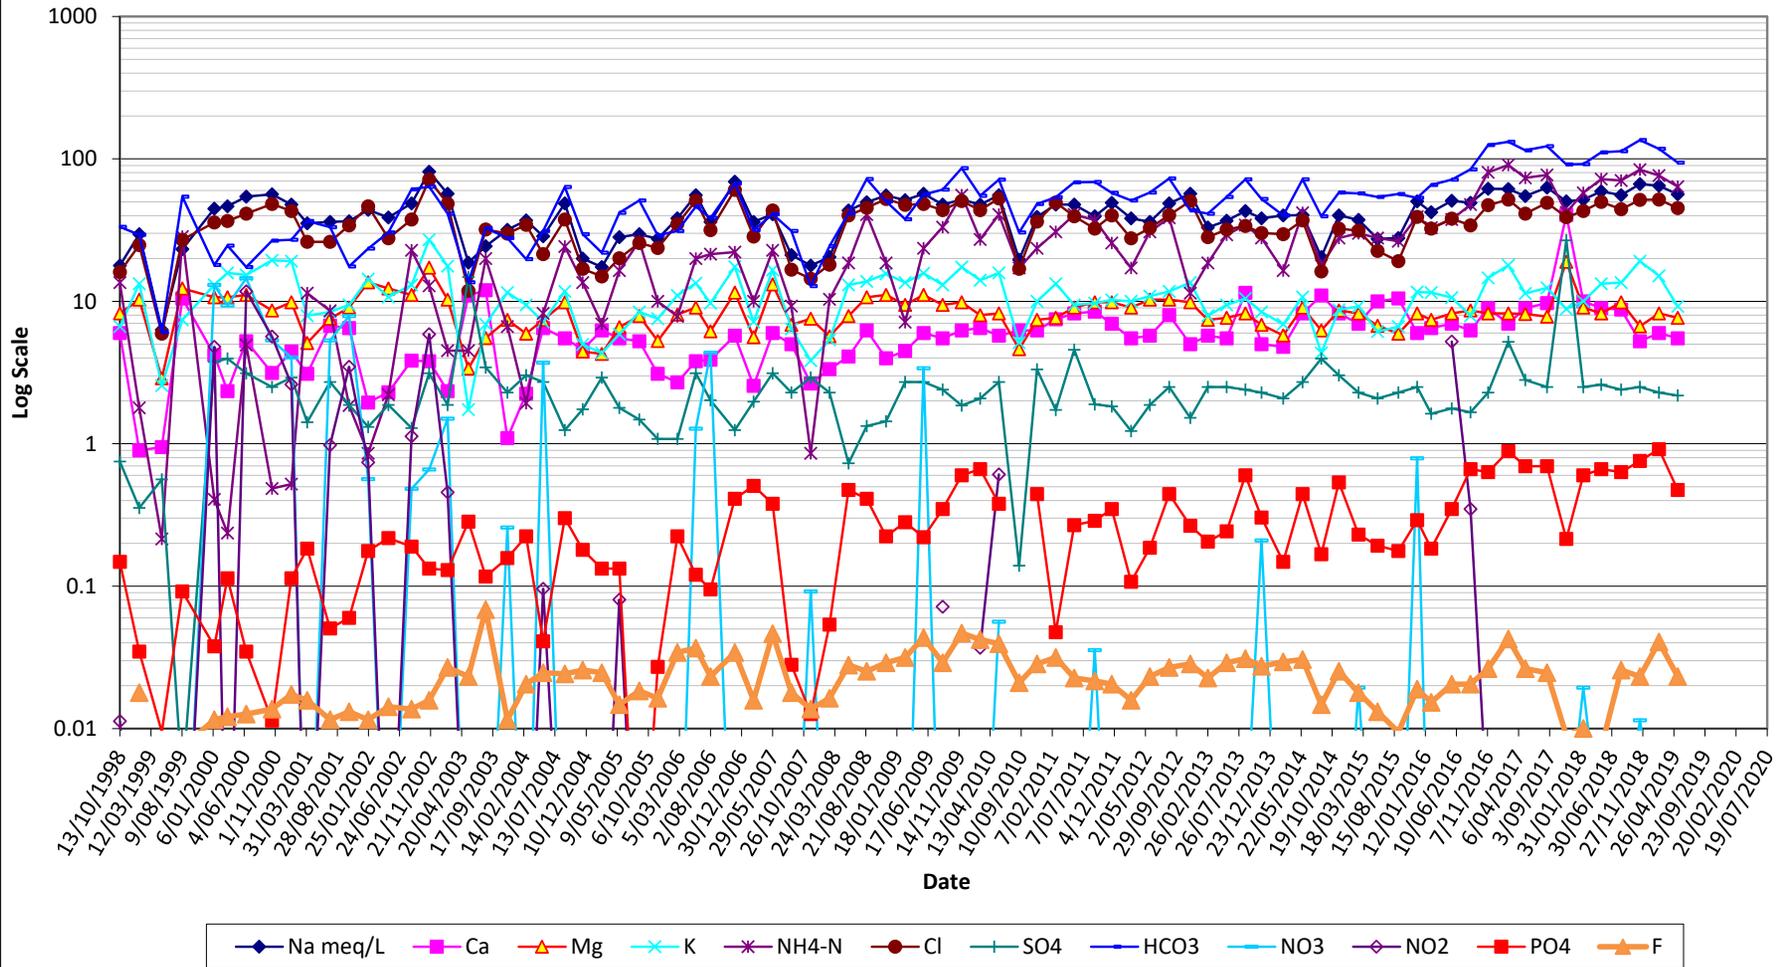
# LP1

The chemistry of leachate water at the Dunmore Recycling and Waste Disposal Depot is significantly different when compared to the surface and groundwater chemistry of non-leachate influenced bores. This is demonstrated through comparison of chemical data presented in **Table 2**. In particular TDS, BOD, TOC, Na<sup>+</sup>, NH<sub>4</sub><sup>+</sup>-N, K<sup>+</sup>, HCO<sub>3</sub><sup>-</sup>, PO<sub>4</sub><sup>3-</sup> and total iron concentrations are generally elevated in leachate pond water compared to other monitoring bores (**Schoeller Plot LP1, Attachment 3**). Ionic ratios (**Table 4**) such as low Ca/K (0.60) and high Na/Ca (10.30) and L/N (83.51) ratios represent landfill leachate chemical characteristics. These chemical characteristics have been relatively stable over the past 10 years of monitoring.

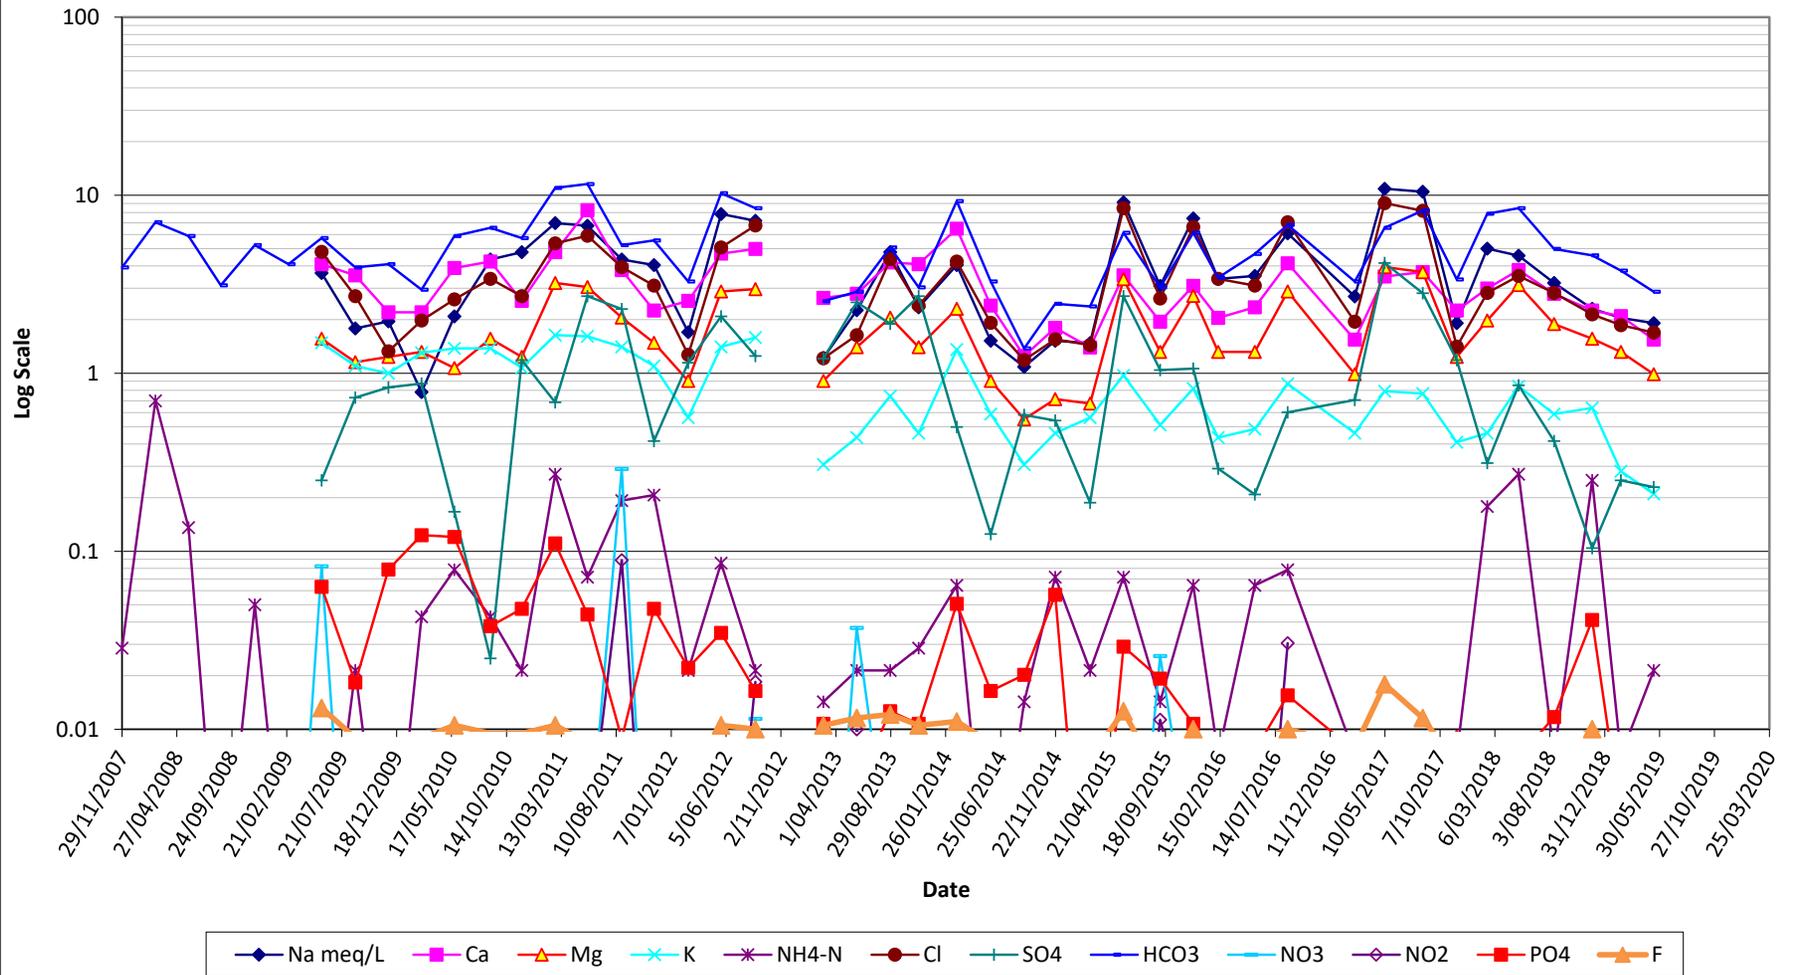
# SWP1

NH<sub>4</sub><sup>+</sup>-N levels detected at SWP1 (0.30 mg/L) increased since the previous monitoring event. Ongoing minor leachate impact has been indicated by consistent L/N ratios > 10% and < 20%. Elevated concentrations of soluble iron and a negative redox potential are indicative of a reducing environment which may have contributed to historical low levels of dissolved oxygen and the production of NH<sub>4</sub><sup>+</sup>-N.

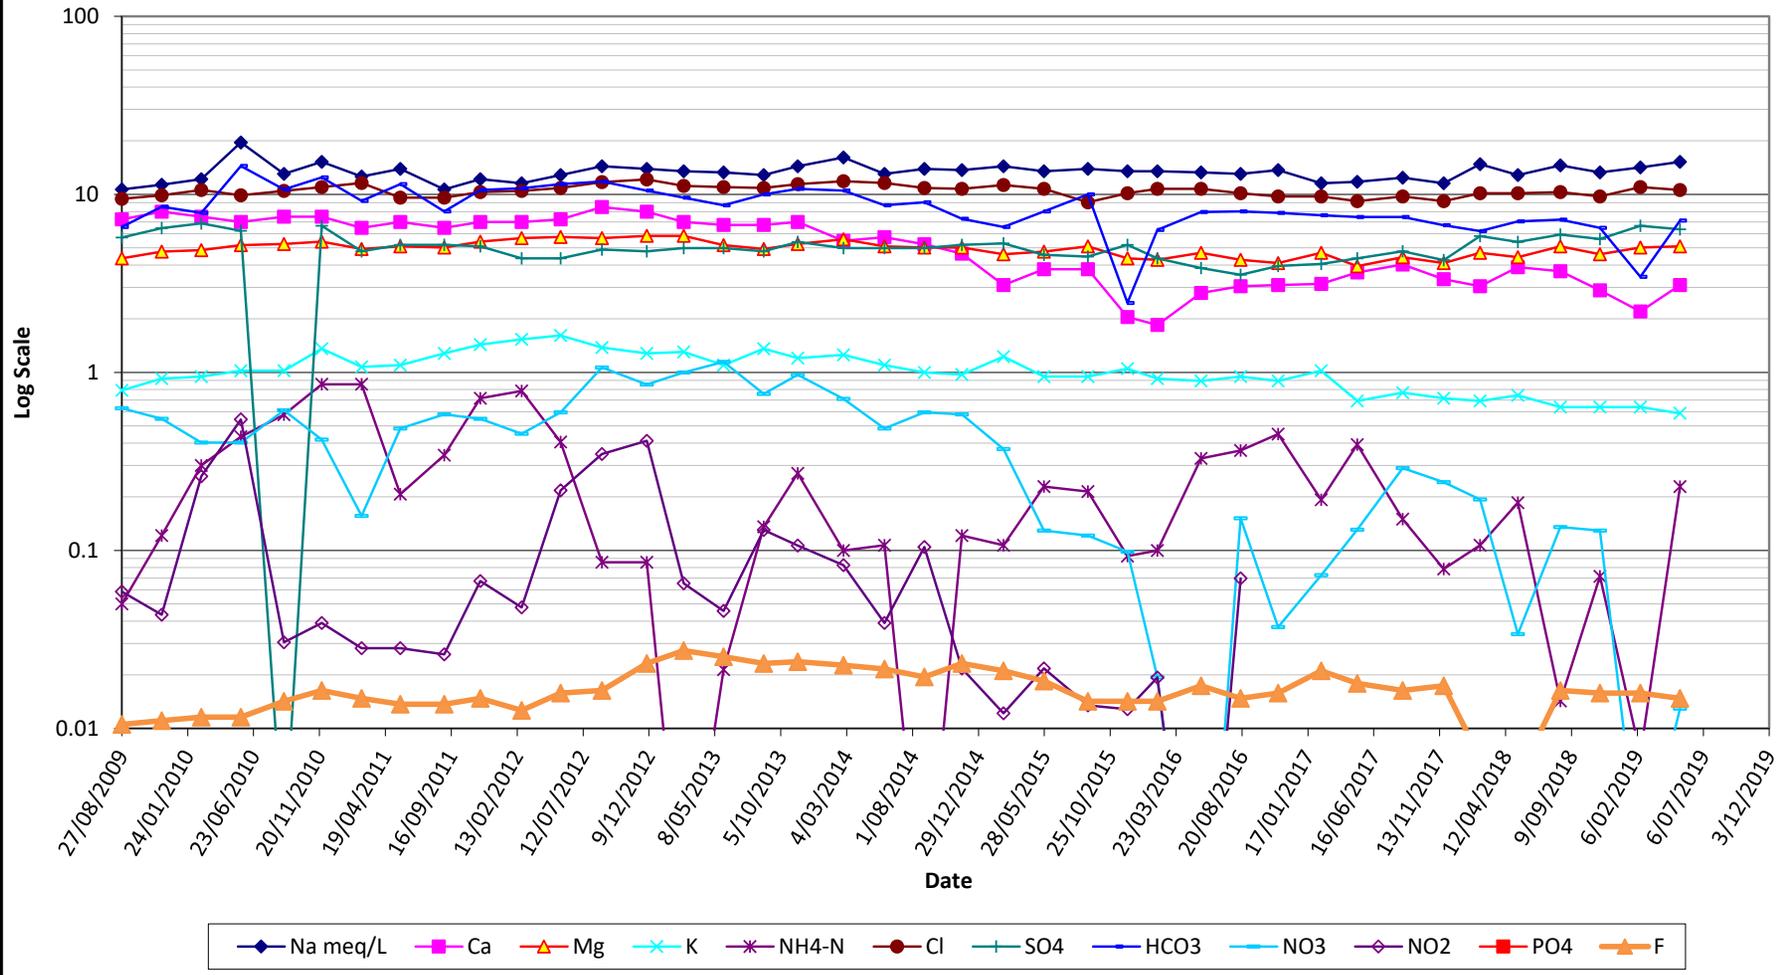
# SWP4

NH<sub>4</sub><sup>+</sup>-N concentration at SWP4 increased significantly from <0.10 mg/L to 3.20 mg/L and exceeded the trigger level of 1.88 mg/L. NO<sub>3</sub><sup>-</sup> levels also increased above the limit of detection to 0.80 mg/L in May 2019. The increase in NH<sub>4</sub><sup>+</sup>-N and NO<sub>3</sub><sup>-</sup> concentrations is indicative of a slow down in the natural process of nitrification by which NH<sub>4</sub><sup>+</sup>-N naturally attenuates. All chemical parameters at this location are within historical ranges.
