Shellharbour City Council

August 2018 Quarterly Environmental Monitoring – Dunmore Recycling and Waste Disposal Depot, Dunmore, New South Wales.

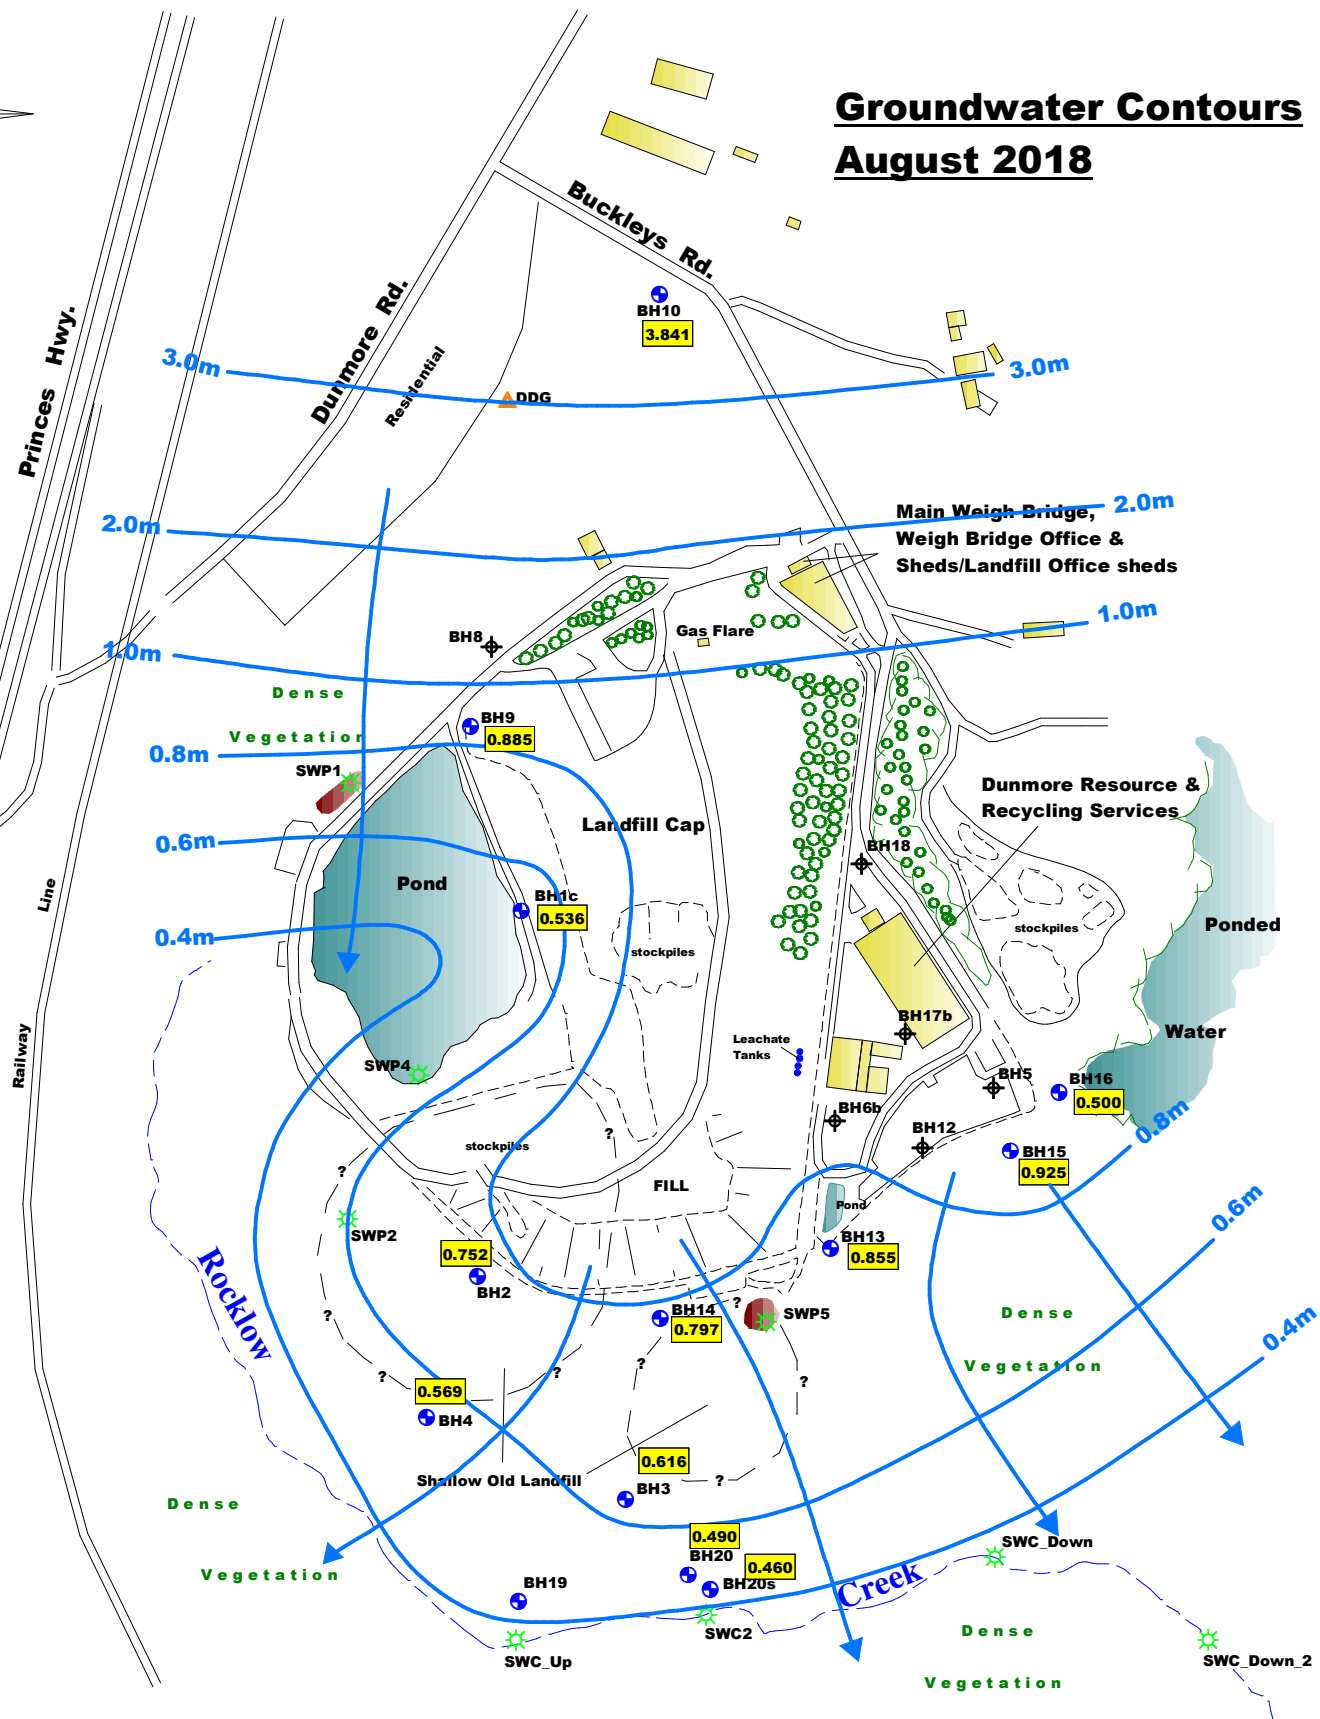
Groundwater Contours August 2018

Inferred groundwater contours from the August 2018 standing water level (SWL) measurements are illustrated in Figure 2 (Attachment 1). These were calculated using SWLs from surveyed bores. Groundwater flow direction was towards Rocklow Creek in a southerly direction similar to previous monitoring events.

Cumulative rainfall for May 2018 (12.8 mm), June 2018 (79.6 mm), July 2018 (4.6 mm) and August 2018¹ (1.6 mm) was 98.6 mm (*BOM – Albion Park Wollongong Airport weather station*) and below 1999-2018 mean rainfall for this period of the year. Groundwater levels increased at all monitoring wells. The average of the measured standing water levels throughout the site has increased by ~0.09 mAHD from 0.78 mAHD in May 2018 to 0.87 mAHD.

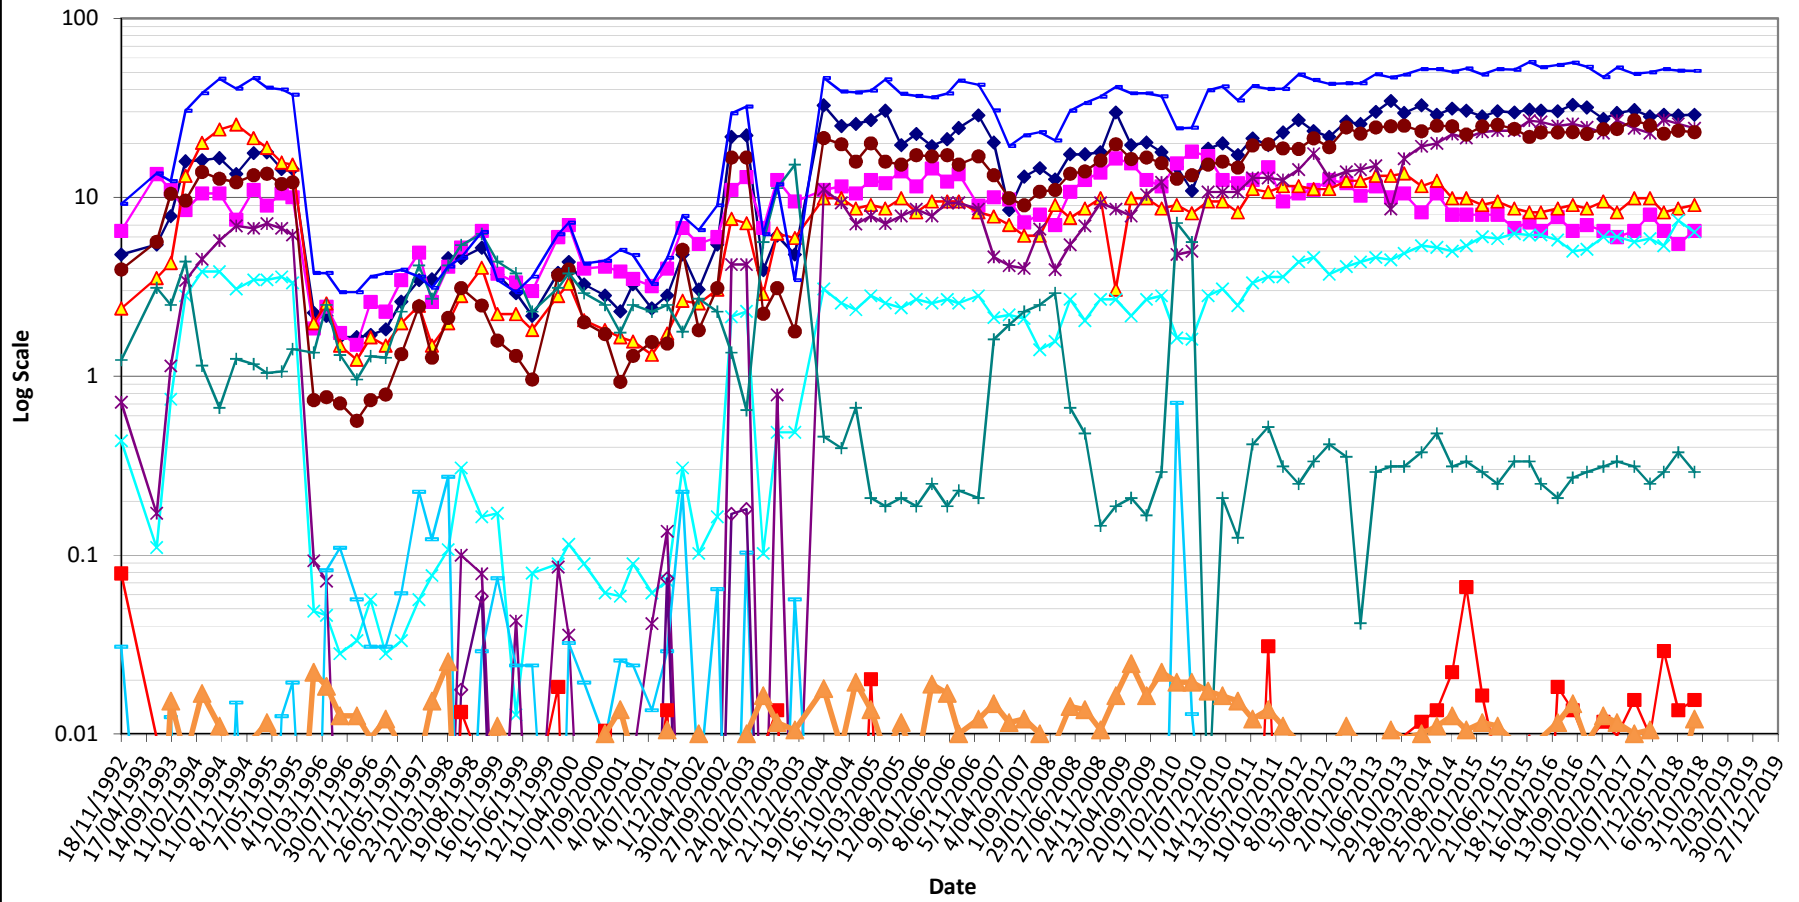
Bore BH1c is located near the old unlined landfill cell and intercepts leachate within the cell. As such the chemical signature of this bore has historically contained elevated leachate indicators in comparison to other monitoring bores (Schoeller plot BH1 a/b/c, Attachment 3). This continued during the current monitoring event and the groundwater was found to have a brown tinge, and leachate odour noted in combination with elevated TDS (3,920 mg/L), K^+ (290 mg/L) [resulting in low Ca/K – 1.01] and NH_4^+ -N (340 mg/L) concentrations. The low levels of oxygen (0.49 ppm, Table 1) and presence of soluble Fe^{2+} (2.2 mg/L) indicate an anaerobic environment and biochemical demand in response to microbial respiration. BOD has fluctuated since the bore was installed, ranging from 830 mg/L to 6 mg/L. BODs have remained at similar levels (6-8 mg/L) since August 2016. In May 2018, there was a slight fluctuation in BOD with levels rising to 12 mg/L and a trend of rising levels continued in August 2018 with BOD rising to 14 mg/L. Further evidence of microbial activity / respiration is elevated HCO_3^- resulting in a low Cl/ HCO_3^- ratio of 0.46 (Table 4). This suggests some degradation of the leachate plume has occurred in this monitoring bore.

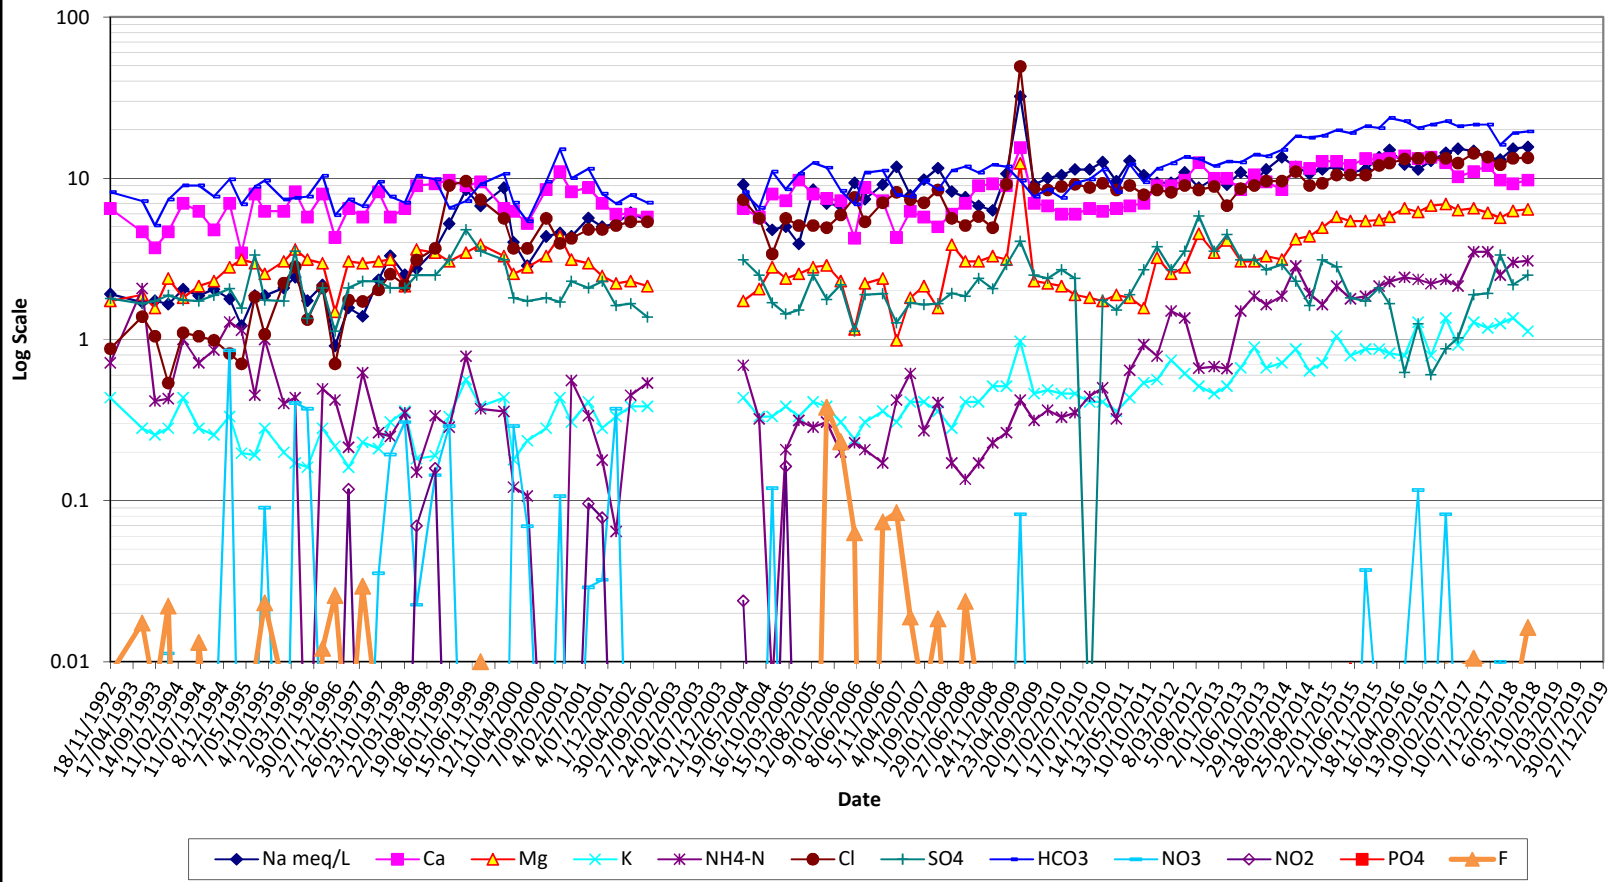
Bore BH2 is located down gradient from the old unlined landfill cell. Historically elevated levels of NH_4^+ -N indicate some leachate impact at this location. NH_4^+ -N concentration at BH2 showed an increasing trend since 2010 and reached its historical maximum in August 2017 and November 2017 (49 mg/L in both months). NH_4^+ -N concentration increased slightly in the August 2018 monitoring round to a level of 43 mg/L (up from 42 mg/L in May 2018). Bicarbonate (HCO_3^-), Na^+ and Mg^{2+} concentrations in groundwater have shown an increasing trend since February 2008 (Table 2, Schoeller plot BH2, Attachment 3). Calcium (Ca^{2+}) concentrations slightly decreased whilst potassium (K^+) and chlorine (Cl-) slightly increased since the last monitoring round (Table 2, Schoeller plot BH2, Attachment 3). These three ions have generally followed the same trend observed in August 2018 monitoring round since September 2015. Low oxygen and negative redox (Table 2) continue to suggest microbial respiration and therefore degradation of the leachate is occurring at this location. Additionally, a leachate odour was noted.

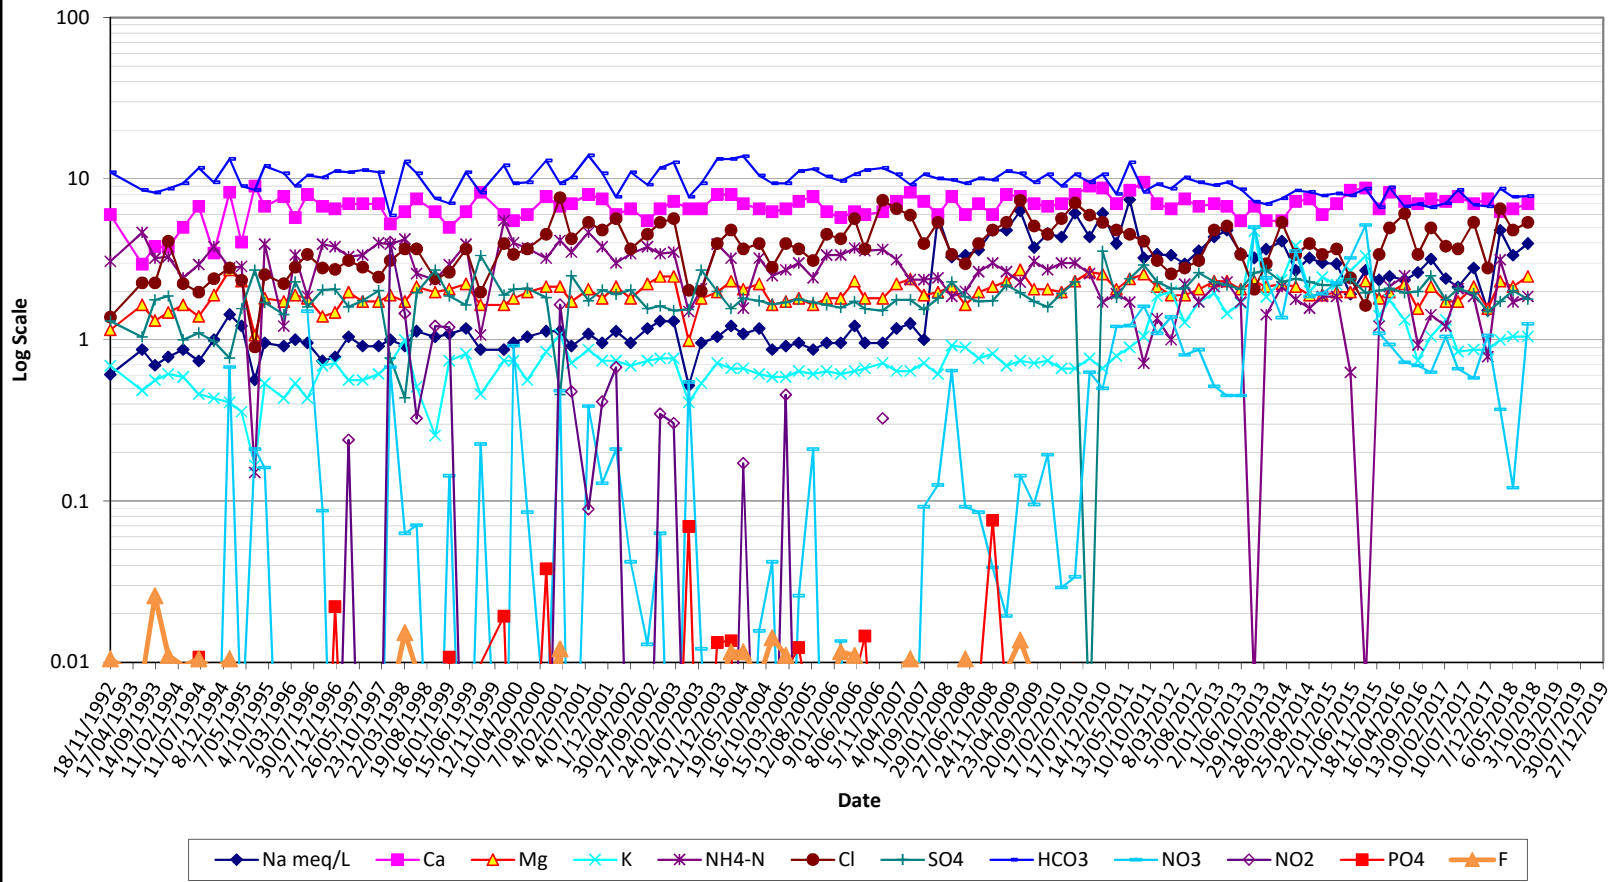
Groundwater from bore BH3 reported increases in concentration of all native ions (Na^+ , Ca^{2+} and Mg^{2+}) as well as non-native ions NO_3^- and $\text{NH}_4^+\text{-N}$ since last monitoring round with NO_3^- recording an increase by an order of magnitude (7.5 mg/L in May 2018 to 78 mg/L in August 2018). Over this period concentrations of HCO_3^- and K^+ remained stable. The L/N ratio (55.56%) has increased significantly since the May 2018 monitoring round (31.12%), however, due to the low TDS (<1000 mg/L) the L/N ratio must be used with some caution. It was reported and verified during the drilling of BH3 that old unconfined waste dumps were in the vicinity of bore BH3 (outside the designated cells near bore BH2). After the relatively high (comparative to May, June and August 2018) rainfall recorded in July 2018 (79.6 mm) it is likely that nitrogen species within the overlying unconfined waste at BH3, along with native ions Na^+ , Ca^{2+} and Mg^{2+} within the residual soil have leached from the soil and entered groundwater, resulting in the elevated levels of NO_3^- and increase in concentrations of native ions. This trend of elevated L/N ratios after significant rainfall has been observed over the historical data range. The best example of this trend was observed during the August 2013 monitoring round, which was undertaken following a cumulative rainfall of 390.2 mm for May, June and July comparative to the 198.5 mm mean rainfall for 1999-2018 for that period. BH3's historic peak L/N ratio (208.90%) was recorded that monitoring round.

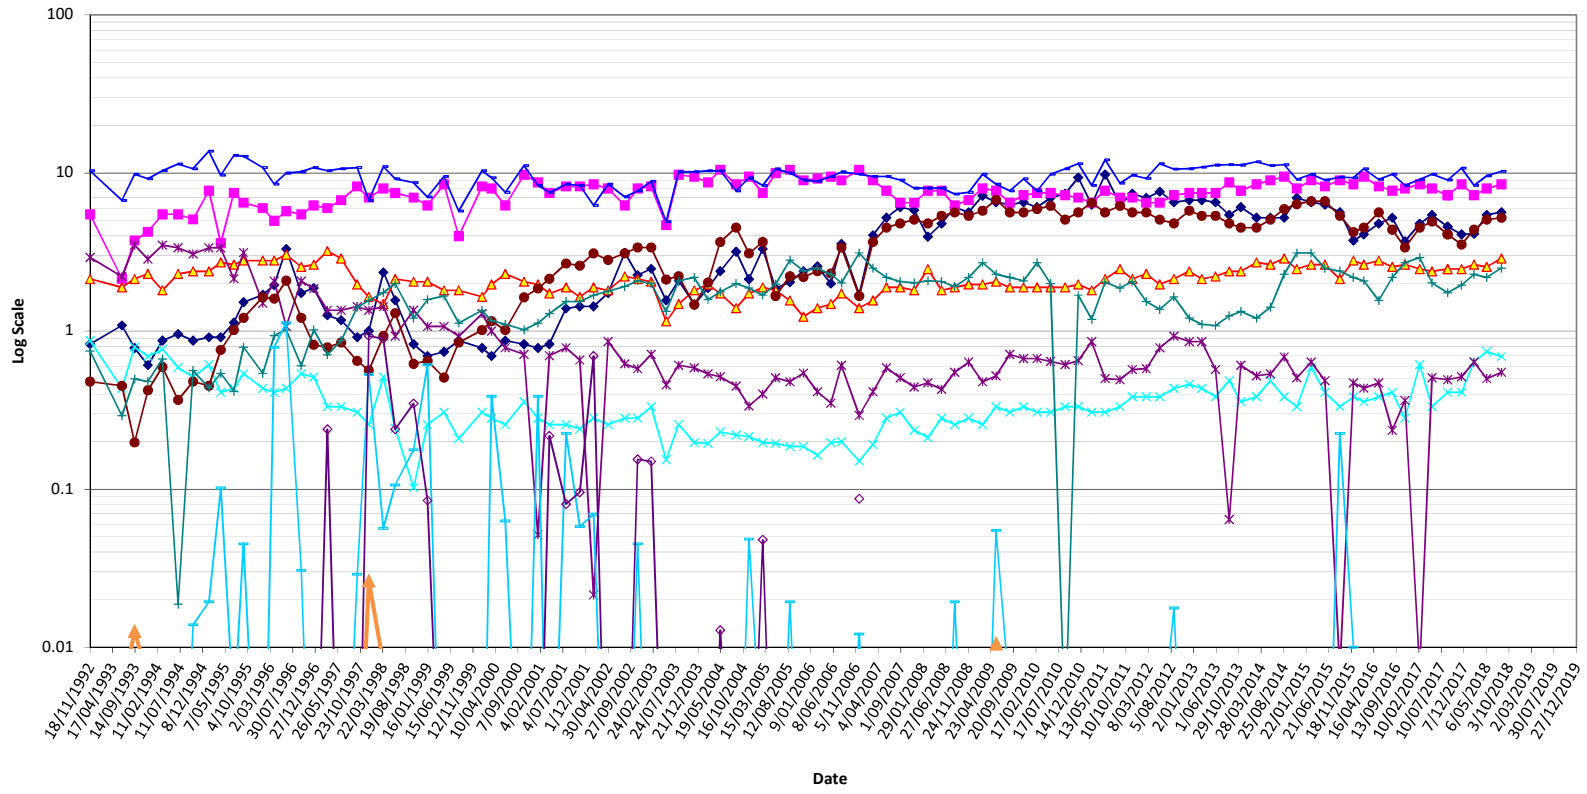
The L/N ratio at bore BH4 showed a slight decrease in the August 2018 round (10.42%) — in May 2018 monitoring round the L/N ratio was 31.39% at this location. The L/N ratio at this location had not exceeded 10% previously since February 2003. Relatively stable $\text{NH}_4^+\text{-N}$ levels (7.70 mg/L), decrease in K^+ and increased concentrations of native ions Na^+ , Ca^{2+} and Mg^{2+} can be attributed to the decrease in L/N ratio however this value should be used carefully due to low TDS <1000 mg/L. BH4 is placed on the border of an historic shallow landfill site and down gradient of landfilling activities. This area should be continually monitored to determine water quality in this area.

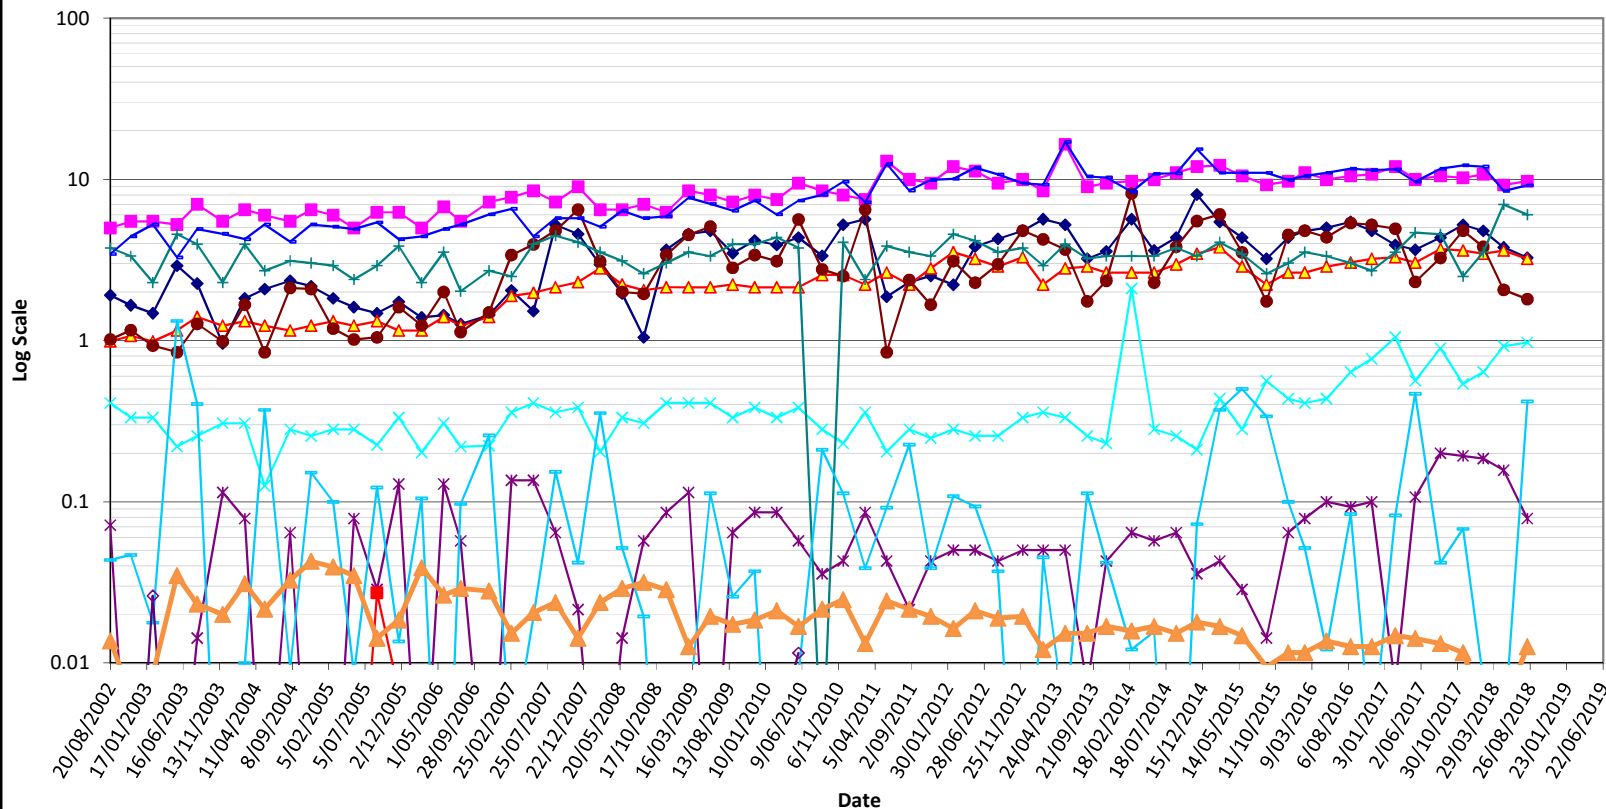
Bore BH13 is in close proximity to a former night soil area (Figure 1). A slight residual leachate influence has been apparent at this location in the past. Analysis of chemical data from the August 2018 monitoring round shows an increase of L/N ratio to 21.07% from 12.16% in May 2018. This significant increase in L/N can be attributed to the increase in NO_3^- to 26 mg/L from 0.22 mg/L in May 2018. Large fluctuations in NO_3^- have previously been observed in the historic data, however, chemical composition of the groundwater has generally remained consistent since monitoring began in 2002 (Schoeller plot BH13, Attachment 3).

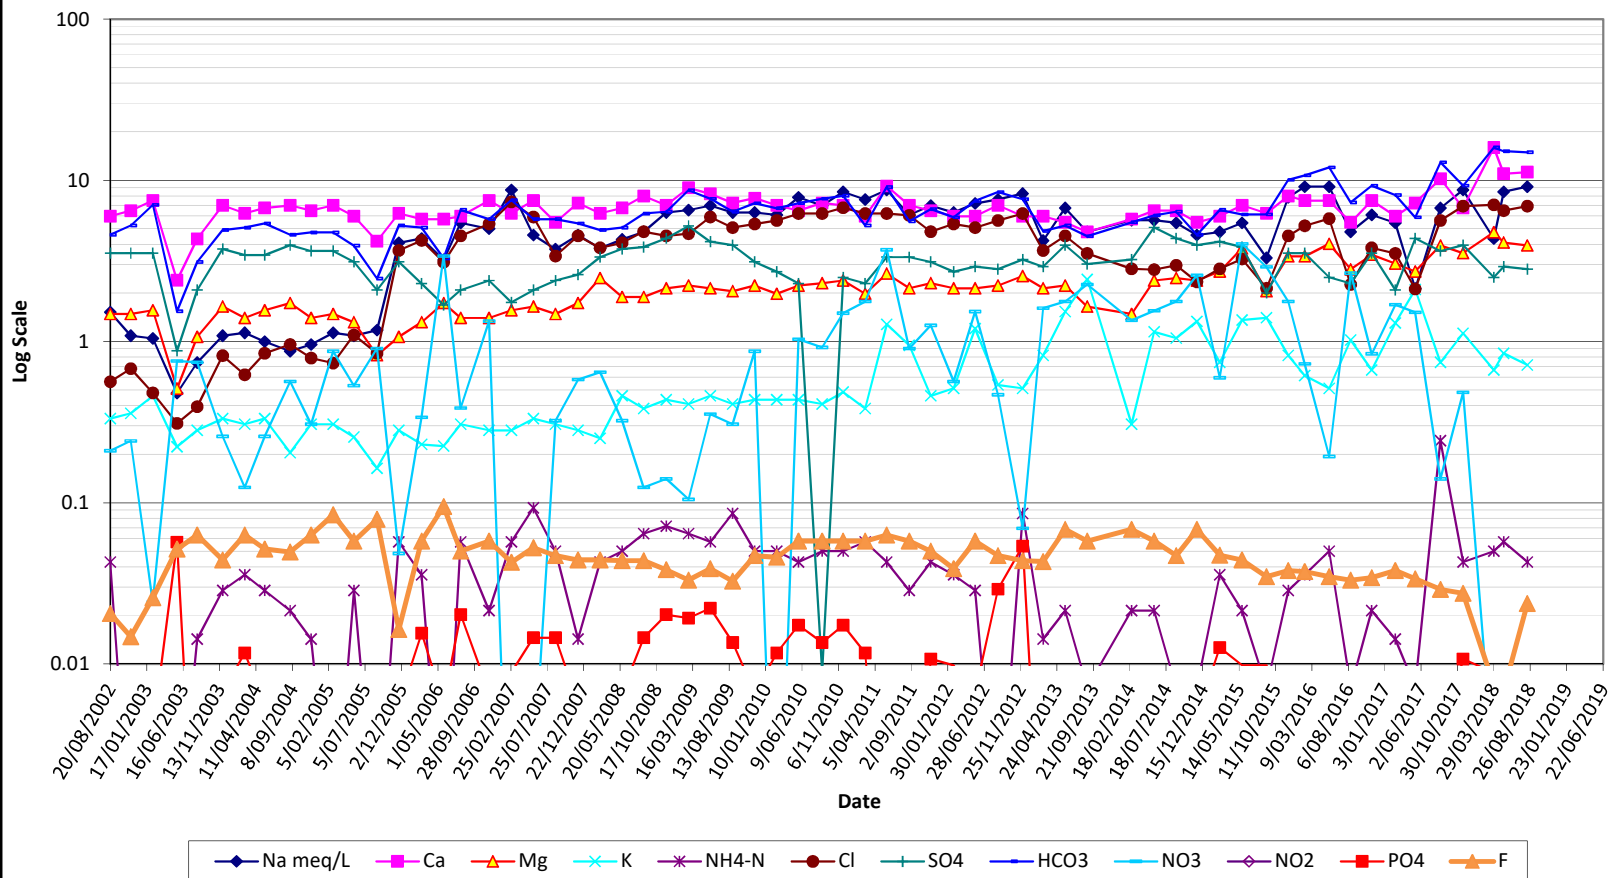
The L/N ratio at bore BH14 showed a slight decrease in the August 2018 round (5.94%) — in May 2018 monitoring round the L/N ratio was 7.29% at this location. The decrease in concentration of K^+ and $\text{NH}_4^+\text{-N}$ and increase in Na^+ and Ca^{2+} account for the decrease in L/N (Schoeller plot BH14, Attachment 3). NO_3^- concentration remained stable at low levels however NO_3^- levels have been historically high at this location. Bore BH14 is strategically placed down gradient of landfilling activities and should be continually monitored to determine the water quality in this area given its history of leachate impact.

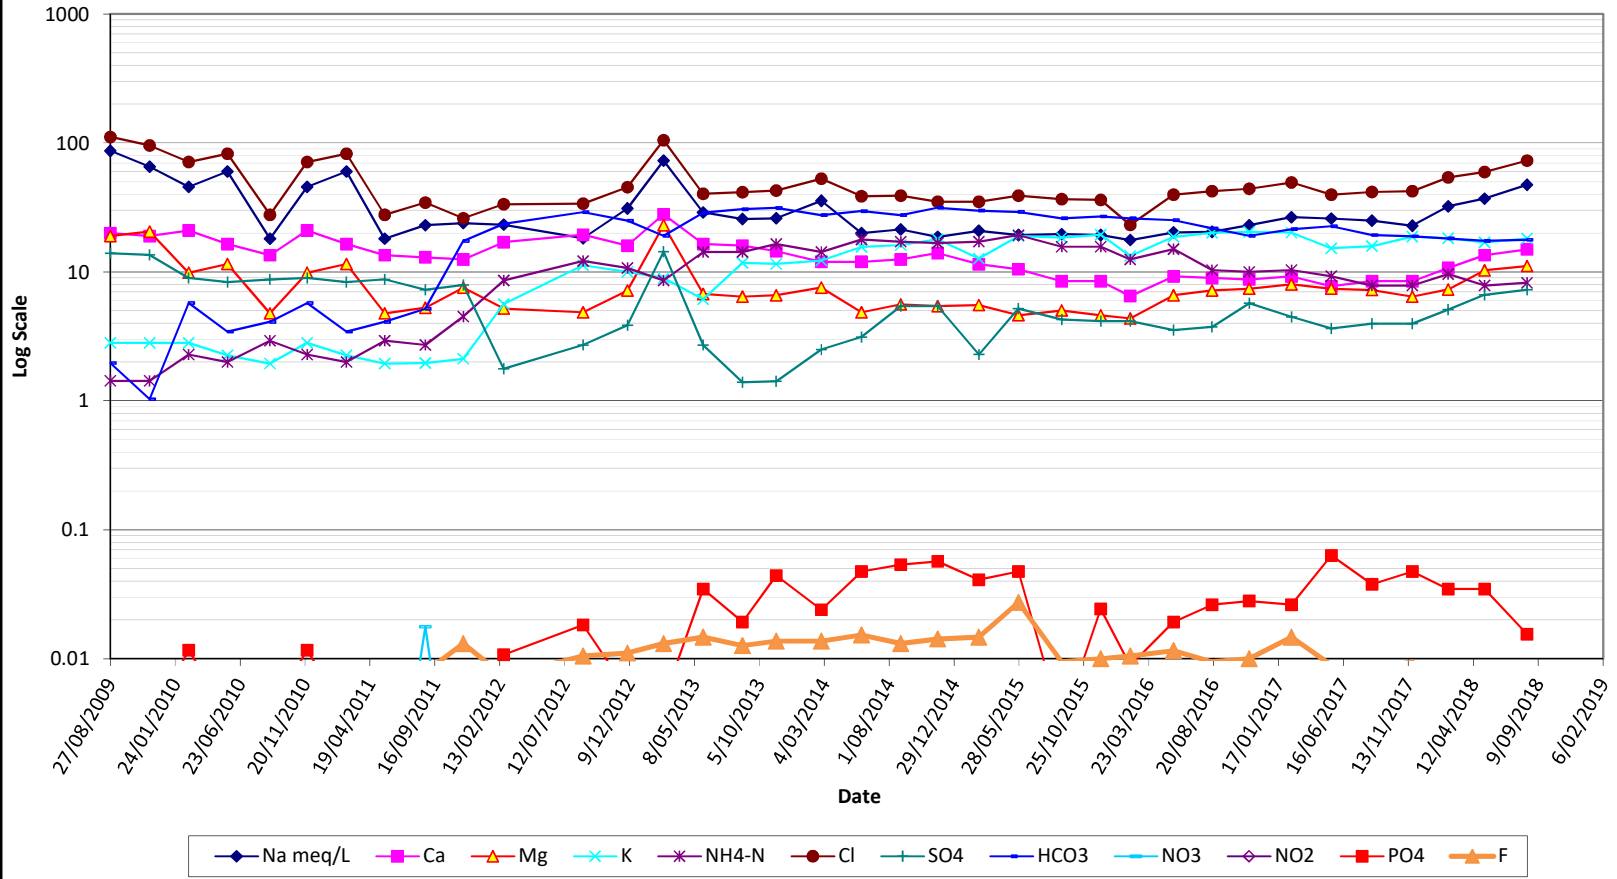
Bore BH15 has displayed a trend of decreasing L/N ratio since November 2017, where the L/N ratio was 109.33%. L/N ratio in August 2018 remains elevated at 54.10%, however, the historic data infers the continuation of decreasing leachate influence as Na^+ , Ca^{2+} and Mg^{2+} accumulate within the aquifer. The K^+/TDS ratio of 12.14% was high when compared to non-leachate influenced sites generally with $\text{K}^+/\text{TDS} < 3$ (Schoeller plot BH15, Attachment 3). Ammonium ($\text{NH}_4^+\text{-N}$) remains elevated at 115 mg/L, compared to other non-impacted locations at the site, which is consistent with previous monitoring rounds. Field measurements of a negative redox (negative ORP) and low dissolved oxygen are indicative of a reducing environment. Elevated levels of soluble Mn^{2+} (0.74 mg/L) and Fe^{2+} (11 mg/L) are indicators of a reducing environment that is favourable for the degradation of leachate. BH15 is located within a swampy environment where microbiological activity drives reducing reactions that can result in naturally high levels of leachate indicators such as organic carbon and HCO_3^- . However, as L/N ratio has decreased, these indicators have also decreased. It is important to note that bore BH15 is located near a drainage line within the groundwater bearing zone <0.5 m below the ground surface. Groundwater therefore has the potential to be influenced from local onsite and offsite works and surface water.

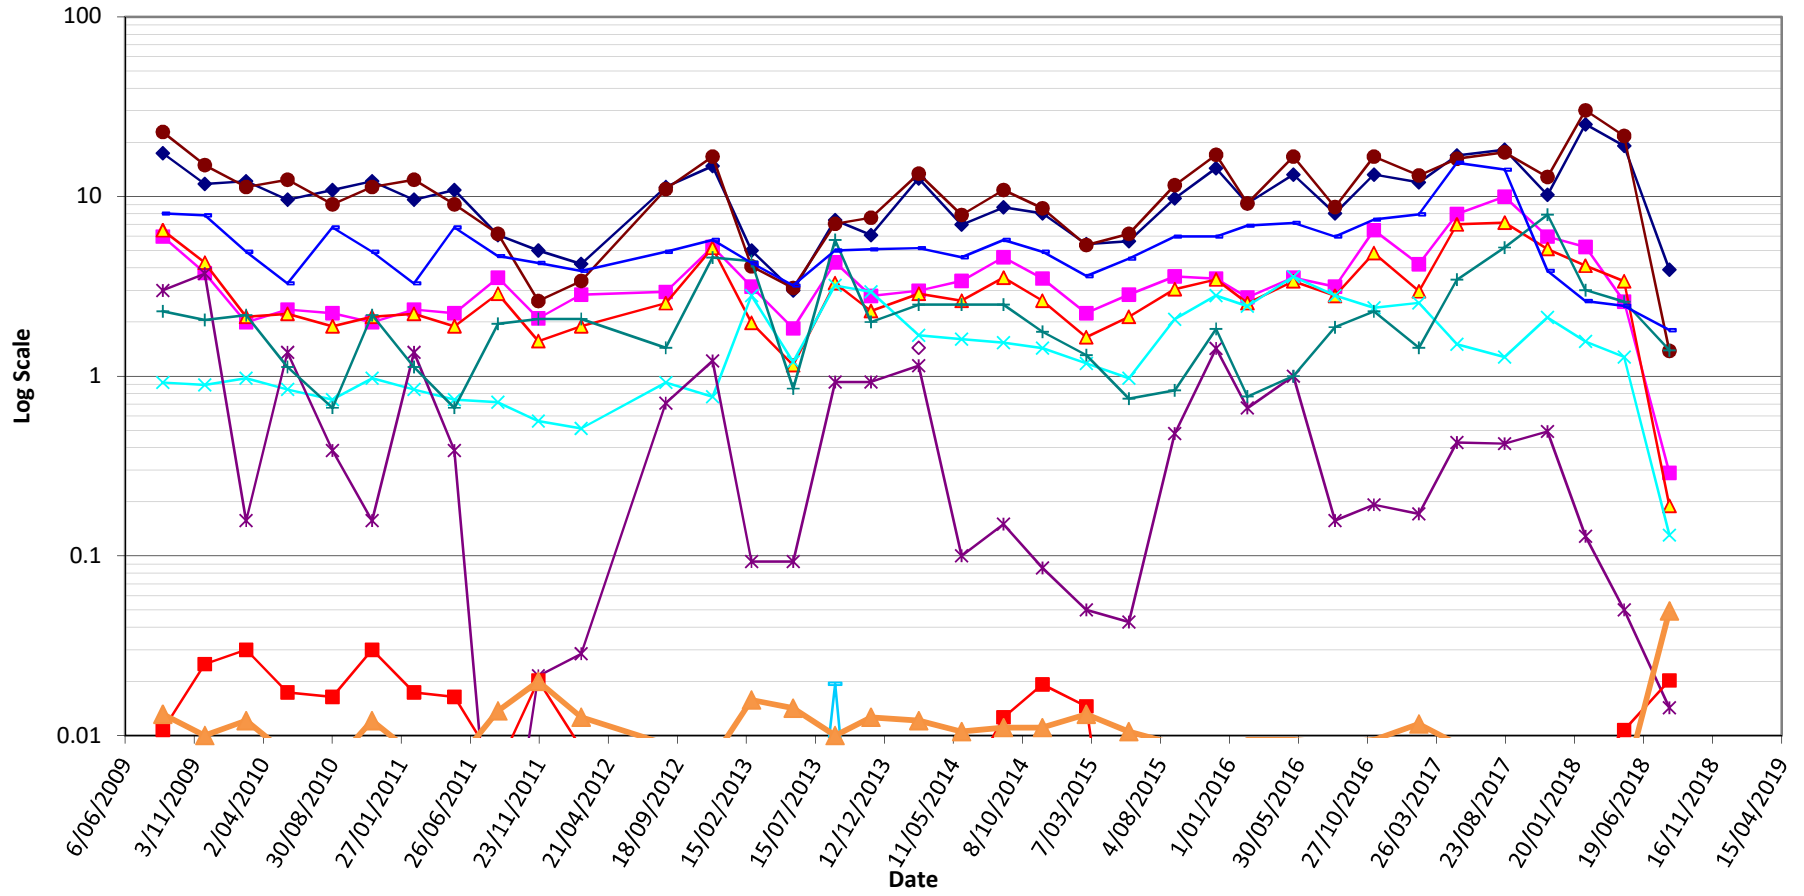
Bore BH16 is located in a swampy area with groundwater field observations recording a brown colour and a minor leachate / sulfuric odour. The sampled redox potential indicates a reducing environment (-177.2 mV), which may have an influence on the historical dominance of $\text{NH}_4^+\text{-N}$ over NO_3^- . This round $\text{NH}_4^+\text{-N}$ concentrations were 0.2 mg/L. Groundwater sampling in August 2018 indicated limited to no leachate impact at BH16 which was represented by the L/N ratio of 5.50%. The L/N ratio increased slightly in August 2018 (9.53%) compared to May 2018 (9.53%). Bores BH15 and BH16 are located close to a drainage channel where offsite impacts can readily influence the chemical characteristics of the shallow groundwater and should continue to be monitored for fluctuations.

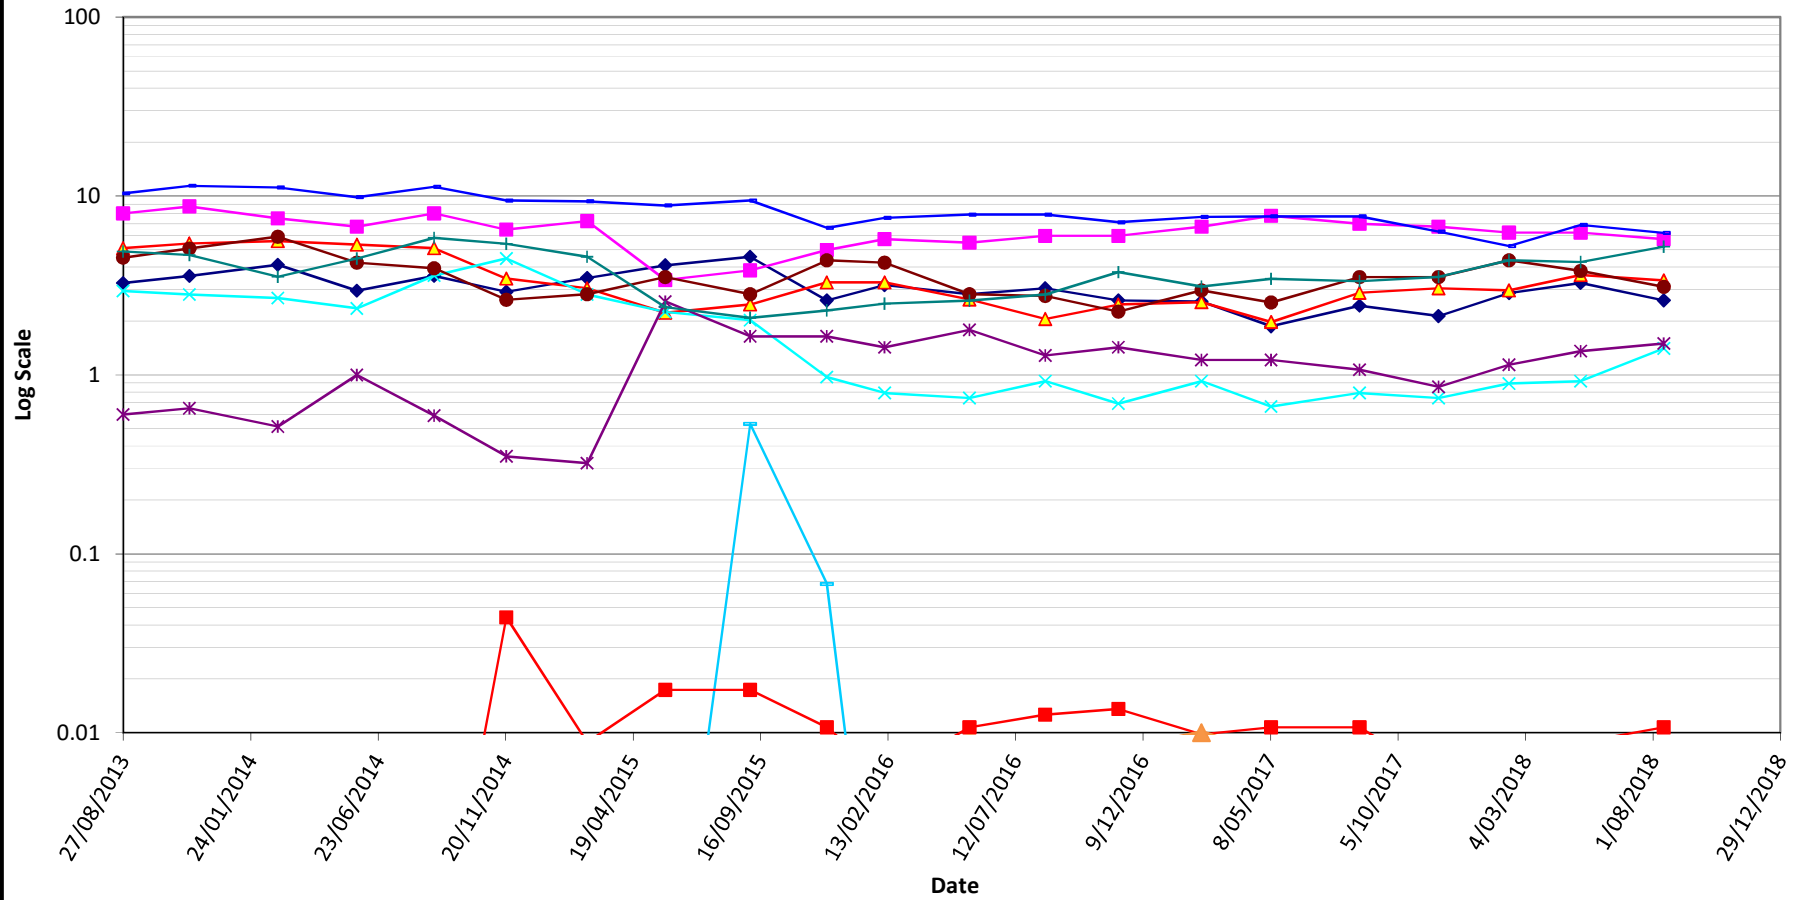
Bore BH20 is located down gradient of the landfill, leachate ponds and shallow old landfill. This bore was positioned to assess the chemical characteristics on the boundary of the landfill site. Field observations at bore BH20 recorded a negative redox (-131 mV) with clear groundwater and H_2S odour. The L/N ratio (35.23%) in the August 2018 round increased considerably from 22.58% in May 2018. The TDS remained relatively low (850 mg/L) making the L/N susceptible to natural variations or fluctuations in chemistry. Chemical characteristics of the bore show groundwater is low in Na^+ , with a moderate Ca/K and K/TDS ratio (Table 4). Ammonium levels remained elevated at 21 mg/L however other landfill indicators were low or absent.

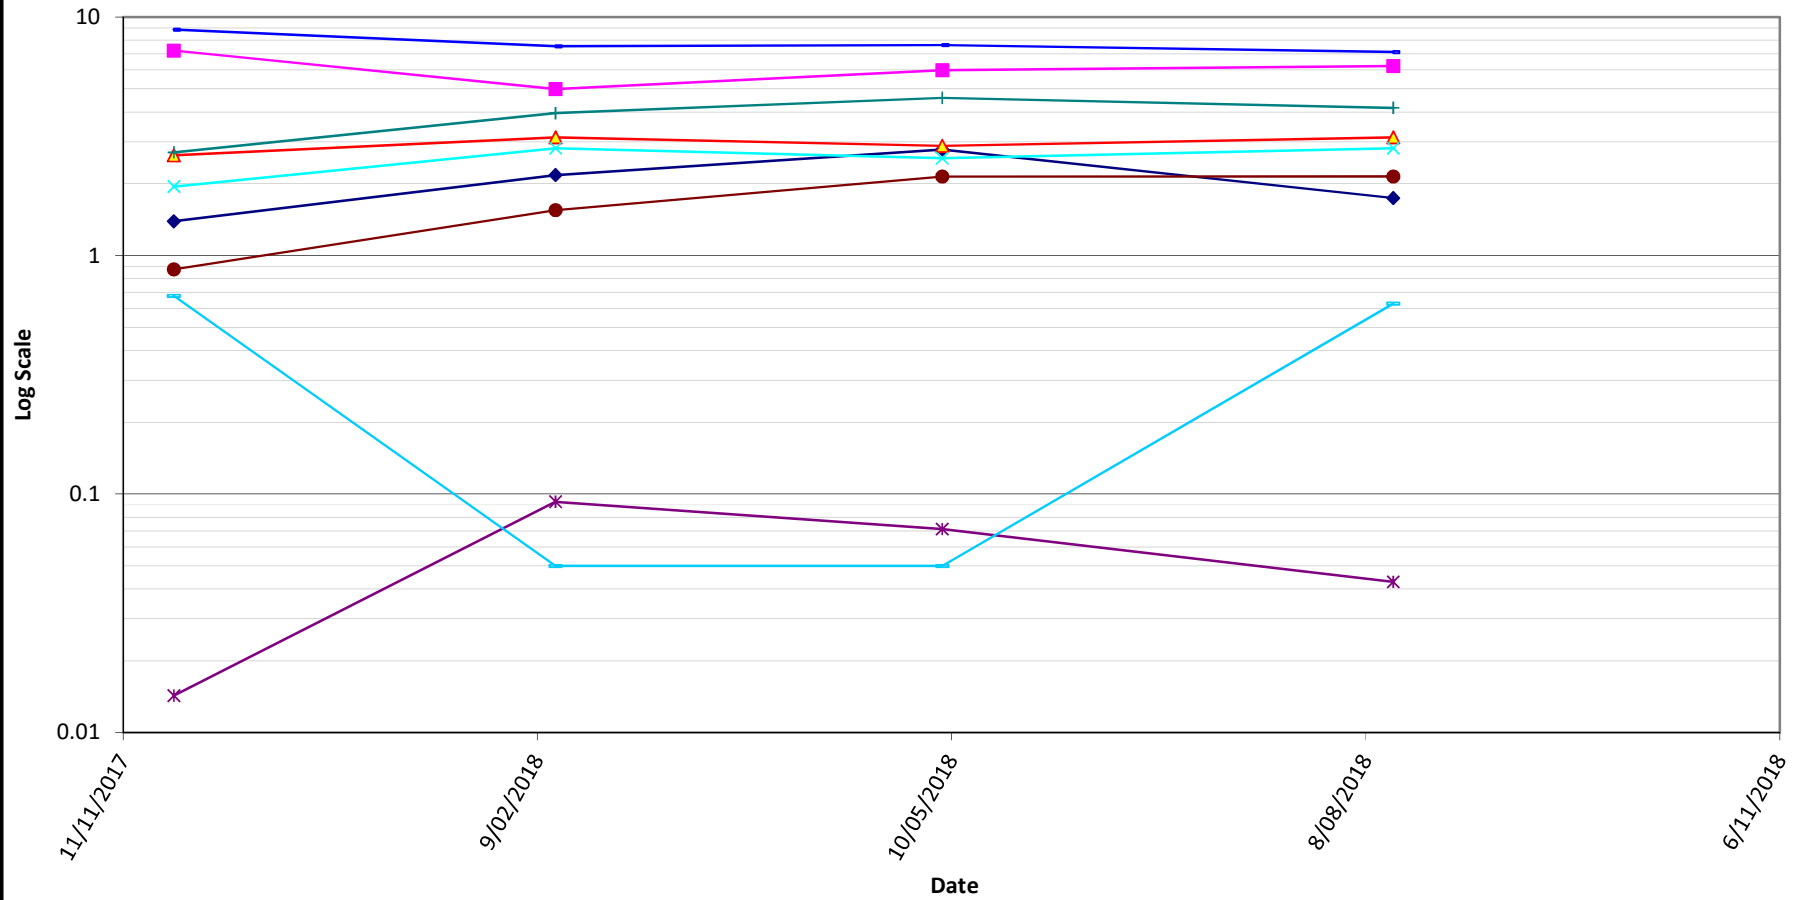
Bore BH20s is located directly adjacent to BH20 but at a shallower depth – *screened intervals of BH20 and BH20s are 6.0-9.0 mBGL and 1.5-4.5 mBGL respectively*. Similarly, this bore was positioned to compare the chemical characteristics on the boundary of the landfill site in order to locate potential transport pathways to Rocklow Creek. In August 2018, field measurements at bore BH20s recorded a negative redox (-60.9 mV), clear colour of the groundwater and no odour was detected. The high levels of NO_3^- (39 mg/L) and increase in K^+ (110 mg/L) led to an elevated L/N ratio (73.69%), indicative of potentially high leachate impact at this site. TDS is relatively low (835 mg/L) making the L/N susceptible to natural variations or fluctuations in chemistry. Chemical characteristics of the bore show groundwater was low in Na^+ , with a moderate Ca/K and K/TDS ratio (Table 4). Ammonium levels (0.6 mg/L) have decreased slightly since May 2018 and remain lower than those seen at the deeper BH20 bore. It was previously thought that high nitrate levels in this shallower bore location was indicative of nitrification throughout the soil profile, however, continued monitoring at this location will be necessary to determine potential leachate transport pathways to Rocklow Creek.

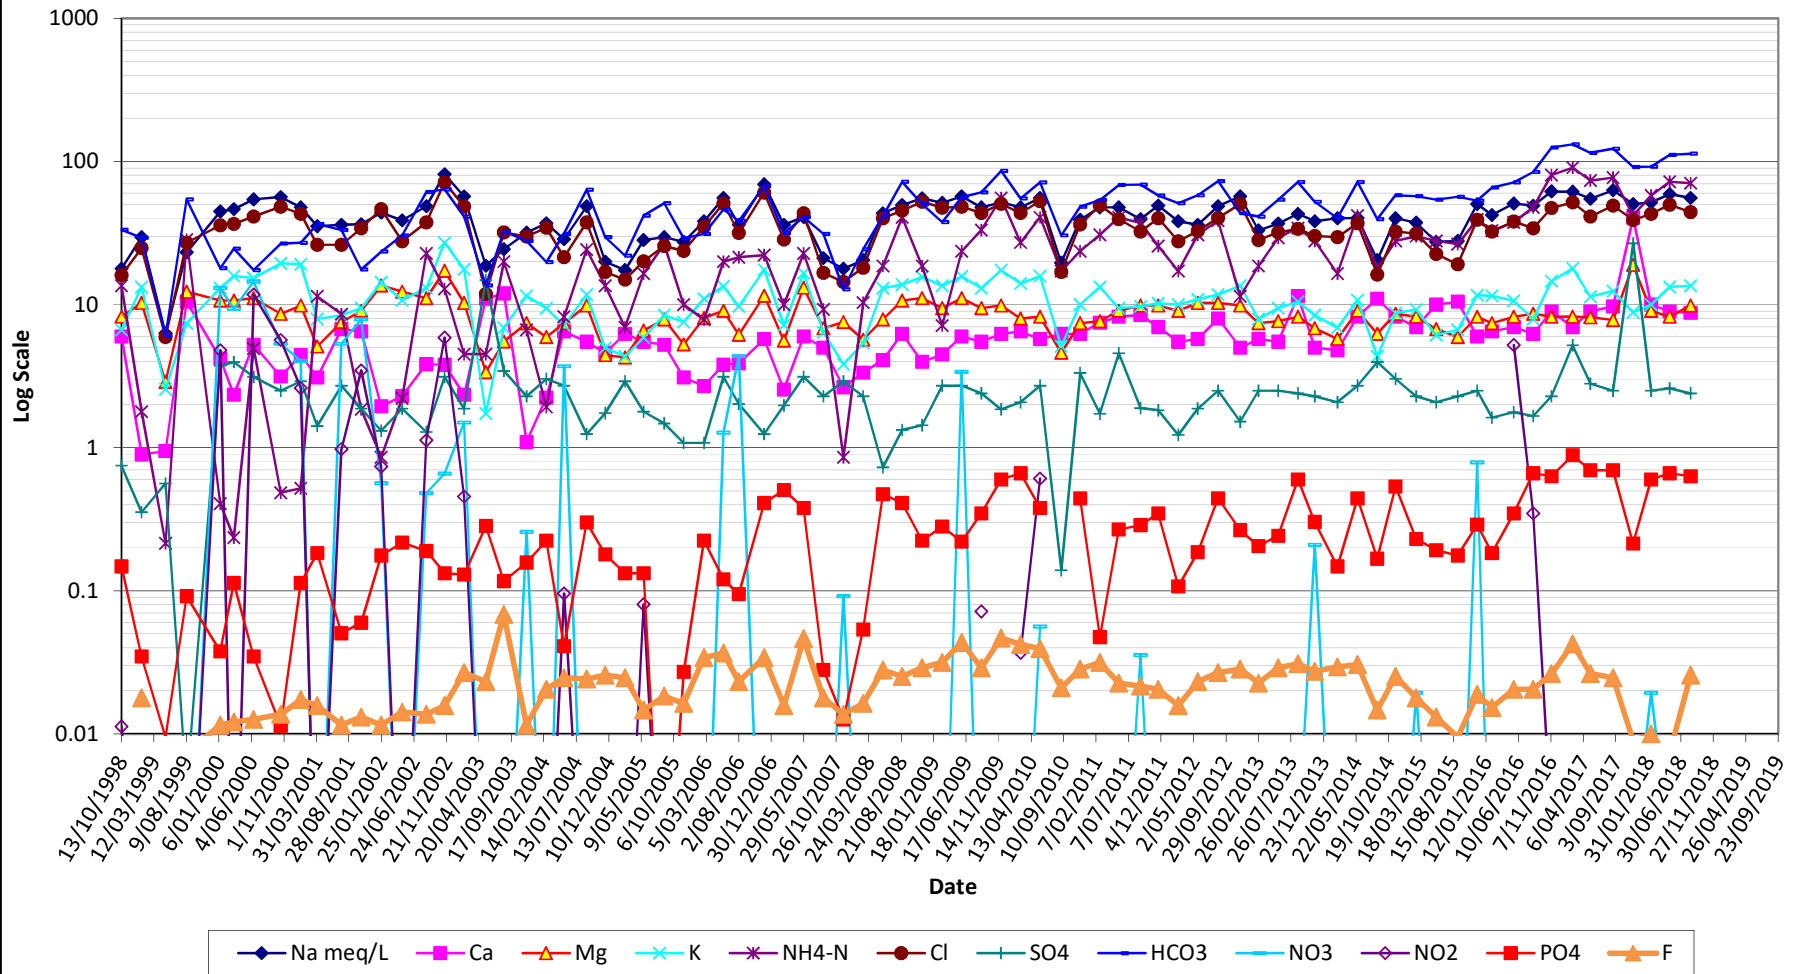
LP1

The chemistry of leachate water at the Dunmore Recycling and Waste Disposal Depot is significantly different when compared to the surface and groundwater chemistry of non-leachate influenced bores. This is demonstrated through comparison of chemical data presented in Table 2. In particular TDS, BOD, TOC, Na⁺, NH₄⁺-N, K⁺, HCO₃⁻, PO₄³⁻ and total iron concentrations are generally elevated in leachate pond water compared to other monitoring bores (Schoeller Plot LP1, Attachment 3). Ionic ratios (Table 4) such as low Ca/K (0.64) and high Na/Ca and L/N ratios represent landfill leachate chemical characteristics. These chemical characteristics have been relatively stable over the past 10 years of monitoring.
