Shellharbour City Council

August 2018 Quarterly Environmental Monitoring – Dunmore Recycling and Waste Disposal Depot, Dunmore, New South Wales.

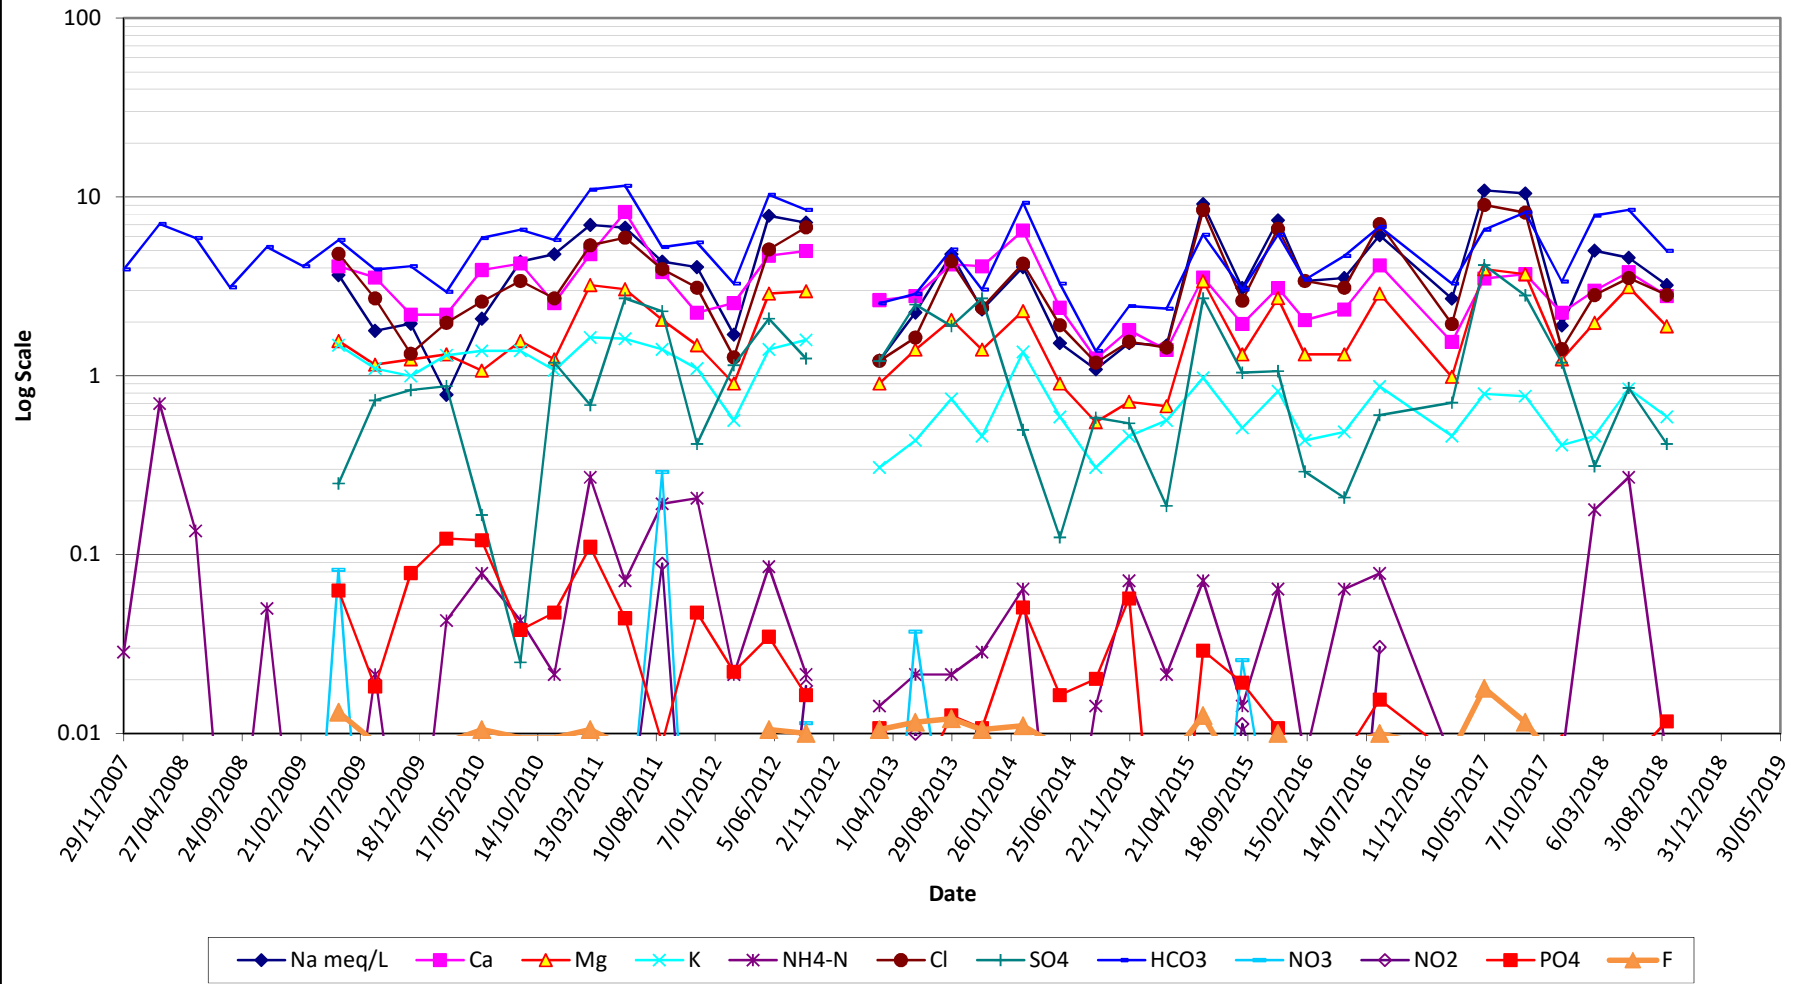
Ammonium levels detected at SWP1 were 0.1 mg/L and were below the ANZECC (2000) trigger levels in the August 2018 monitoring round. In May 2018, ammonium concentrations reached 3.80 mg/L, a peak since November 2011, and ongoing minor leachate impact has been indicated by consistent L/N ratios > 10% and < 20%. Elevated concentrations of soluble iron and a negative redox potential (-89.5 mV) in the August 2018 sampling event were indicative of a reducing environment which may have contributed to low levels of dissolved oxygen and the production of ammonium.

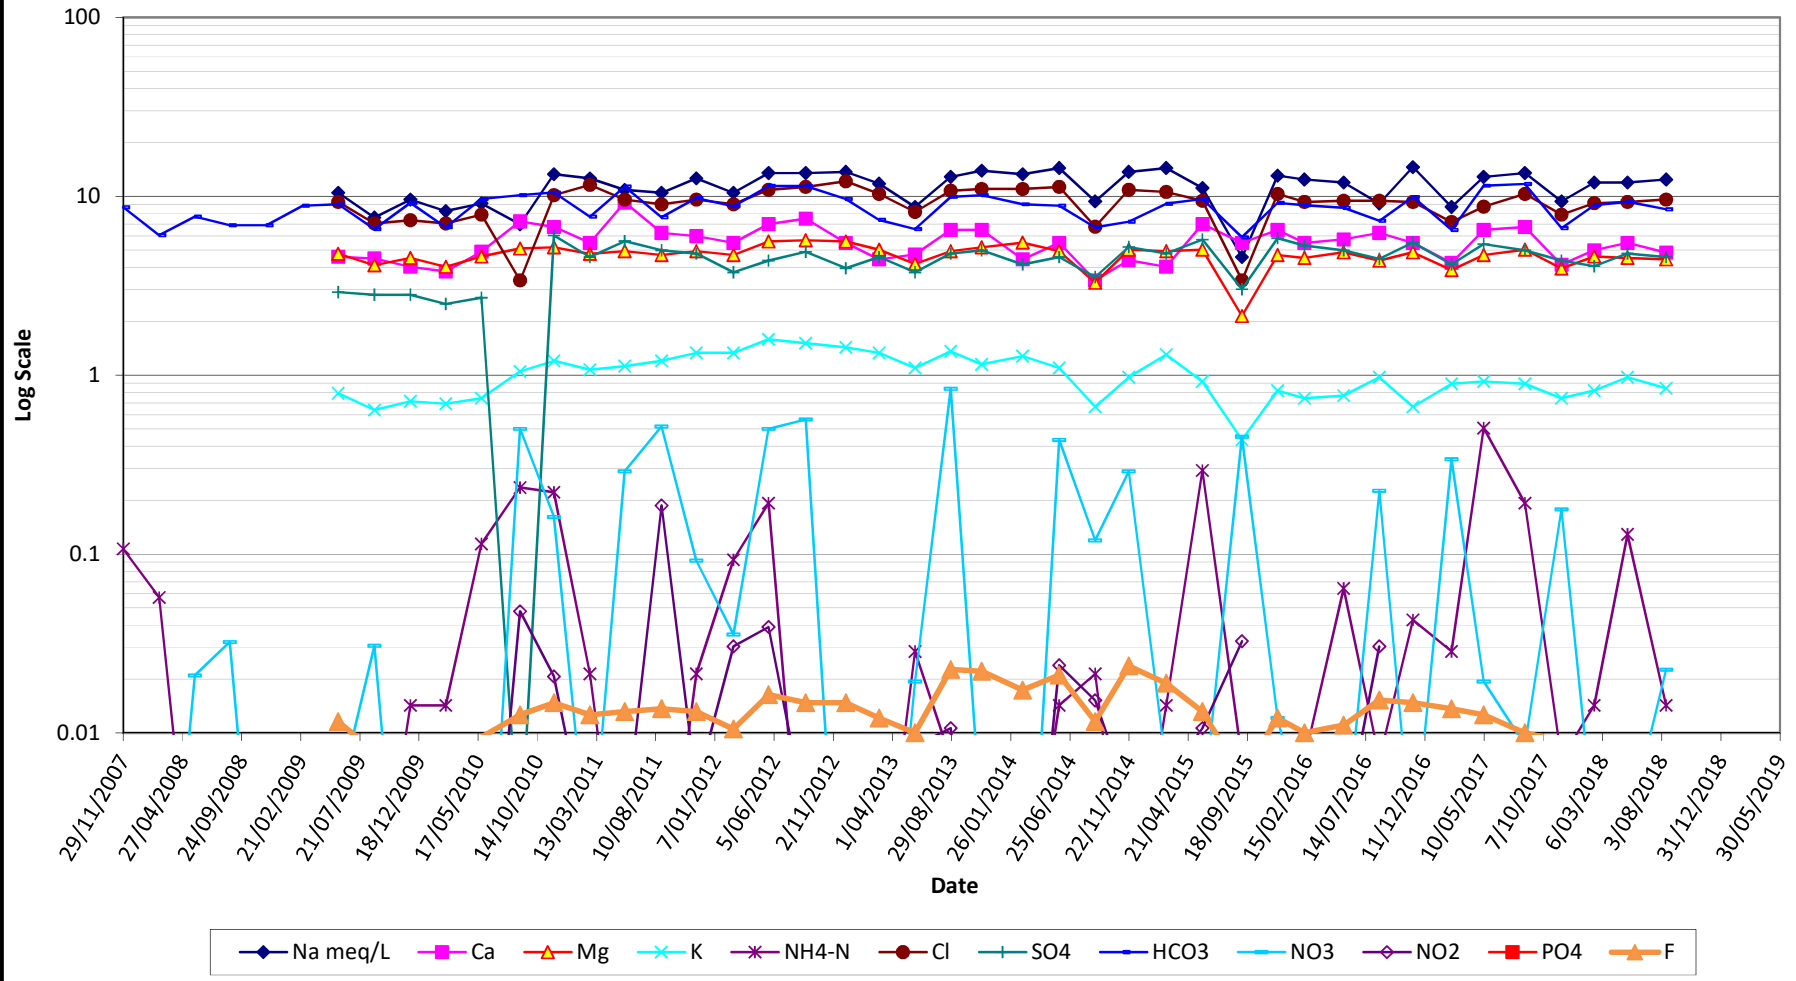
Surface water sampled at SWP2 showed little to no leachate impact. The surface water pond collects runoff from around the site and potential impacts from site activities are often observed. Ammonium concentration decreased to 0.2 mg/L during this sampling round compared to May 2018 (1.8 mg/L). Fluctuating ammonium is common at this location with previous monitoring events ranging between 0.01 and 15 mg/L. Nitrate (NO₃⁻) levels (1.4 mg/L) remained below the ANZECC (2000) trigger value (10.6 mg/L). All chemical parameters at this location are within historical ranges.

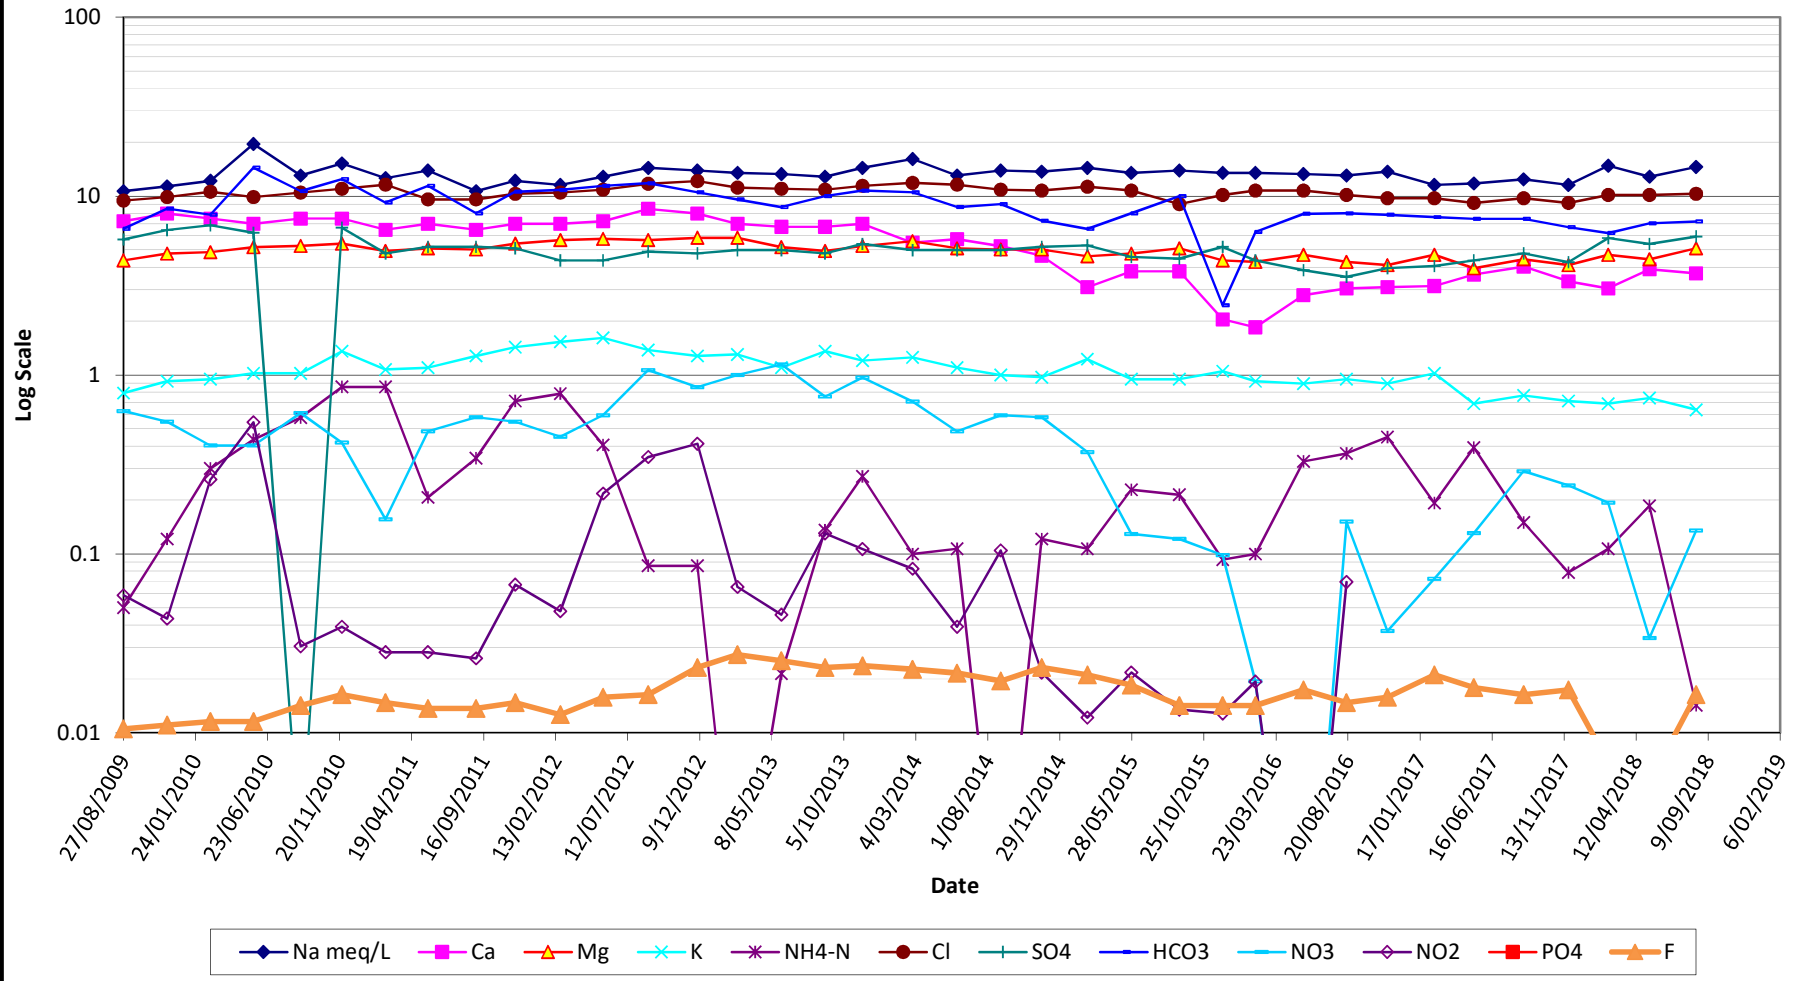
SWP4 displayed ammonium (NH₄⁺-N) levels that dropped below the defined trigger level of 1.88 mg/L that was exceeded in May 2018 (2.60 mg/L). Nitrate (NO₃⁻) levels increased to 8.40 mg/L which is below the trigger value established by the ANZECC (2000) guidelines. The decrease in NH₄⁺-N and increase in NO₃⁻ is indicative of the occurrence of the natural process of nitrification by which NH₄-N naturally attenuates. All chemical parameters at this location are within historical ranges.
