# QUARTERLY ENVIRONMENTAL MONITORING REPORT (QEMR) DECEMBER 2019

DUNMORE RECYCLING & WASTE DEPOT 44 BUCKLEYS ROAD, DUNMORE, NSW, 2529

**ENVIRONMENT PROTECTION LICENCE (EPL) 5984**

Prepared For:Shellharbour City CouncilProject Number:ENRS0033Date:January 2020

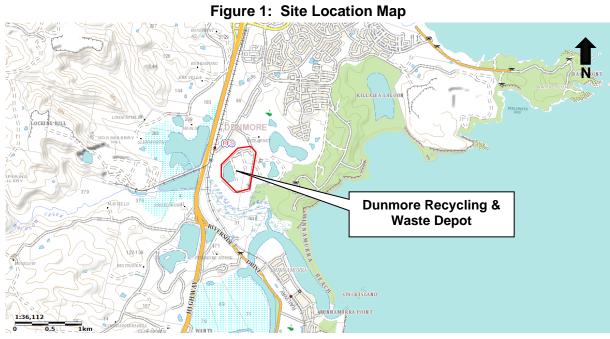
The Site is located at 44 Buckleys Road, Dunmore, NSW, 2529, legally defined as Lot 21 in Deposited Plan 653009 and Lot 1 Deposited Plan 419907. The Site is situated approximately three and a half (3.5) kilometres southwest of the Shellharbour town centre. The area's regional location is defined in **Figure 1** below. Details of the Site boundary and sampling points are provided in the Site Plan (see **Figure 2**). The key features required to identify the Site are summarised in **Table 1**.

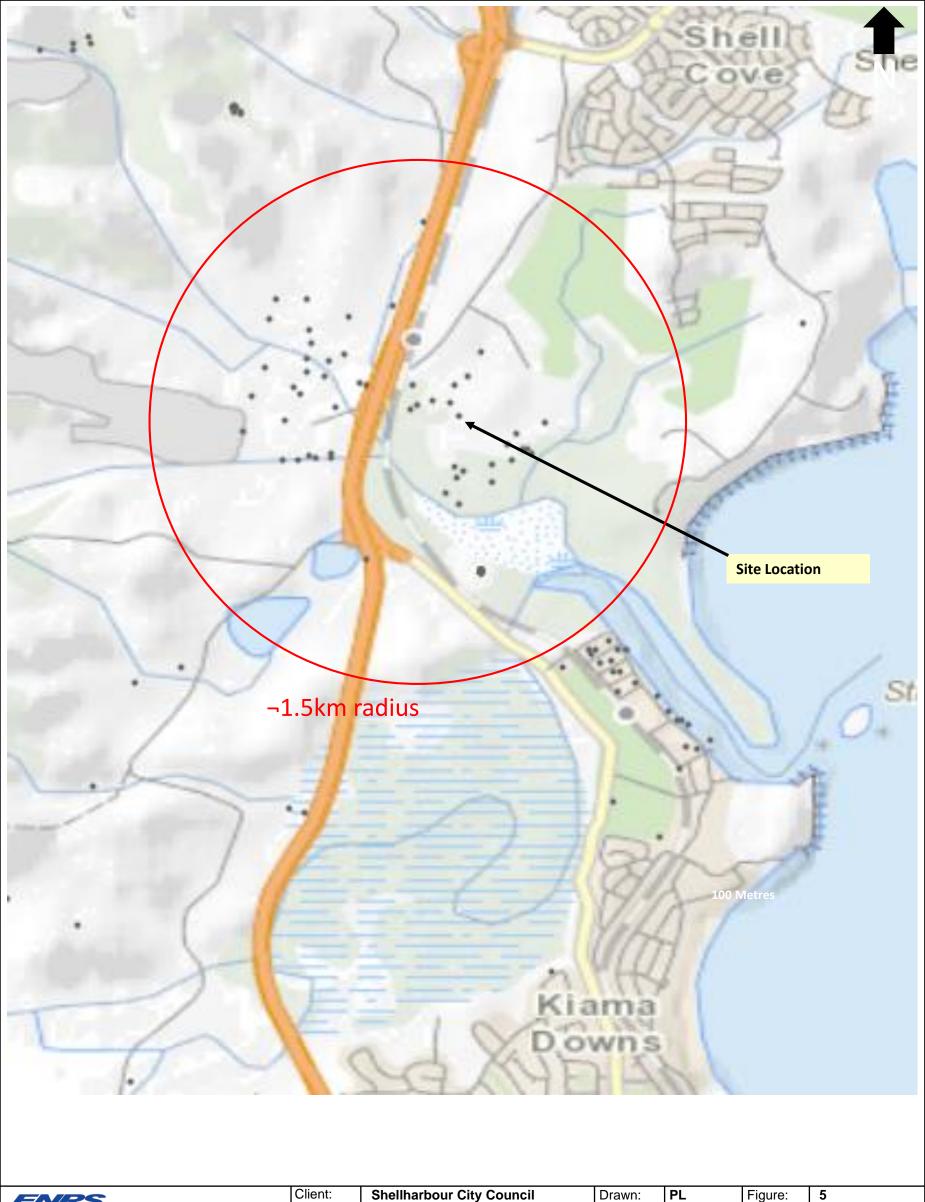
A review of the *NSW Office of Water (NOW)* existing bore records was conducted to develop the conceptual understanding of regional groundwater conditions, including aquifer depths, yields, water quality, and distribution. A search of the Bureau of Meteorology Australian Groundwater Explorer groundwater database identified a total of eighty-eight (88) registered bores within one and a half (1.5) kilometres of the Site (see **Figure 5**). Registered bores in the area are predominantly associated with the Landfill Site and with the quarry complex (*Boral Site*) to the west of the EPL Site. The majority of bores are registered for monitoring purposes, excluding a single well (GW044447), which is registered for stock and domestic purposes. The stock bore is located approximately one (1) kilometre to the north of the Site, on the western side of the Princes Highway, which is considered to be up gradient of the Site and not in direct hydraulic connectivity. Registered bore depths are between 1.25 m and 22 m. Bore records indicate shallow unconsolidated aquifer systems.
