QUARTERLY ENVIRONMENTAL MONITORING REPORT (QEMR) JUNE 2023

**DUNMORE RECYCLING & WASTE DEPOT
44 BUCKLEYS ROAD,
DUNMORE, NSW, 2529**

ENVIRONMENT PROTECTION LICENCE (EPL) 5984

Date: **July 2023**

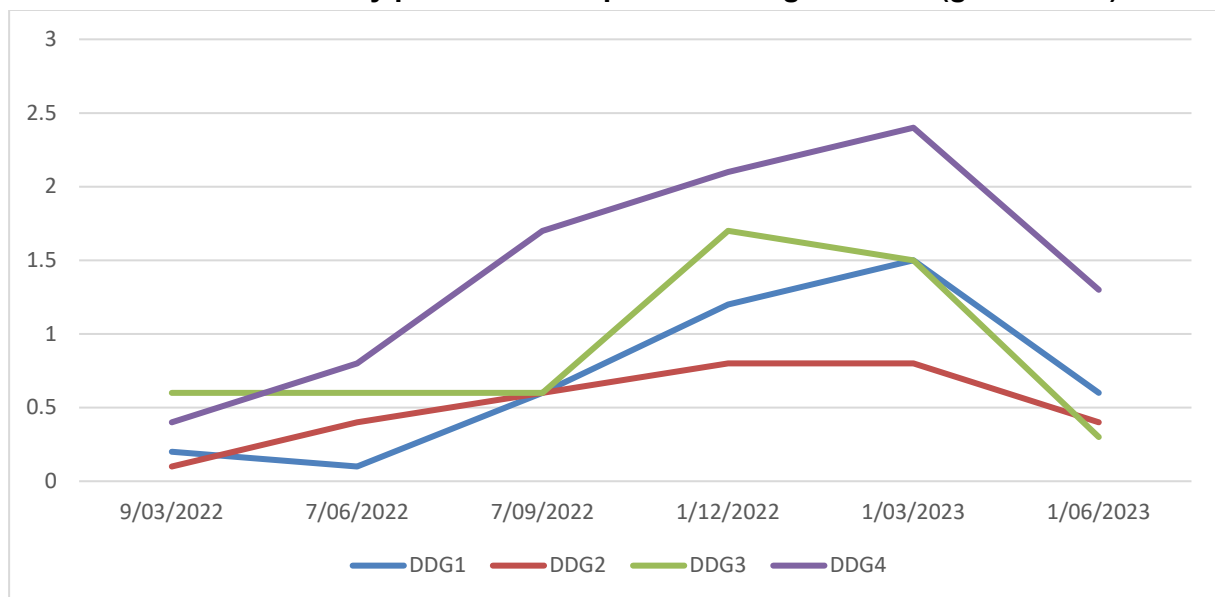
Chart 1: Monthly plot of Dust Deposition Gauge Results (g.m².month)

Results for depositional dust during the June 2023 quarterly monitoring period reported levels of dust below the adopted assessment criteria of **4 g/m²/month**.

The results were considered satisfactory. Dust gauge locations are provided in **Figure 2** attached. It is recommended that monitoring is continued in accordance with EPL 5984.

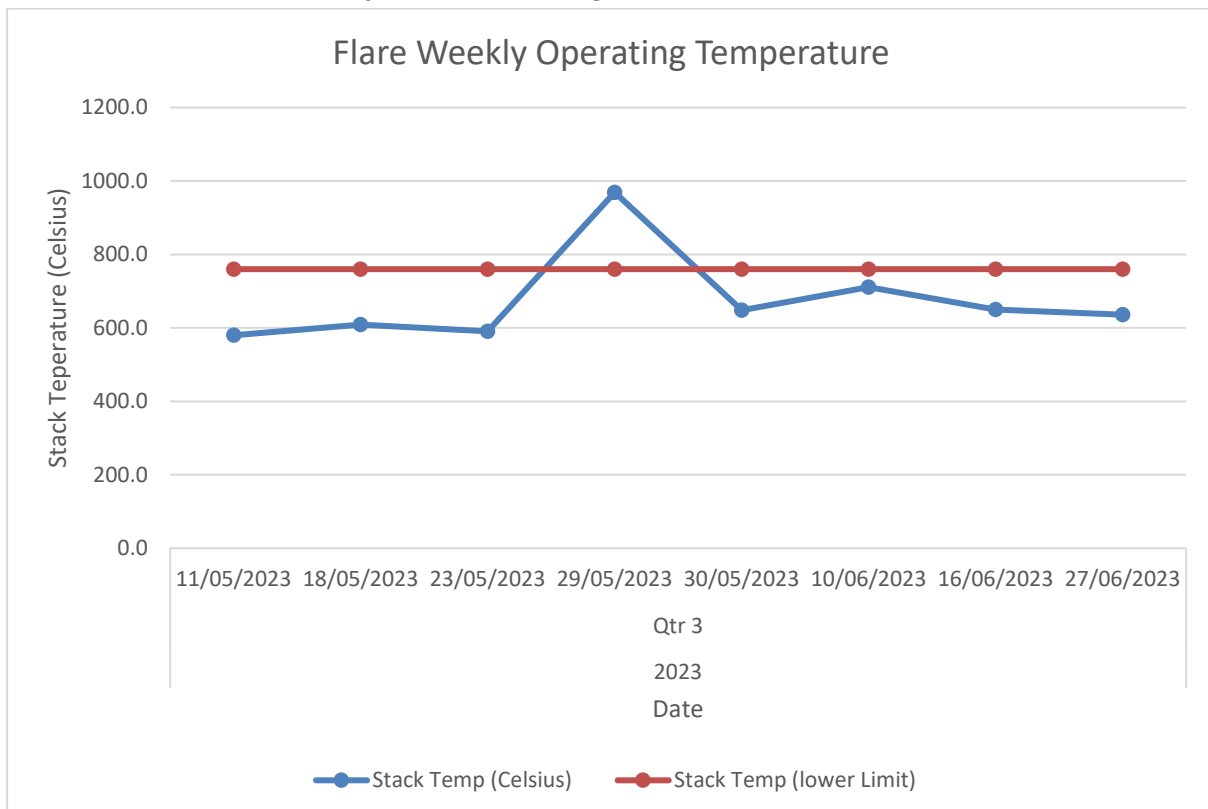
Chart 2: Weekly Flare Operating Temperatures June Quarter 2023

Weekly average operating temperatures supplied by LGI displayed typical variation associated with a continuous process. Weekly operating temperatures at the Flare were generally below the Operational temperature lower limit of 760 degrees.

The actions taken to address the root causes are outlined in the LGI Gas Flare reports included as **Appendix G**.

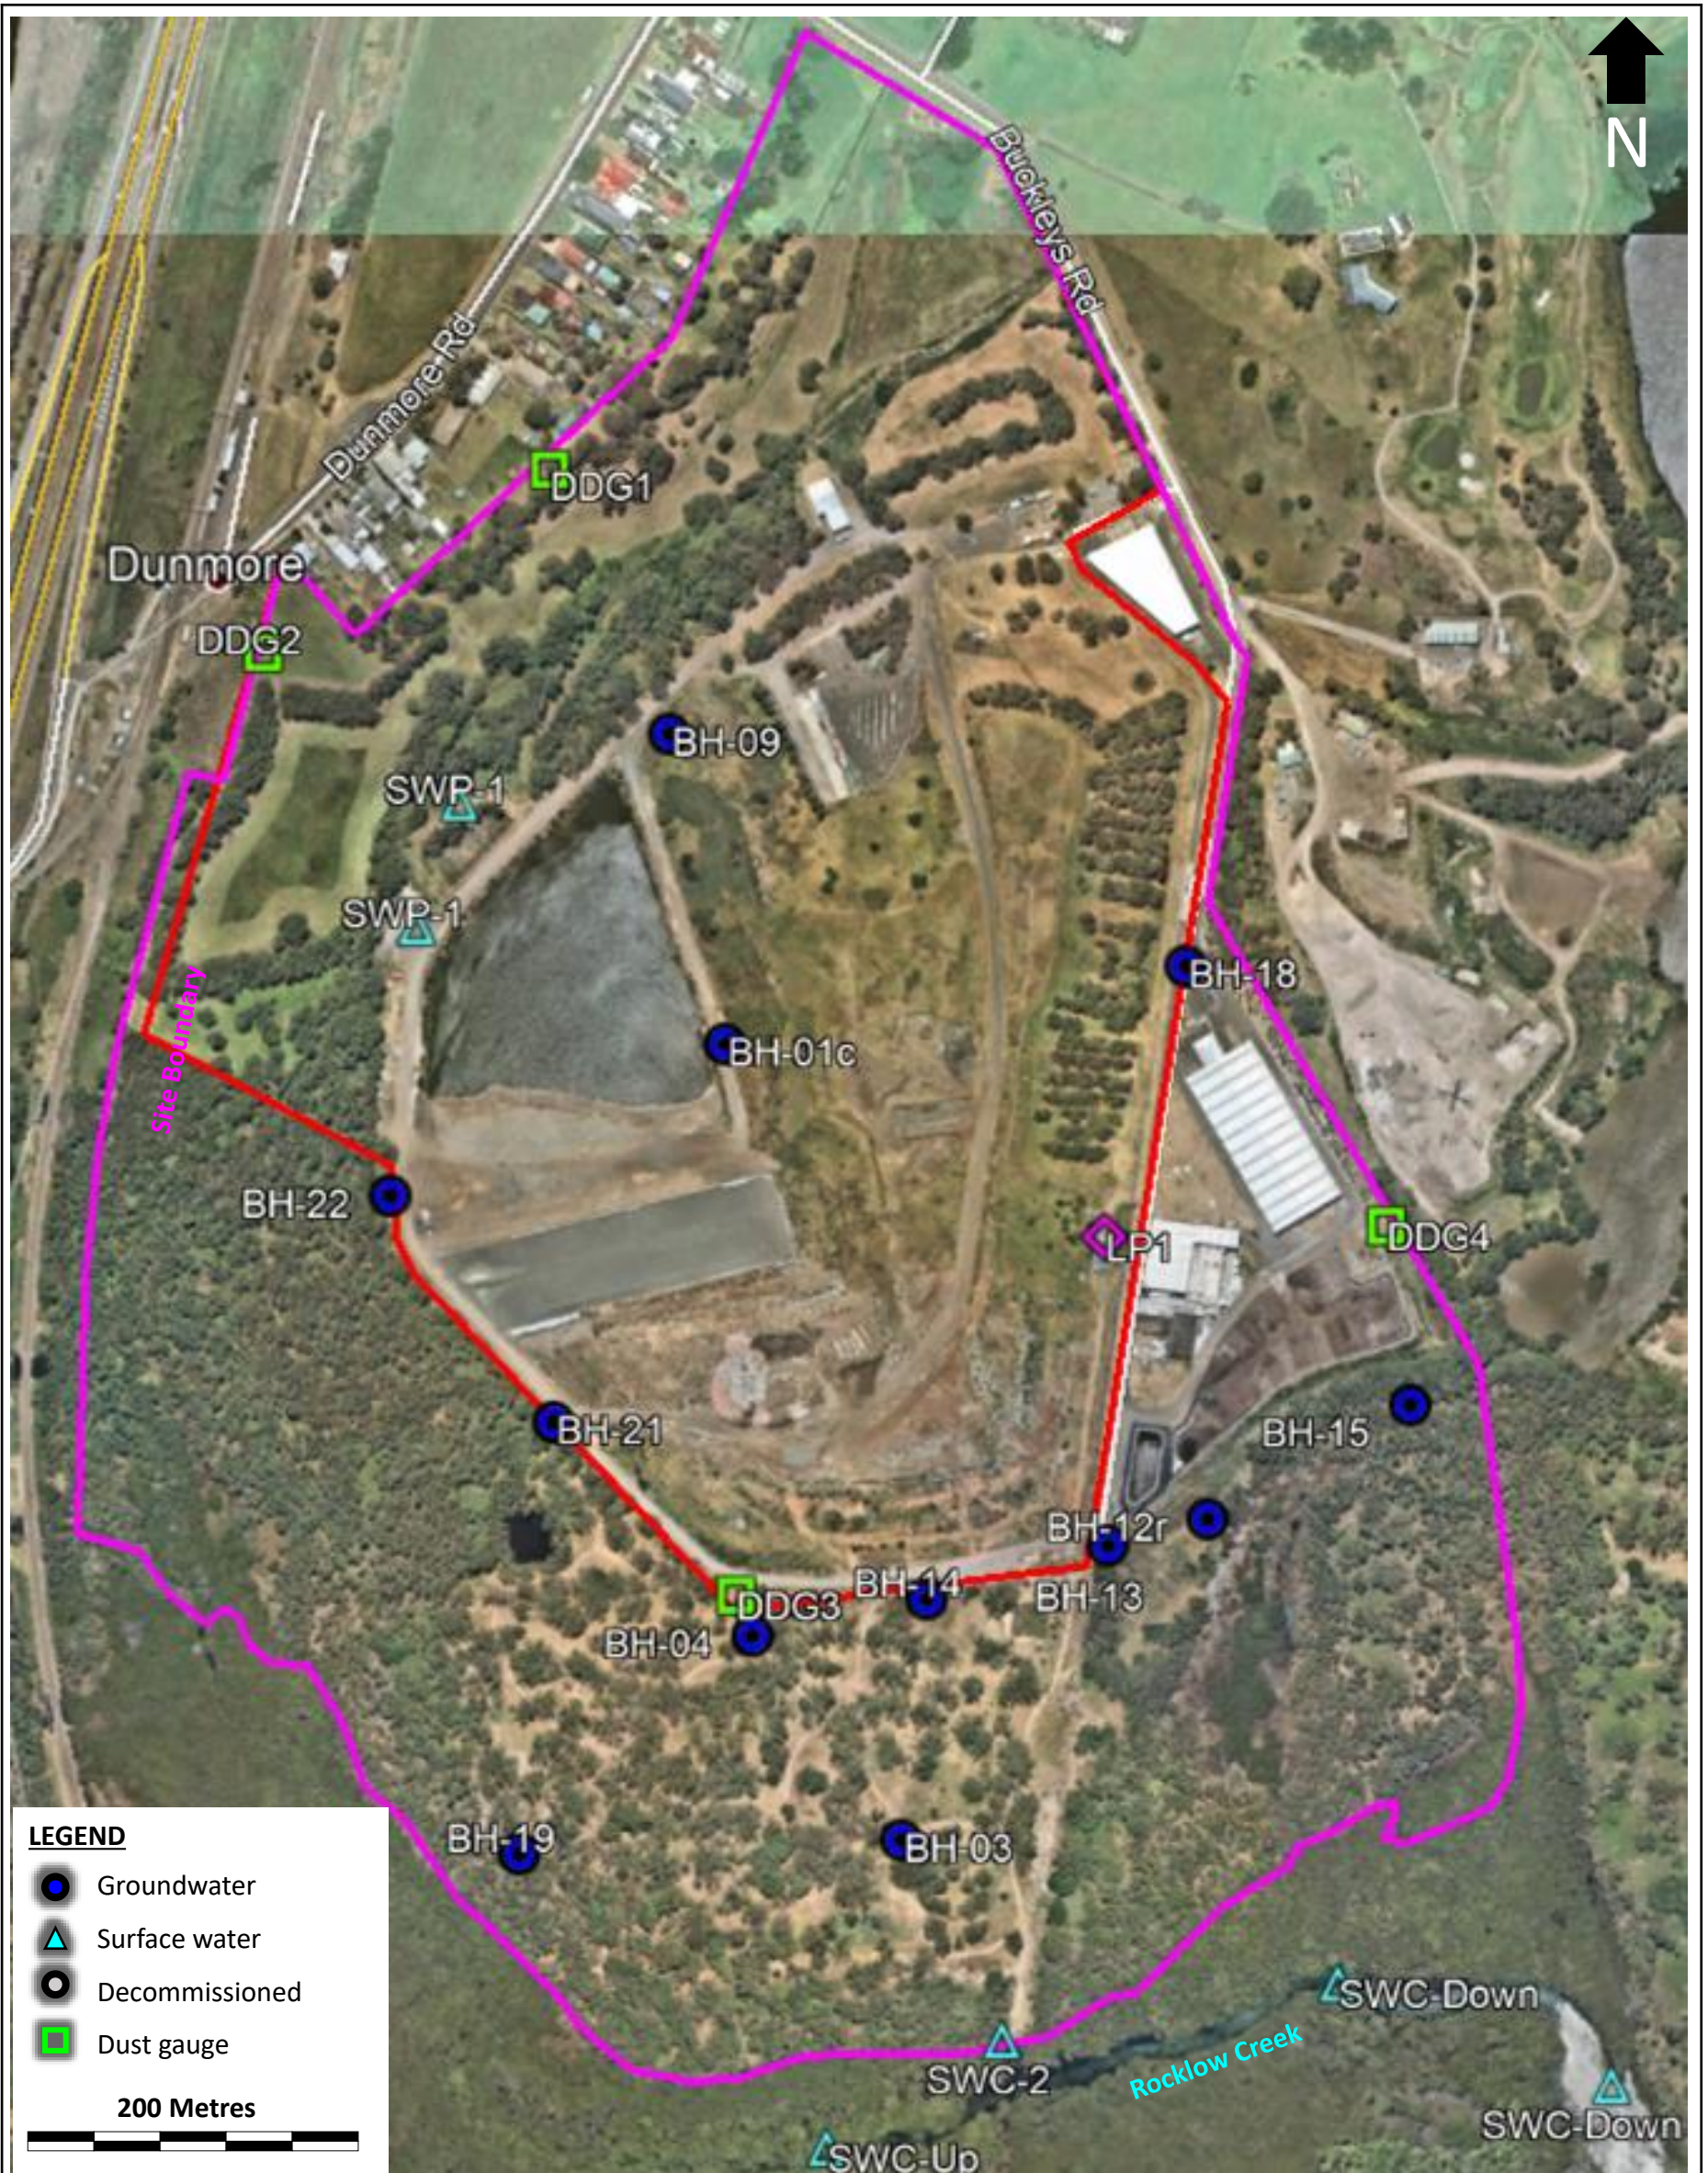
are provided in the Site Plan (see **Figure 2**). The key features required to identify the Site are summarised in **Table 1**.

Client:	Shellharbour City Council	Drawn:	PL	Figure:	2
Project:	ENRS0033	Source:	NearMaps	Date:	21/05/2021
Location:	Dunmore Recycling & Waste Depot 44 Buckleys Rd, Dunmore, NSW	Scale:	NA	Title:	Site Plan
		Status:	Rev 2

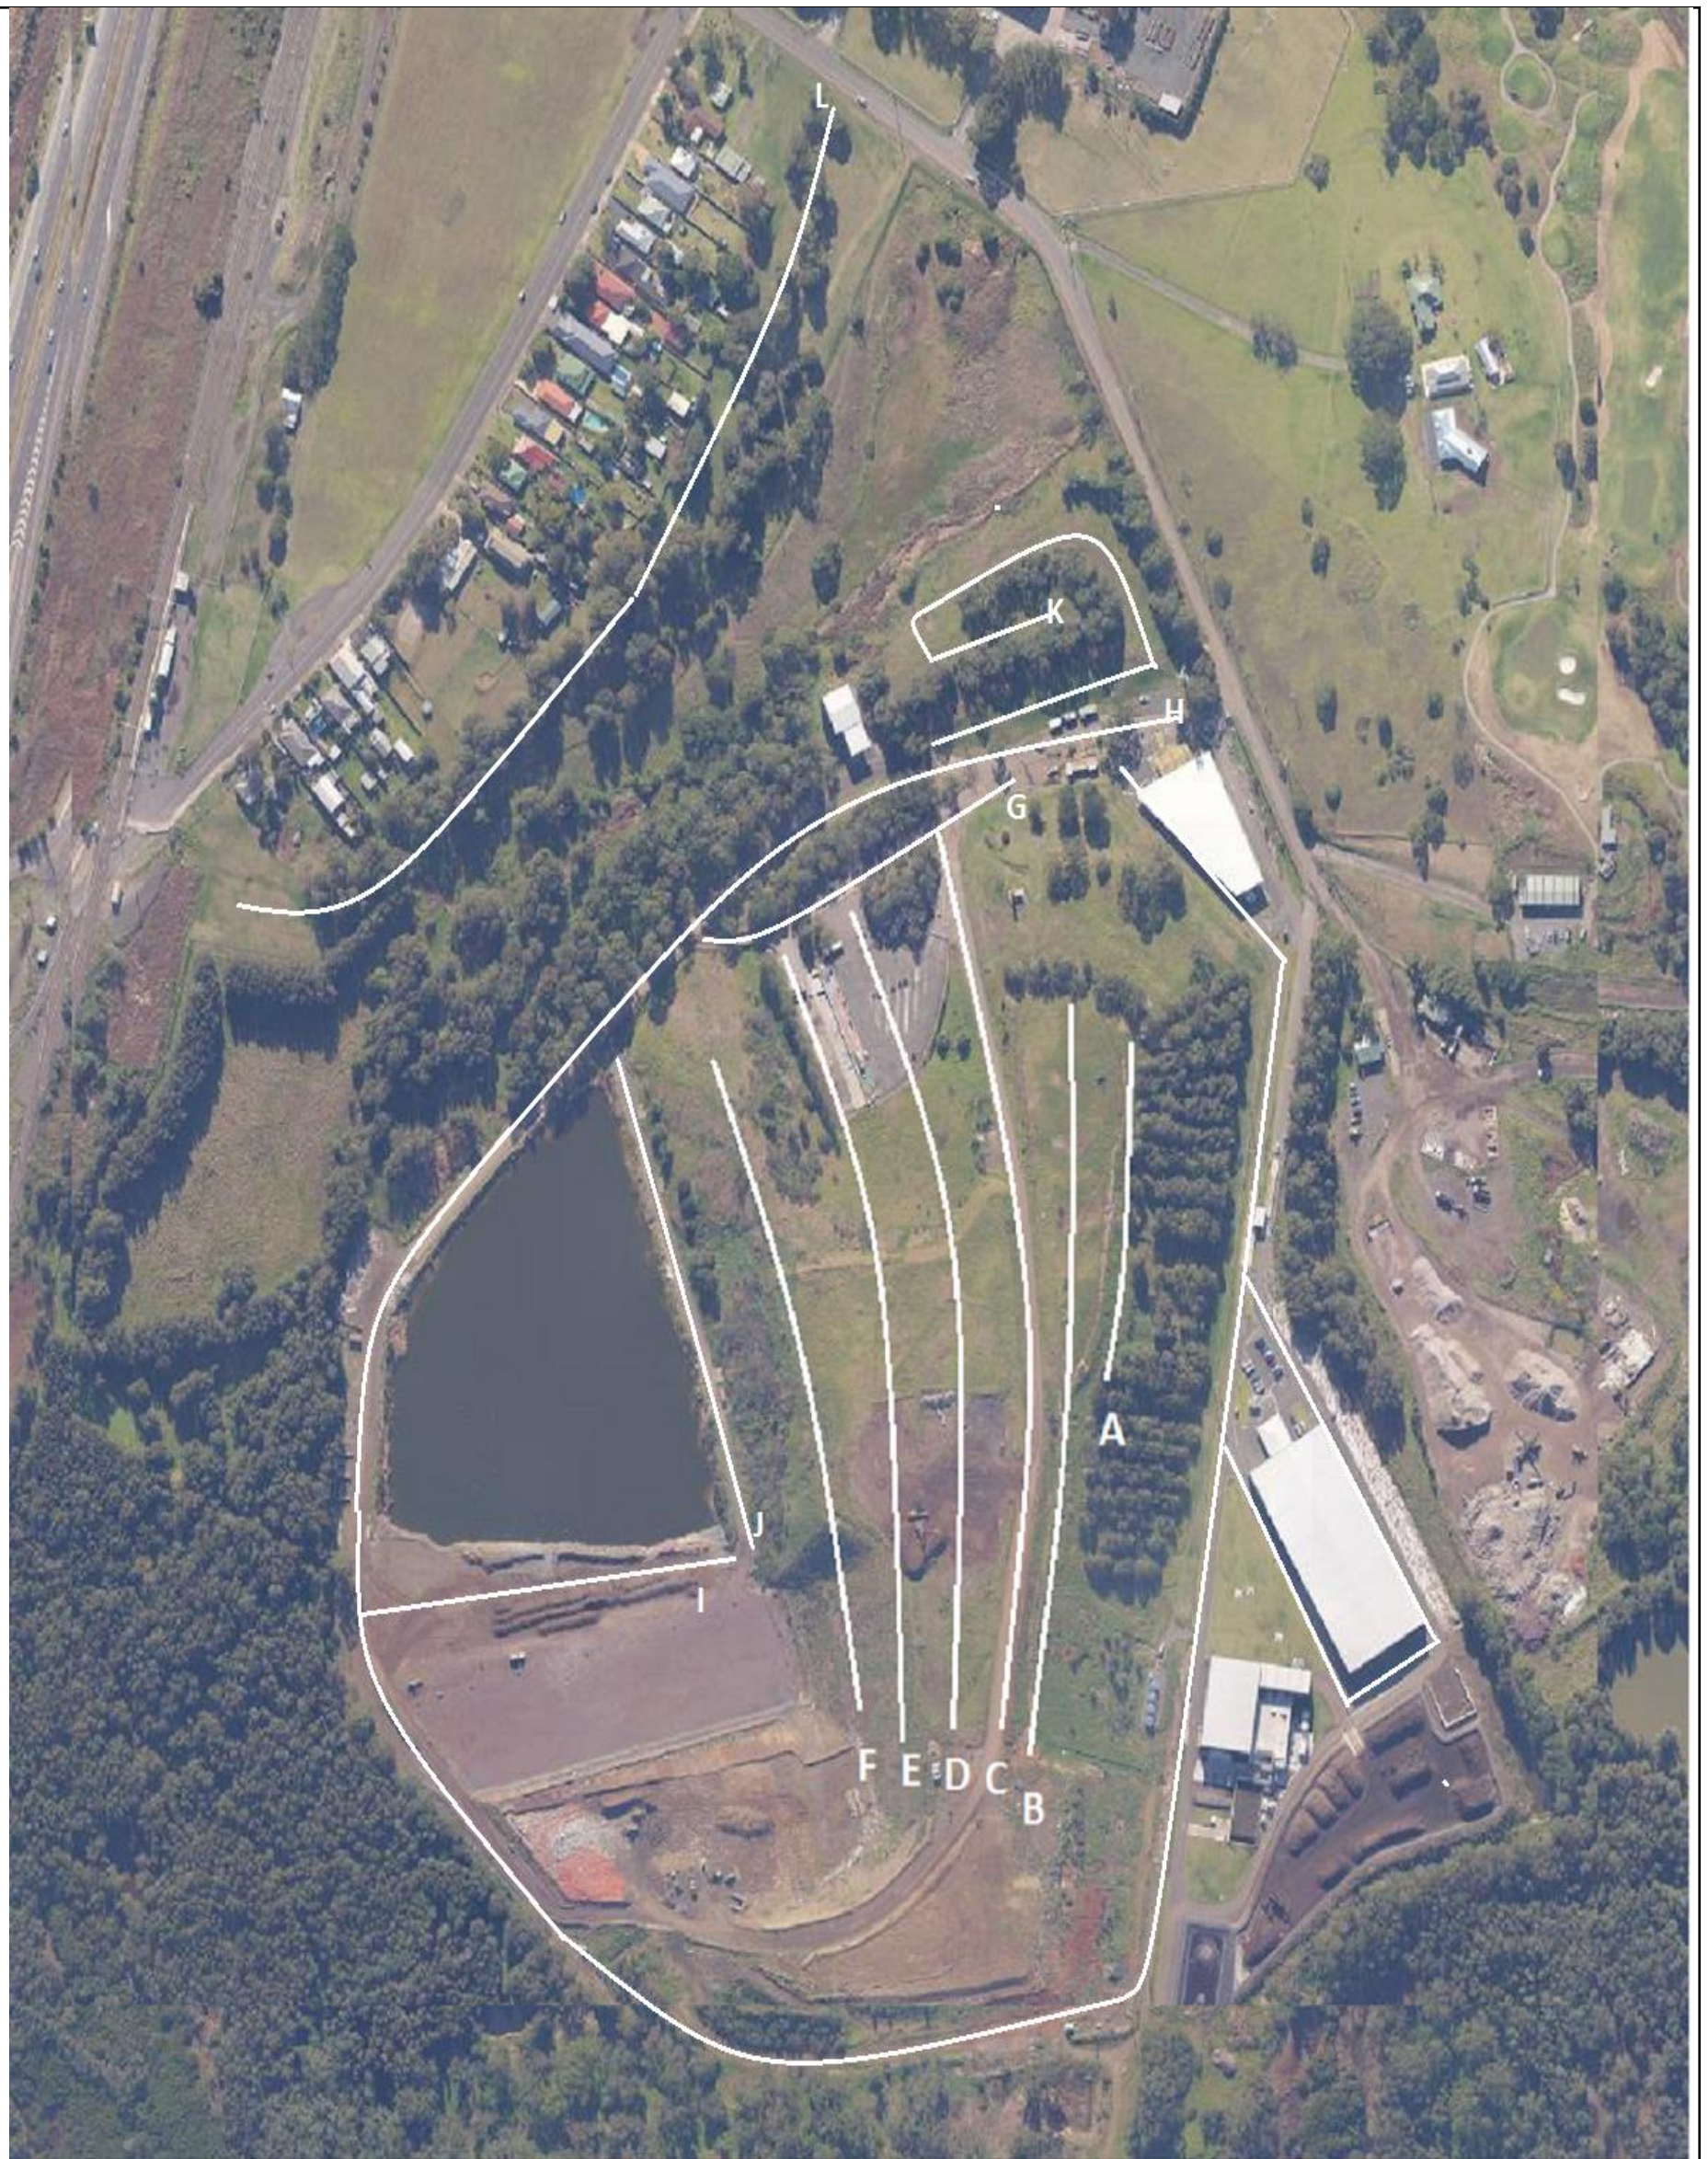
The internal methane concentrations for each enclosed structure were recorded by a field technician. A site plan depicting the location onsite of each structure provided in **Figure 3**. Any depressions or surface fissures away from the sampling grid were also investigated.

Client:	Shellharbour City Council	Drawn:	PL	Figure:	3
Project:	ENRS0033	Source:	SixMaps	Date:	16/01/2020
Location:	Dunmore Recycling & Waste Depot 44 Buckleys Rd, Dunmore, NSW, 2529	Scale:	NA	Title:	Surface Gas Sample transects
		Status:	Rev 1

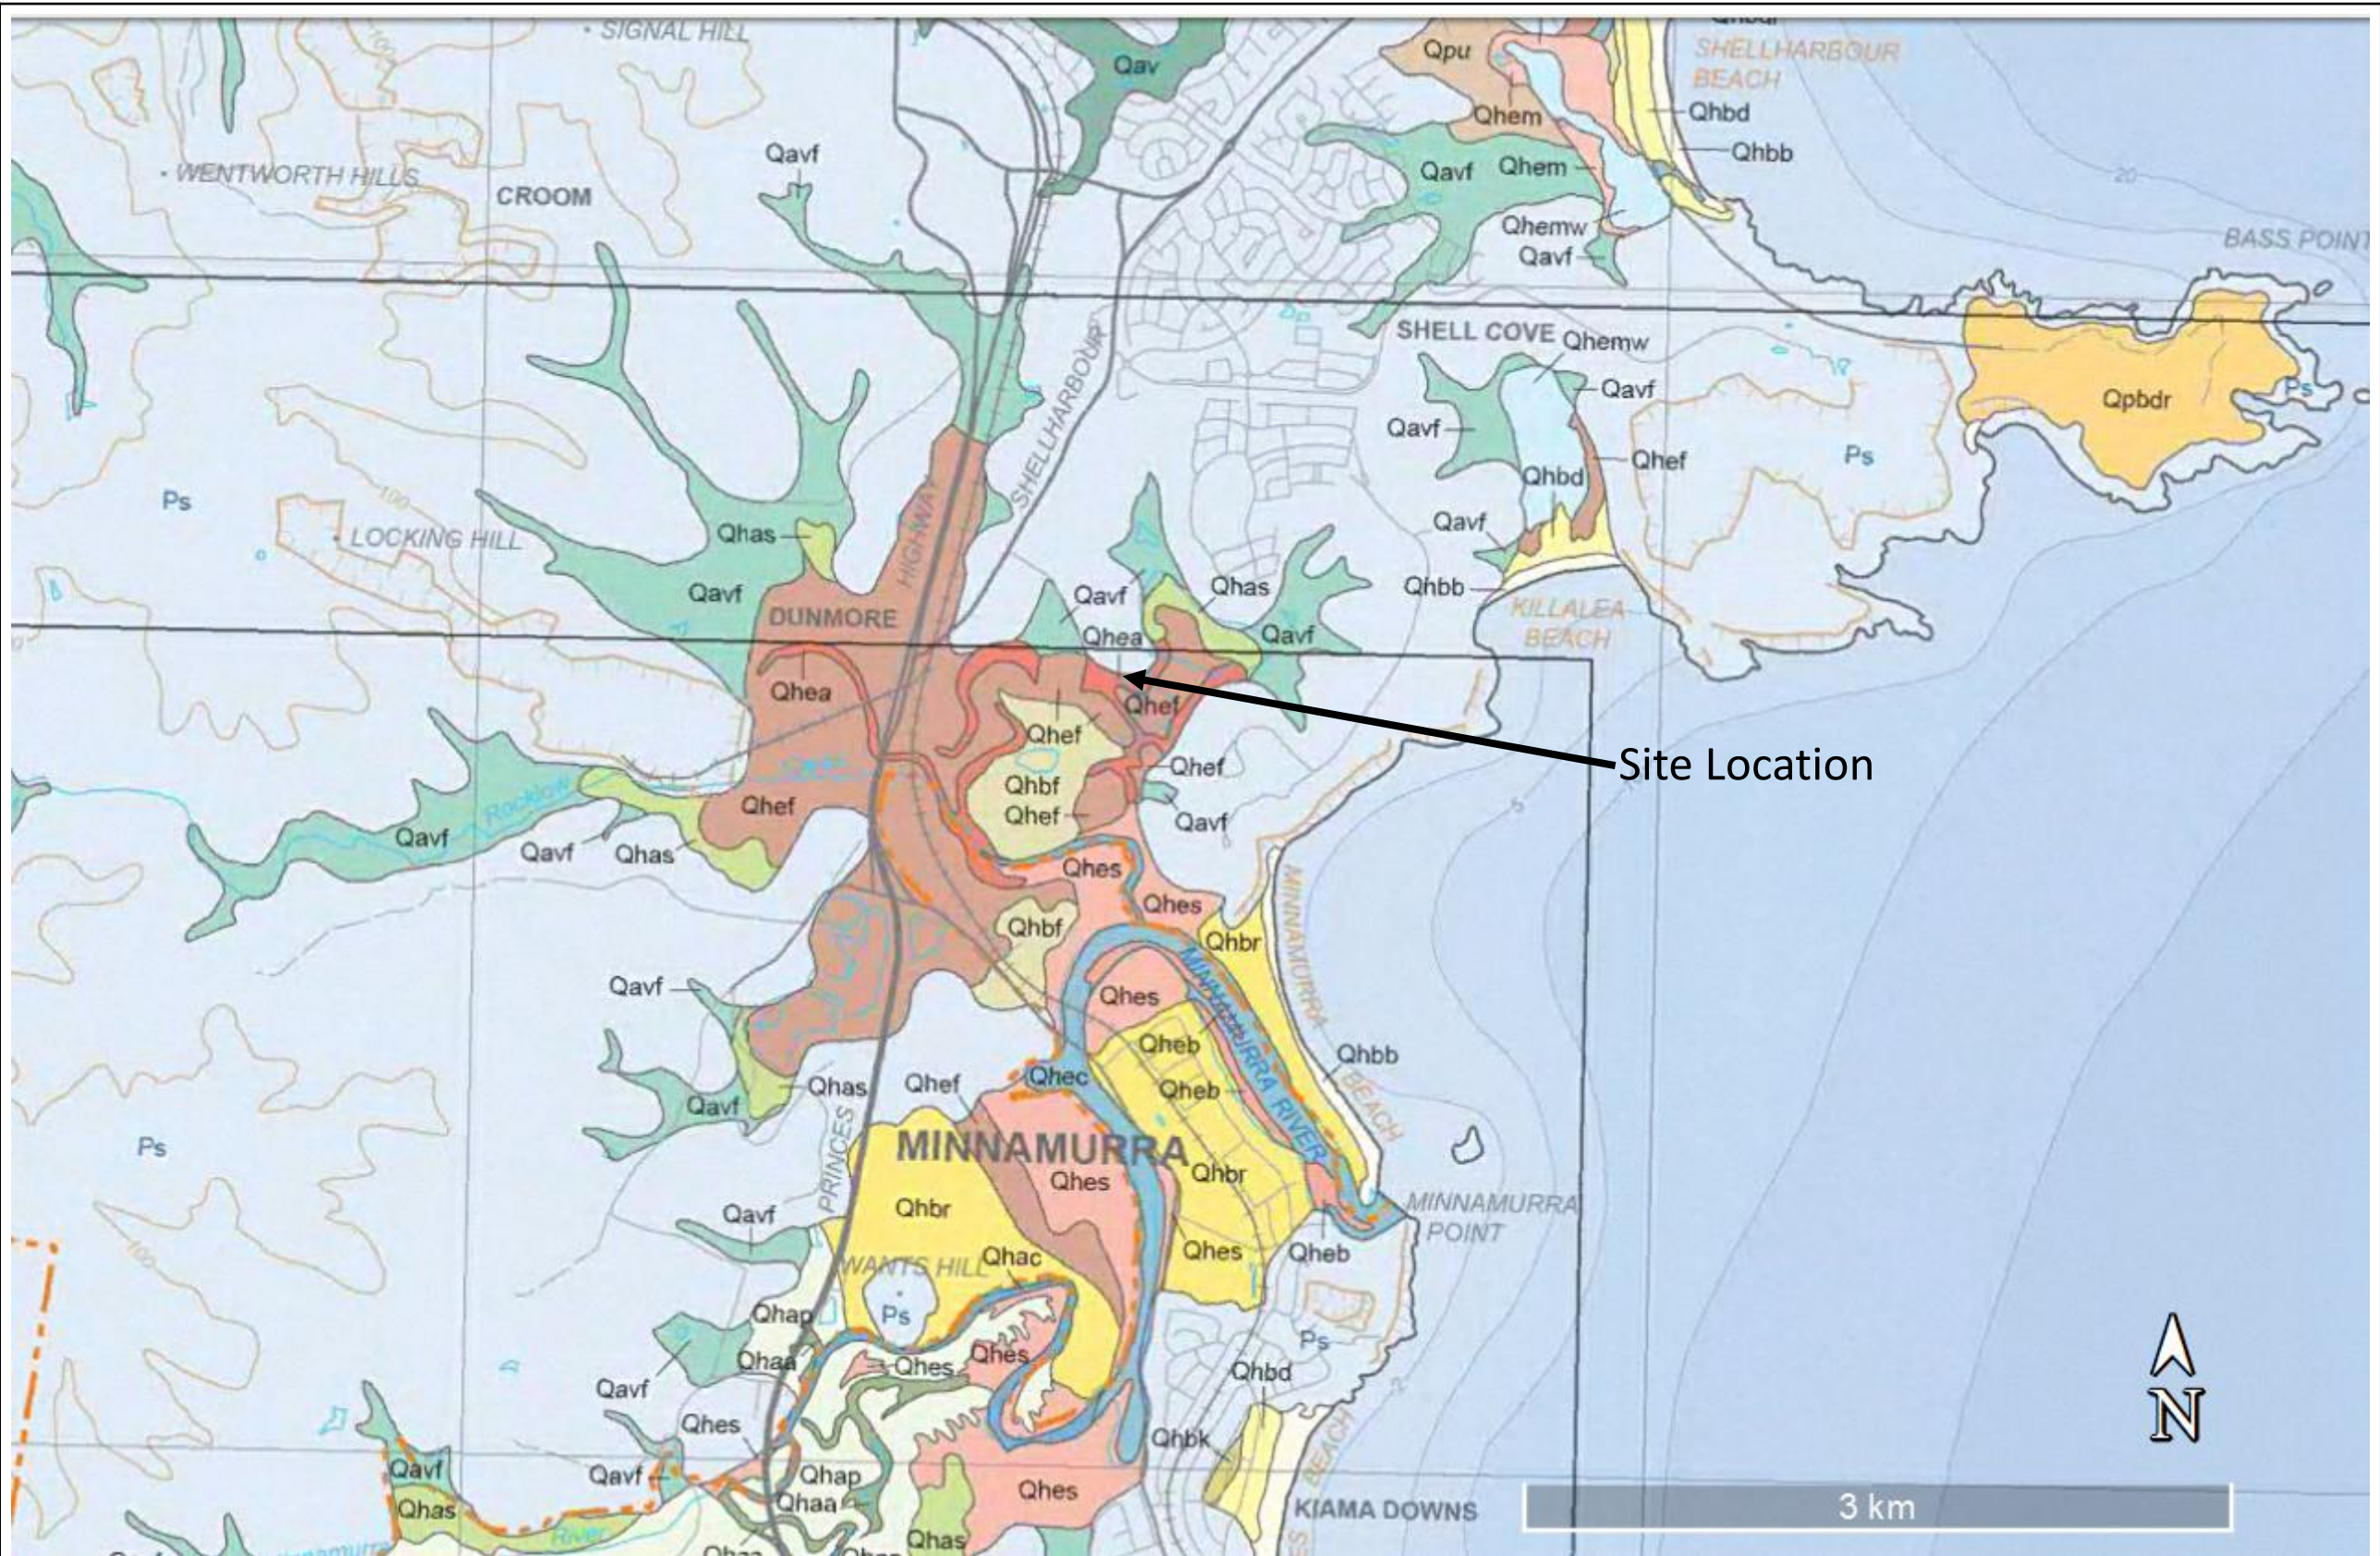
Client:	Shellharbour City Council	Drawn:	PL	Figure:	4
Project:	ENRS0033	Source:	Geological Survey of NSW	Date:	16/01/2020
Location:	Dunmore Recycling & Waste Depot 44 Buckleys Rd, Dunmore, NSW, 2529	Scale:	See figure	Title:	Site Geology
		Status:	Rev 1
