Quarterly Environmental Monitoring Report (QEMR) Q1 December 2023

**Address: Dunmore Recycling & Waste Depot
44 Buckleys Road,
Dunmore, NSW, 2529**

Project No.: ENRS0033

Date: December 2023

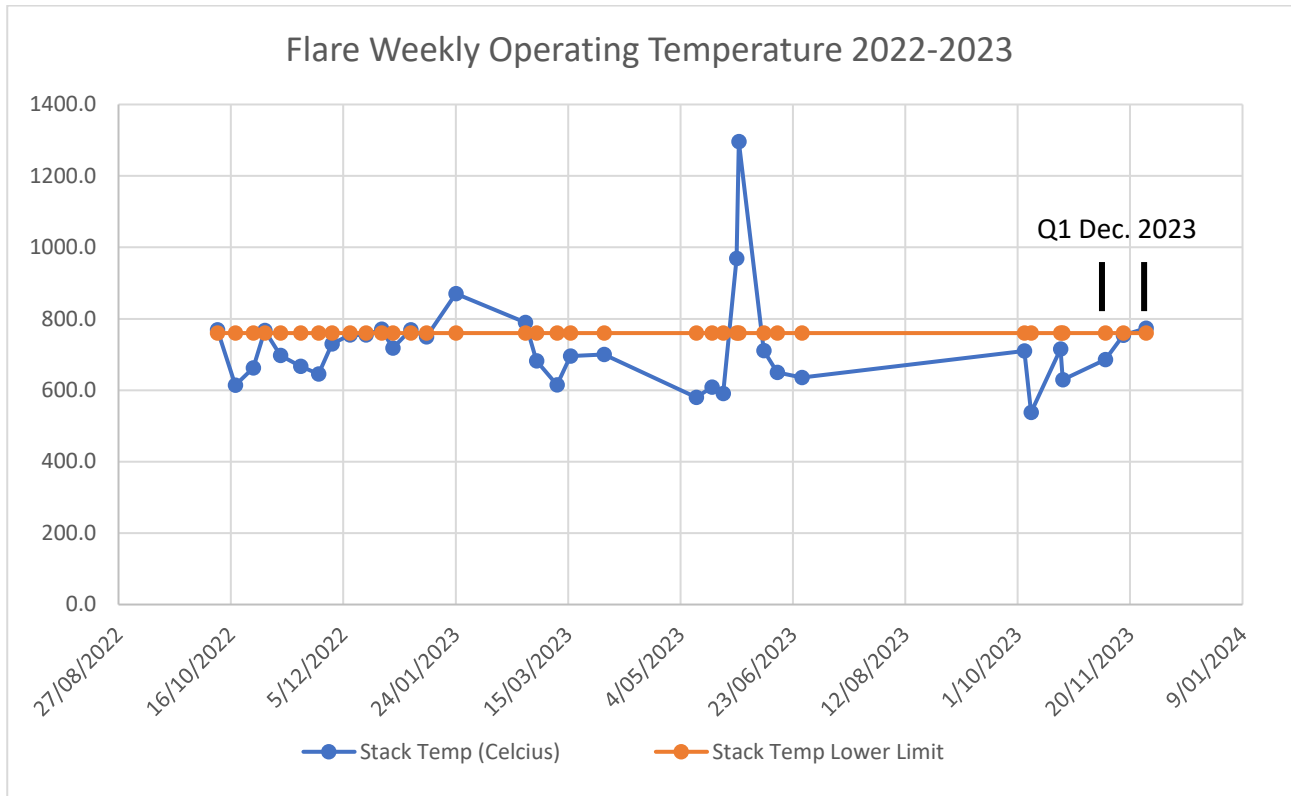
Chart 1: Weekly Flare Operating Temperatures 2022-2023

Weekly average operating temperatures supplied by LGI displayed typical variation associated with a continuous process. Weekly operating temperatures at the Flare fell below the Operational temperature Limit of 760 degrees on one (1) event on the 9/11/2023 during the quarterly monitoring period. This is in line with the historical data. The actions taken throughout to address the root causes are outlined in the LGI Gas Flare reports included as **Appendix G**. Chart 1 below depicts historical results between October 2022 and December 2023.

- Flare temperatures fell below the required KPI of 760 degrees Celsius on one occasion. The reader is referred to the LGI Flare Reports provided in **Appendix G**;

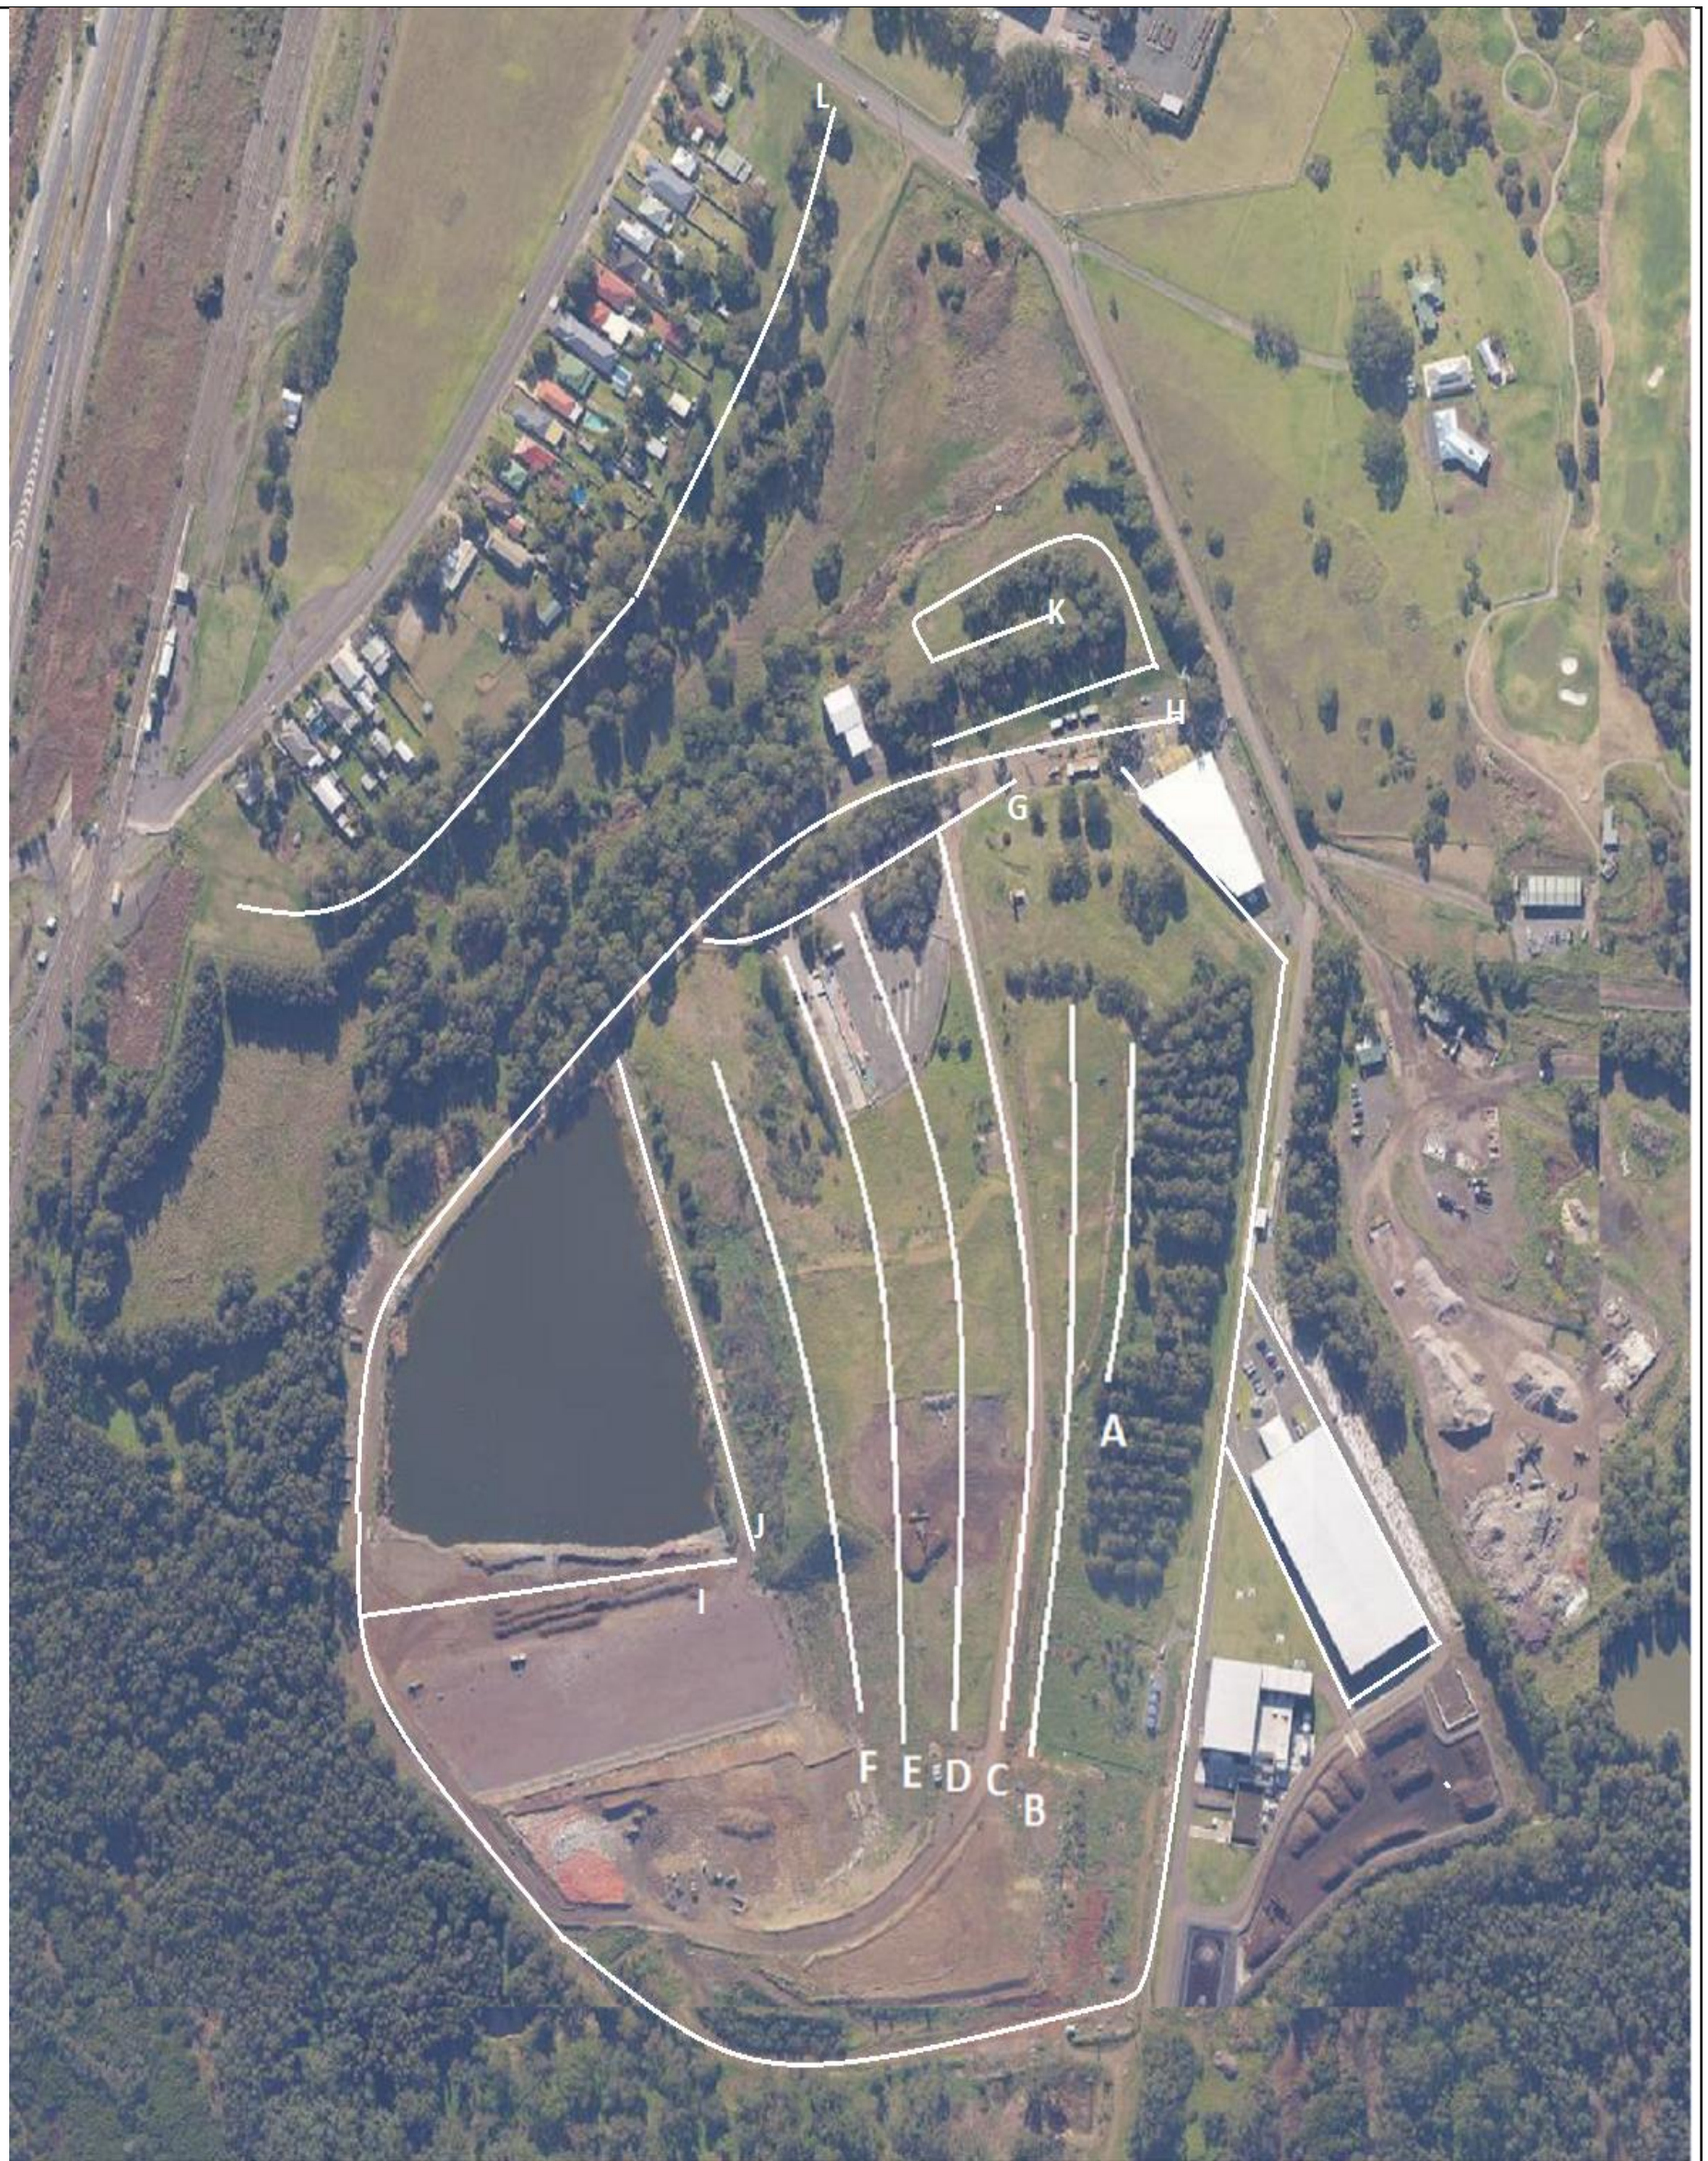
Results for depositional dust during the December 2023 Q1 monitoring period generally reported levels of dust below the adopted assessment criteria of 4 g/m2/month. A single exceedance was report for Quarter 4 of 8.7 g/m2/month. Dust gauge locations are provided in Figure 14-1 attached. It is recommended that monitoring is continued in accordance with EPL 5984.

The assessment was limited to sampling locations listed in EPL 5984. As listed in **Appendix A** and depicted in **Figure 14-1 - Figure 14-2**.
