Quarterly Environmental Monitoring Report (QEMR) Q1 December 2024

Project No: ENRS0033

Dunmore Recycling & Waste Depot, 55 Buckleys Road, Dunmore, NSW Address:

10/03/2025 Date:

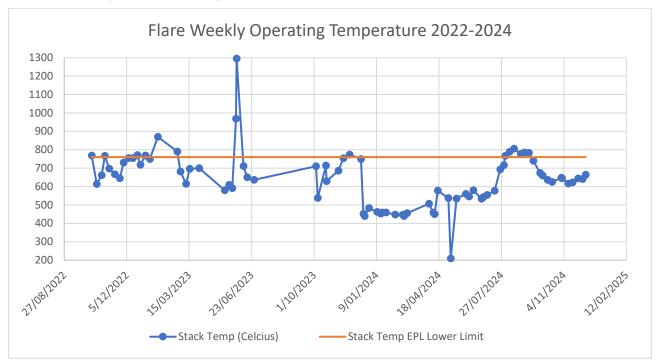
Chart 1: Weekly Flare Operating Temperatures October 2022 – December 2024

Weekly average operating temperatures for the Q1 2024-2025 monitoring period supplied by LGI displayed an average temperature of 642.4 degrees Celsius. This was below the lower operation limit of 760 degrees as specified within EPL 5989. Further information is documented within the LGI reports in Appendix G.

Notes: Data sourced from the LGI reports provided in Appendix G.

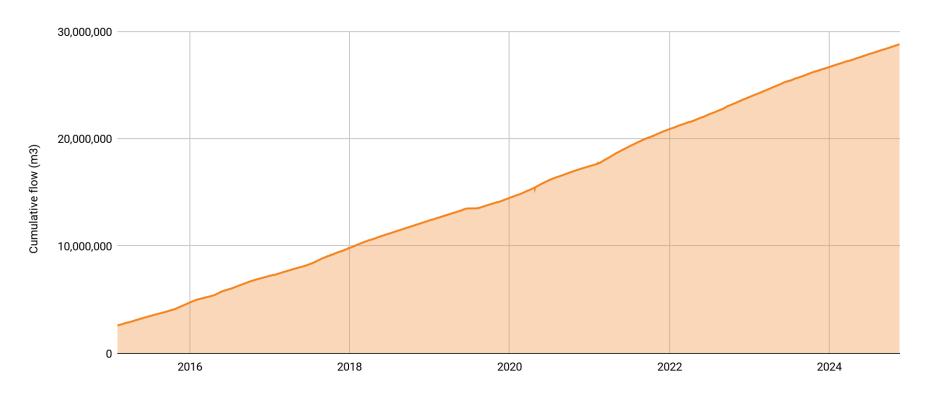
Dunmore - Cumulative Flow

28,708,171 m3 of combusted landfill gas from the beginning of the project up to 1 November 2024 represents:

- 272,659 tonnes of CO2 equivalent (total methane abated by gas capture system to date).
- 4,544,312 seedlings planted for 10 years
- 4,952 (cars off the road for the last 12 months)
- 92,714 Australian Carbon Credit Units (ACCUs)

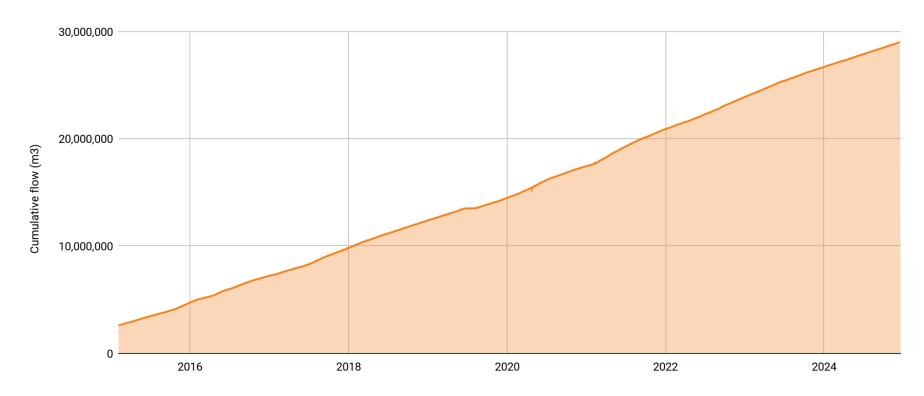
Dunmore - Cumulative Flow

28,907,639 m3 of combusted landfill gas from the beginning of the project up to 1 December 2024 represents:

- 274,553 tonnes of CO2 equivalent (total methane abated by gas capture system to date).
- 4,575,887 seedlings planted for 10 years
- 4,954 (cars off the road for the last 12 months)
- 141,543 Australian Carbon Credit Units (ACCUs)

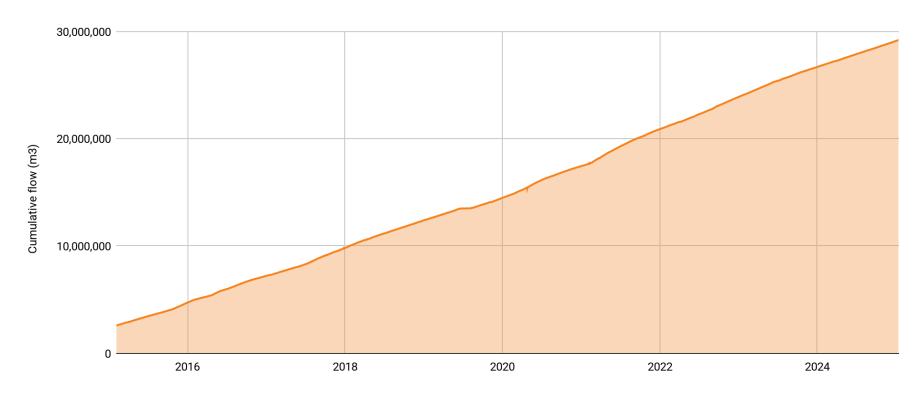
Dunmore - Cumulative Flow

29,123,751 m3 of combusted landfill gas from the beginning of the project up to 1 January 2025 represents:

- 276,606 tonnes of CO2 equivalent (total methane abated by gas capture system to date).
- 4,610,096 seedlings planted for 10 years
- 4,991 (cars off the road for the last 12 months)
- 141,543 Australian Carbon Credit Units (ACCUs)
